## ALERT SERVICE BULLETIN

**SUBJECT: REVISION "B" TO ALERT SERVICE BULLETIN 206L-98-114:  
TAILBOOM 206-033-004-ALL, INSPECTION OF.**

NO. 206L-98-114  
DATE 11-25-98  
PAGE 1 of 4

**SUBJECT:** TAILBOOM 206-033-004-003, /-011, /-103, /-045, /-143, /-175 AND /-177 INSPECTION OF. B.

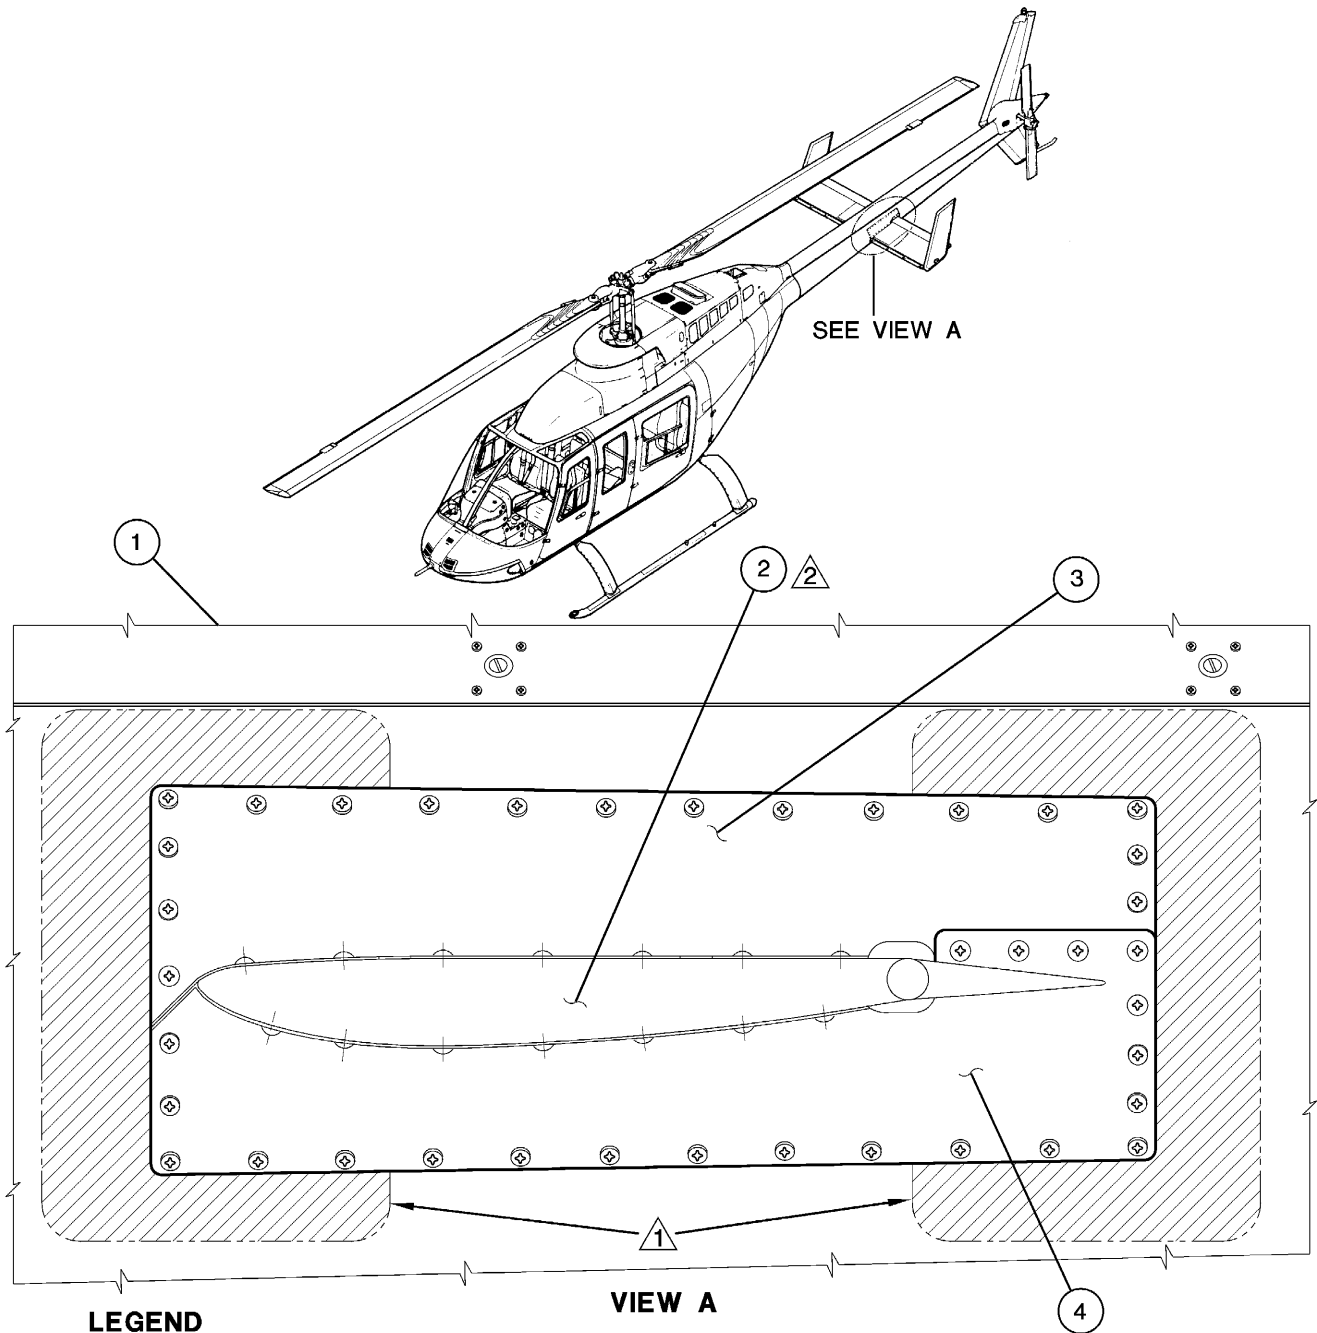
**Figure 1. Inspection of the Tailboom Assembly**

Bell Helicopter has received seven reports of cracks to the tailboom skin in the area of the horizontal stabilizer since ASB 206L-97-107 was published. The cracks were found by normal visual inspection. The average time accumulated on the tailbooms was more than 2000 hrs. Bell Helicopter is now developing a remedy to prevent this condition.

- △1 Inspect these two areas for cracks on both sides of the tailboom.
- △2 Horizontal stabilizer not shown for clarity.

2. Before the first flight of the day, do a check of the tailboom assembly for cracks (Figure 1).
  - a. If there is a crack on the tailboom skin, replace the tailboom before the next flight.
  - b. If no crack is found, the aircraft is serviceable.
3. Make an entry in the helicopter historical records to show that this bulletin is completed.
