ALERT SERVICE BULLETIN

NO. 212-00-109
DATE 10-19-00
PAGE 1 of 3

MODEL AFFECTED: 212

SUBJECT: MAIN HYDRAULIC SERVO ACTUATOR ROD
END LOCK WASHER, INSPECTION AND
REPLACEMENT OF

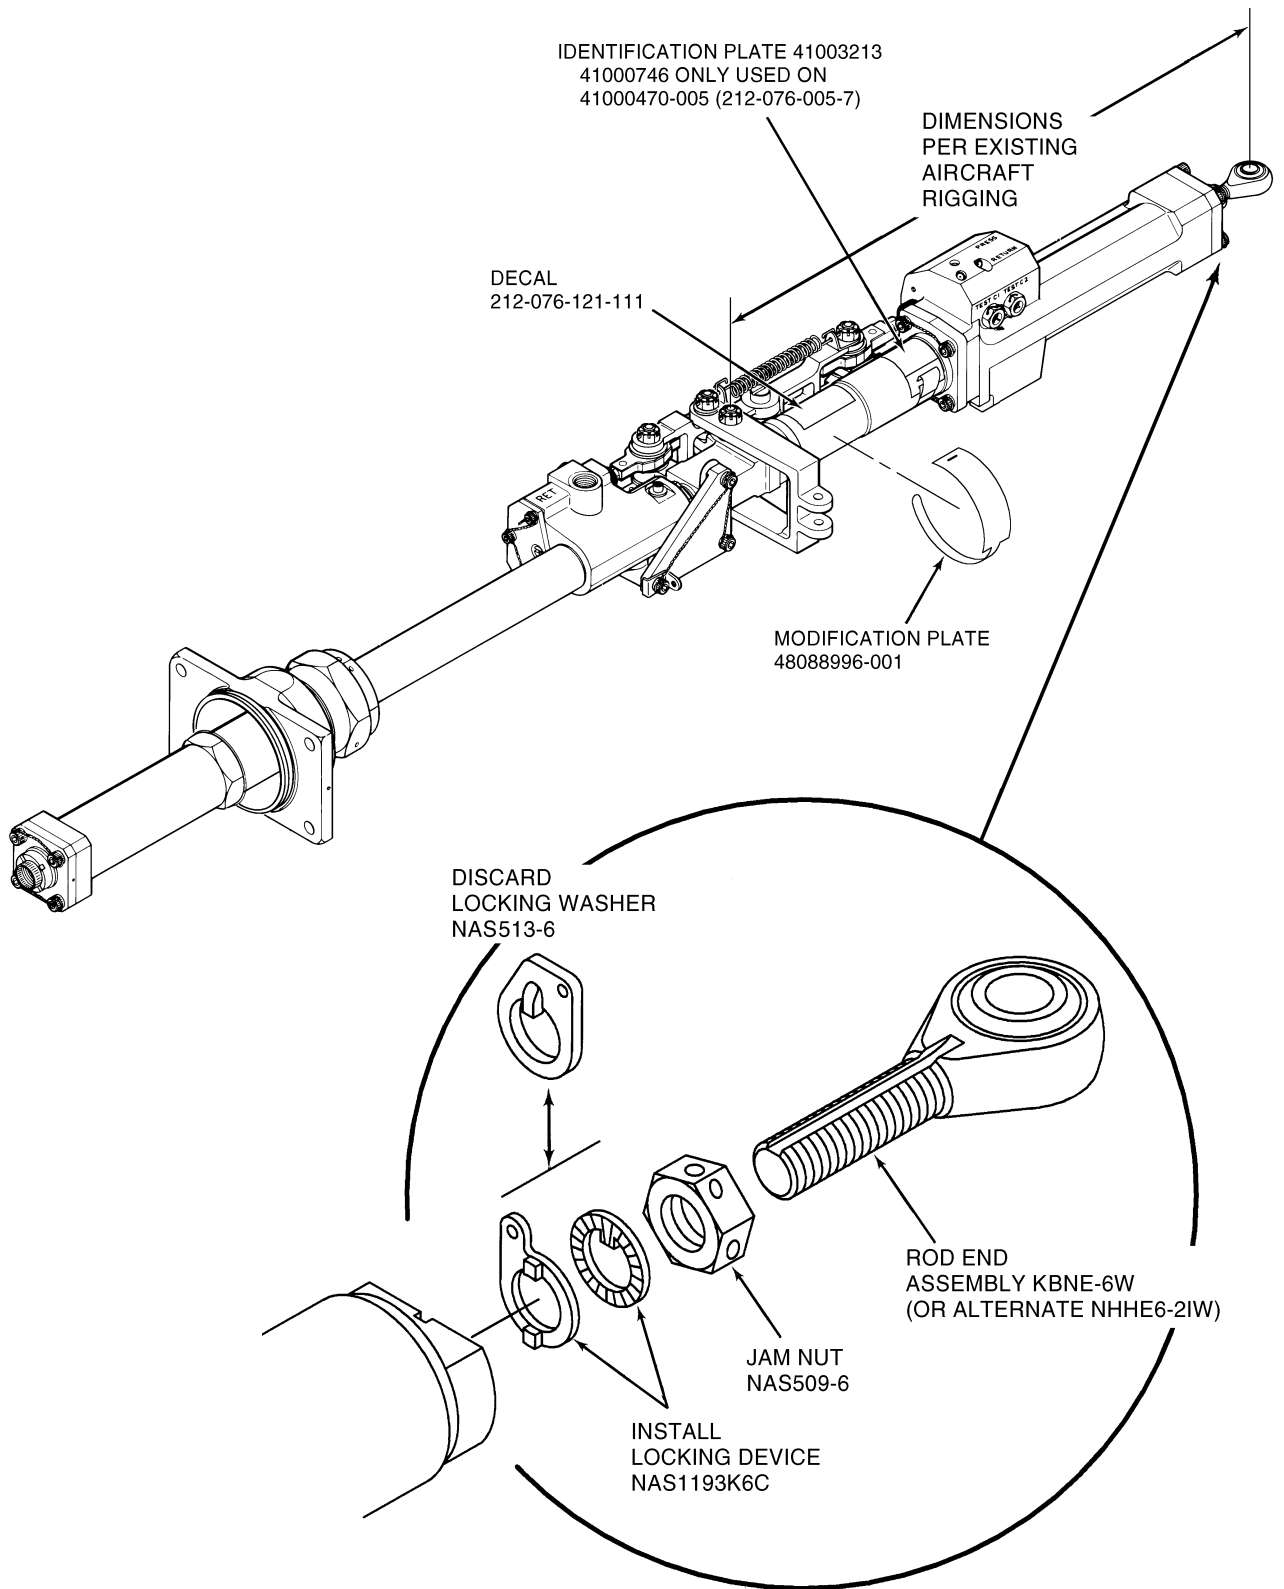
A customer recently discovered a damaged locking washer that had allowed the piston to back itself out of the locking jam nut (Figure 1). This condition prevented the aircraft from taking off and presented a Safety of Flight condition. Bell Helicopter's subsequent investigation determined that all existing locking washers NAS513-6 used on applicable actuators shall be replaced with new locking devices NAS1193K6C.

Locking Washer Inspection Area

- (1) Without removing actuator from aircraft, gain access to locking washer (Figure 1).
- (2) Visually inspect locking washer to ensure it is not broken. Tab shall be in groove of rod end assembly. Immediately replace any locking washer whose tab is twisted or hanging askew.

- (7) Carefully install new 2-piece locking device NAS1193K6C onto rod end assembly. Refer to Figure 1 and the following substeps:
 - (a) Install round ring onto threaded rod so that tab fits into groove on rod end and serrated side faces away from jam nut.
