**ALERT SERVICE BULLETIN**

**Bell Helicopter** **TEXTRON**

**TO: All Owners/Operators of Bell 212 Helicopters**

**SUBJECT: REVISION "A" TO ALERT SERVICE BULLETIN 212-00-110: FIN SPAR  
CAP P/N 212-030-125-001, P/N 212-030-447-001/101, INSPECTION OF**

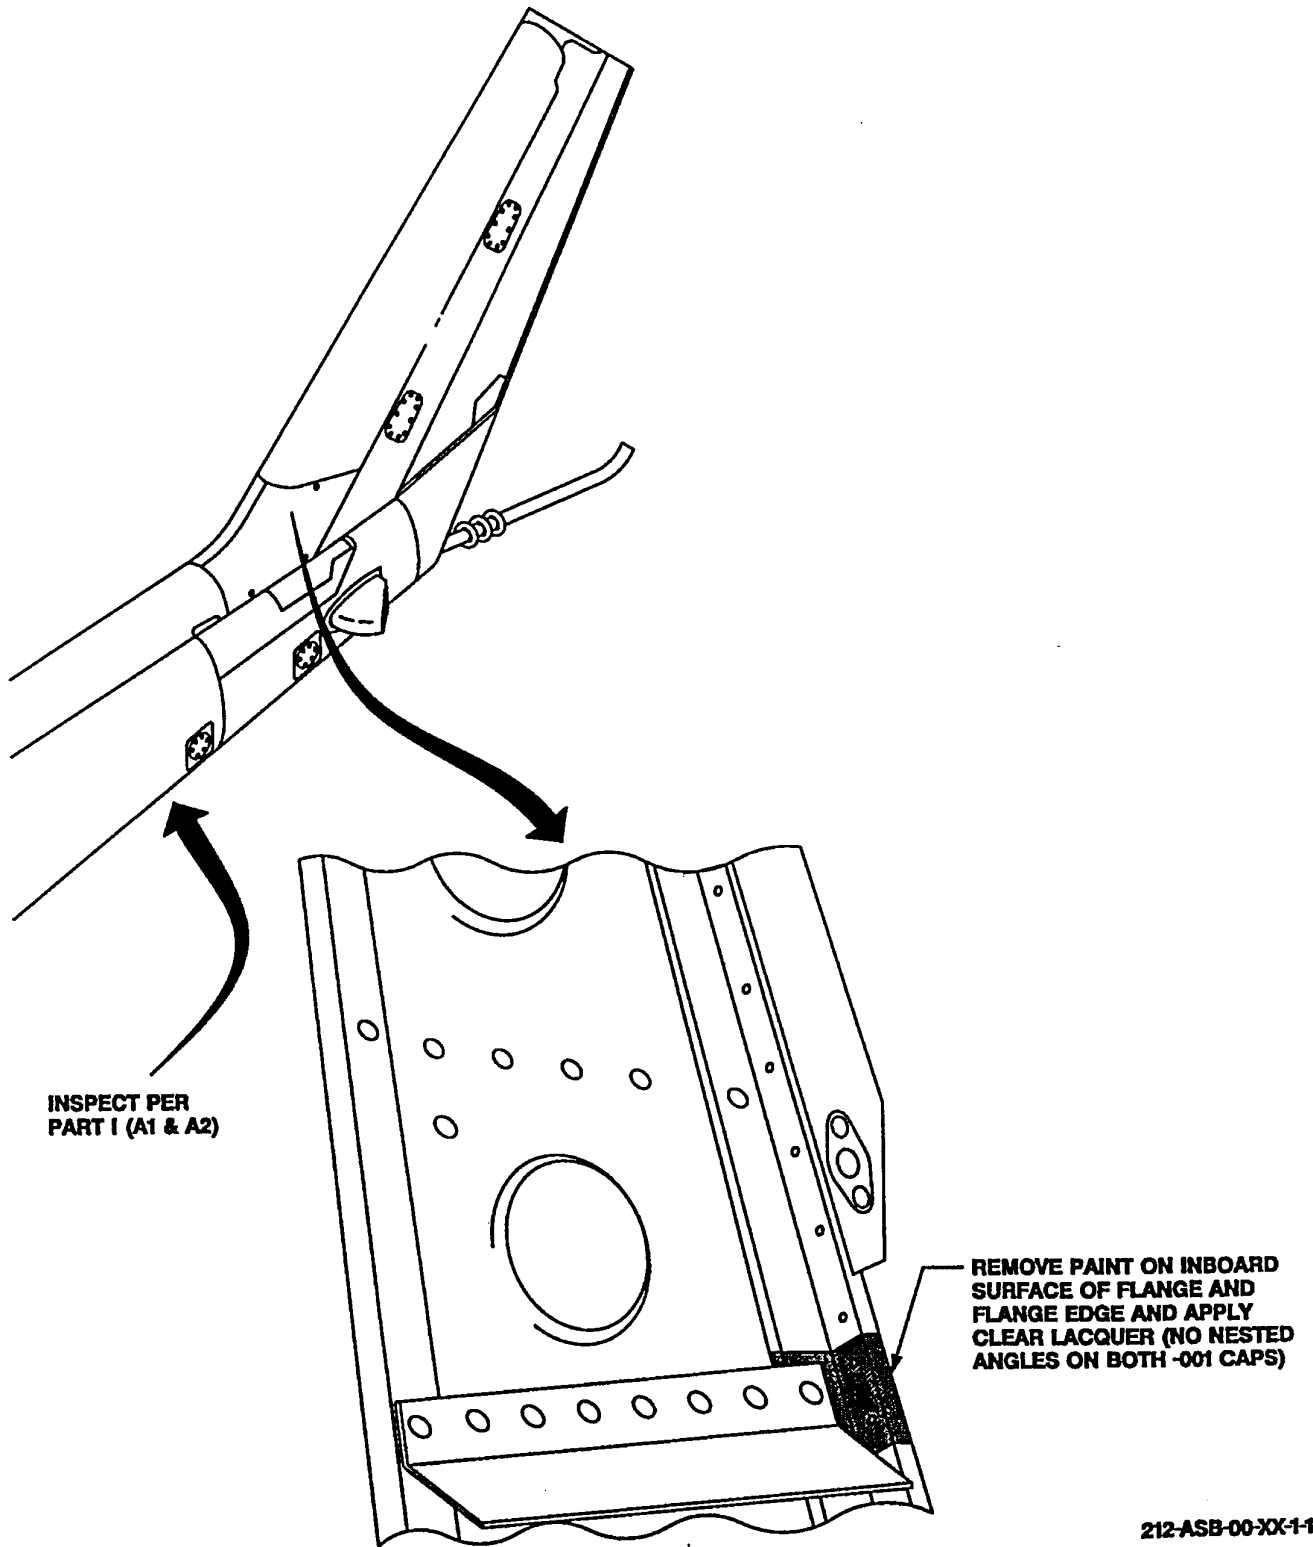
FIGURE 1. (SHEET 1) - PART I

Cracks have been found on fin spar cap P/N 212-030-125-001, P/N 212-030-447-001/101. Fatigue cracks originated from the rivet holes in the area of fin station 60 to 75. Loose rivets, debonding of the doublers and corrosion contributed to cracking of the spar cap. This bulletin establishes additional inspection requirements for the vertical fin cap.

4. Using bright light, a small mirror and a 10x magnifying glass, inspect the exposed areas of the spar assembly adjacent to the tailboom top skin looking from both the top and the bottom. Pay attention to the inboard surface of the spar cap between fin station 66.31 and 75.00, particularly in the area noted in Item 2. Access to fin station ~72.00 to 75.00 is difficult. This area should be inspected through the tailboom lower inspection door with a bright light and a mirror. Any questionable defect should be inspected more carefully with a boroscope. Refer to Figure 1.

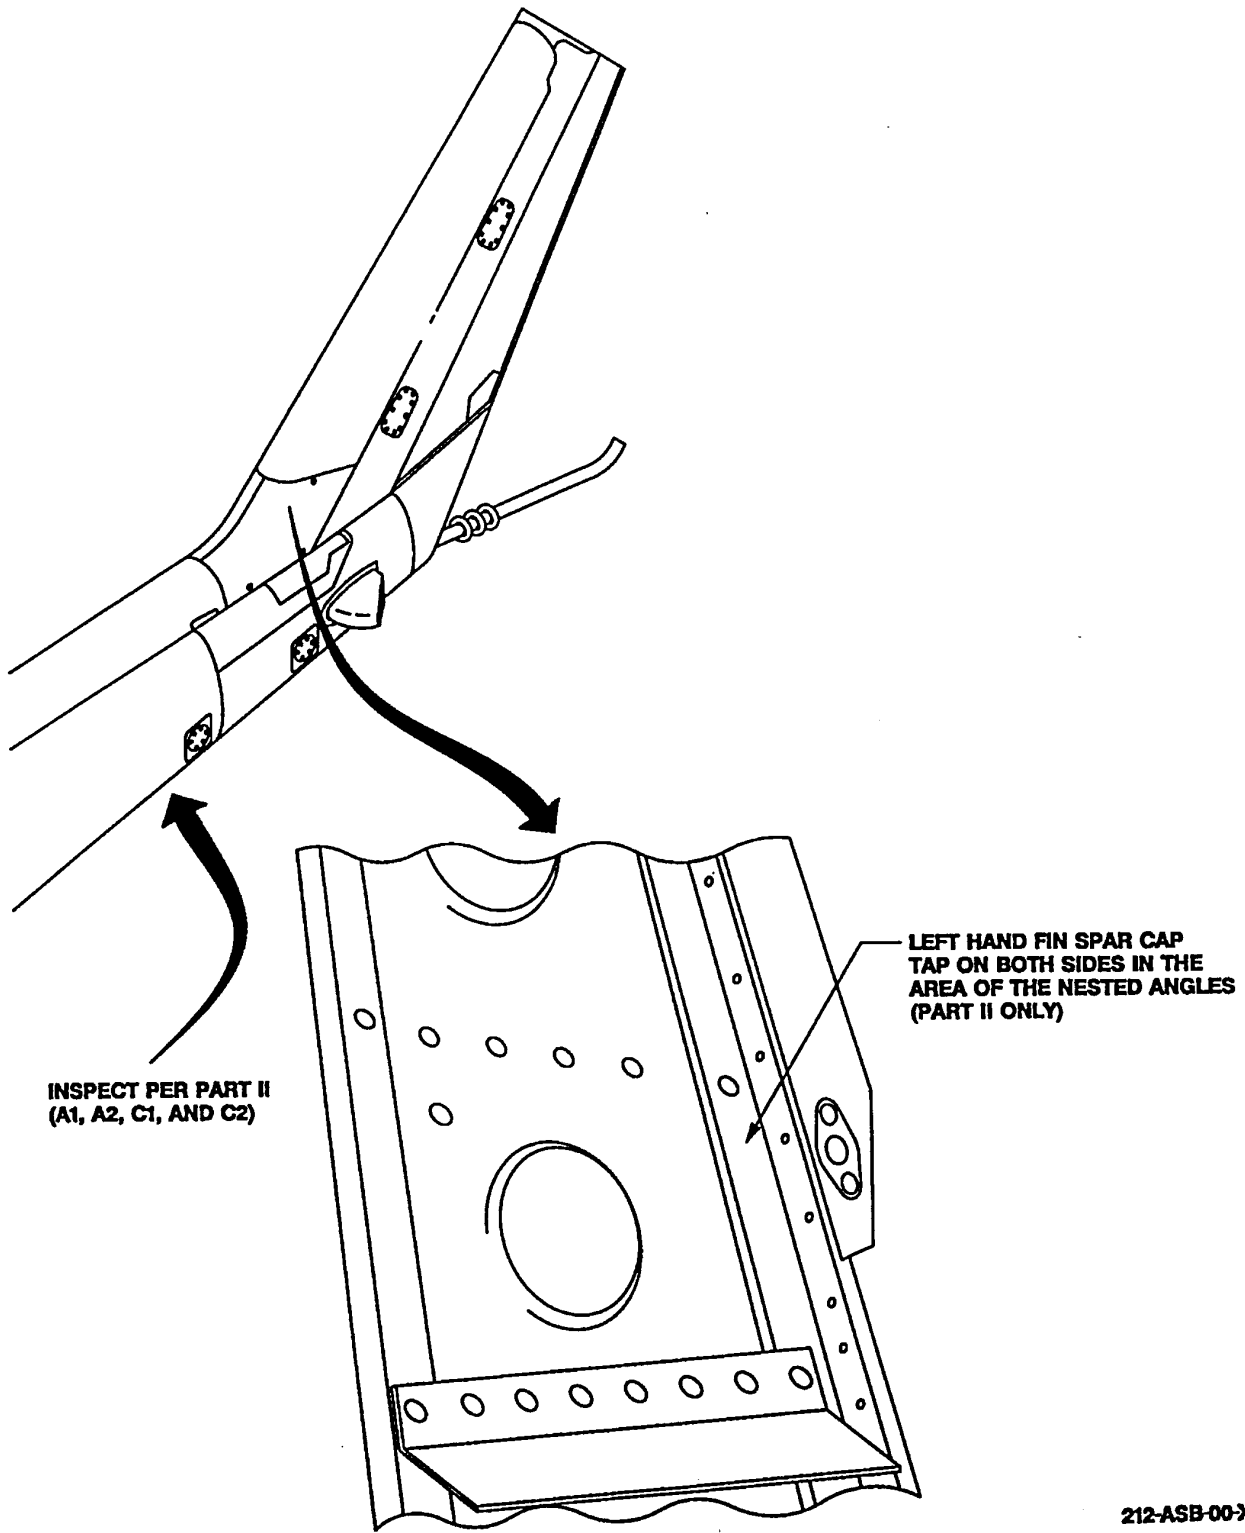
FIGURE 1. (SHEET 2) - PART II

5. Using bright light, a small mirror and a 10x magnifying glass, inspect the exposed areas of the spar assembly adjacent to the tailboom top skin looking from both the top and the bottom. Pay attention to the inboard surface of the spar cap between fin station 66.31 and 75.00, particularly in the area noted in Item 2. Access to fin station ~72.00 to 75.00 is difficult. This area should be inspected through the tailboom lower inspection door with a bright light and a

mirror. Any questionable defect should be inspected more carefully with a boroscope. See Figures 1, 2 and 3.

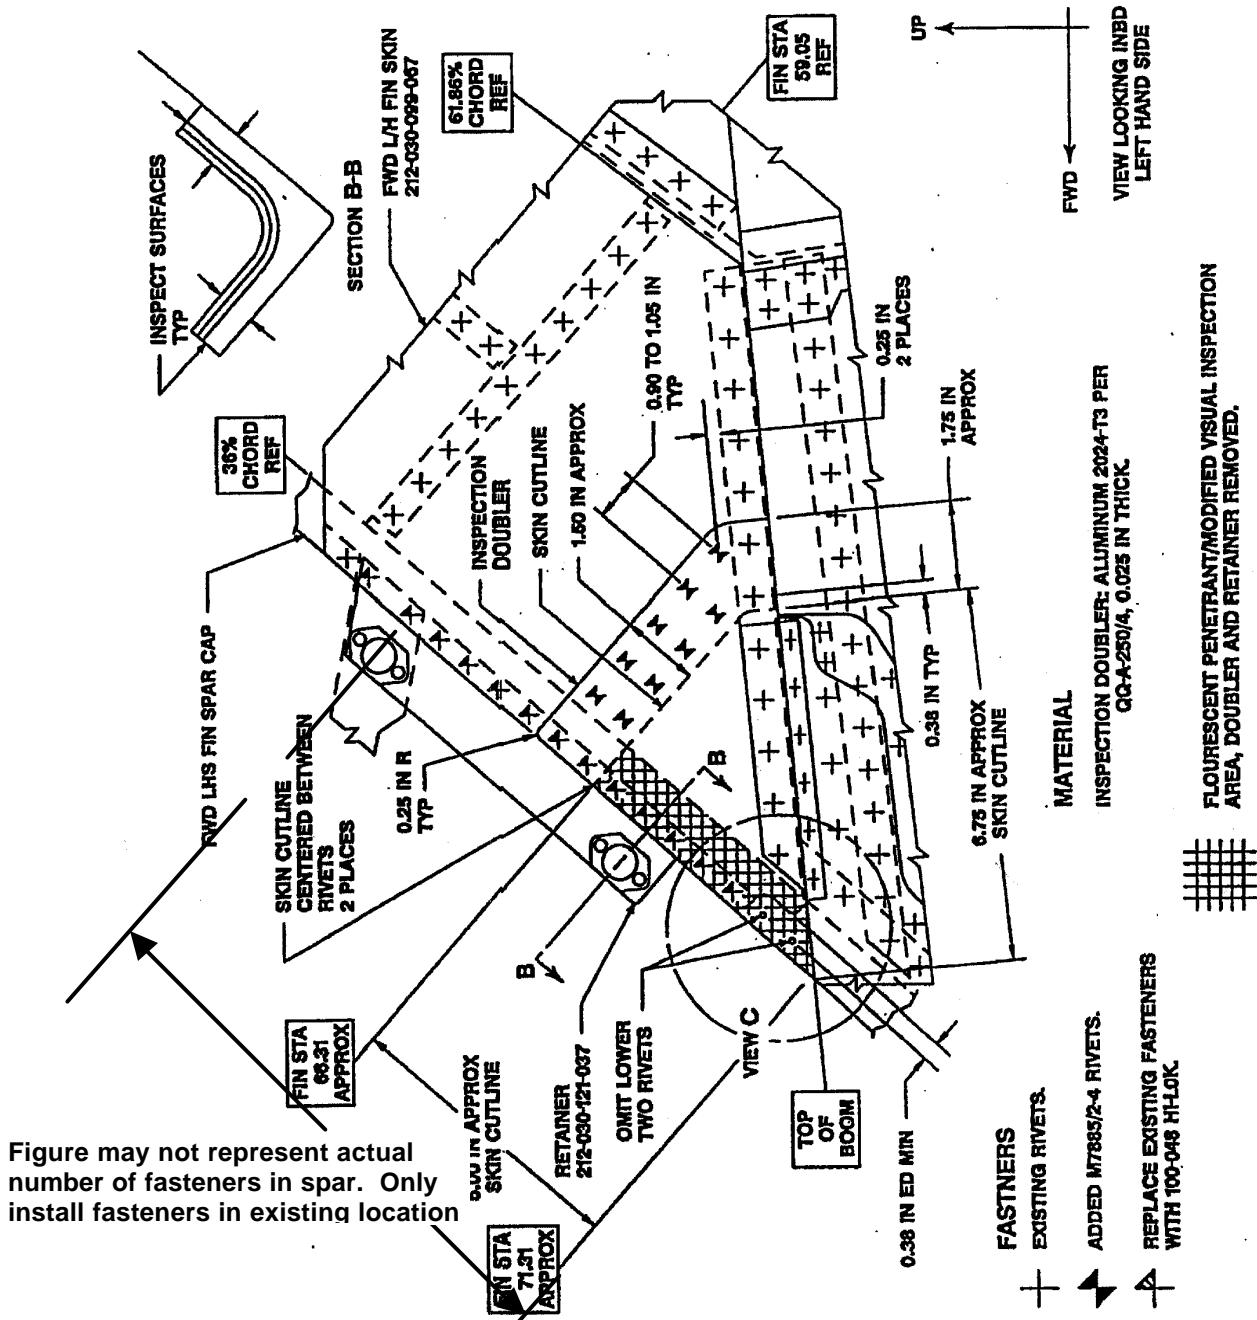
FIGURE 2. (SHEET 1 OF 2) - PART II INSPECTION CONFIGURATION FOR 212-030-447-101

Figure may not represent actual number of fasteners in spar. Only install fasteners in existing location

2. For P/N 212-030-447-101, remove Clip P/N 212-030-099-091 and Radius Block P/N 212-030-099-095, if existing. Remove sufficient rivets from the bottom row of the FWD L/H Fin Skin and from the P/N 212-030-121-037 Retainer and Spar Cap, to allow trimming of the FWD L/H Fin Skin as shown by the crosshatched area of Figure 2, View C. For P/N 212-030-125-001 with Retrofit Kit P/N 212-704-087, remove Clip P/N 212-030-099-091 and Radius Block P/N 212-030-099-095, if existing. Remove sufficient rivets from the bottom row of the FWD L/H Skin and from the P/N 212-030-121-033 Retainer and Spar Cap, to allow trimming of the FWD L/H Fin Skin and P/N 212-030-121-033 retainer, as shown by the crosshatched area and the skin cutlines Fin 66.31 to 71.31 of Figure 3, View C.

8. Fasten the FWD L/H Fin Skin and the P/N 212-030-121-037 or P/N 212-030-121-033 Retainer back to the spar assembly using Hi-Loks and blind rivets as shown in Figure 2 or Figure 3. Reinstall Clip and Radius Block (if existing) removed in item 2.
9. Refinish reworked area as per instructions found in Standard Repair Manual except in area where protective coat of MIL-C-16173, Grade 2 was used.
10. Install the inspection door, intermediate gearbox cover and tail rotor driveshaft cover.
11. Make an entry in helicopter historical records indicating compliance with this bulletin.

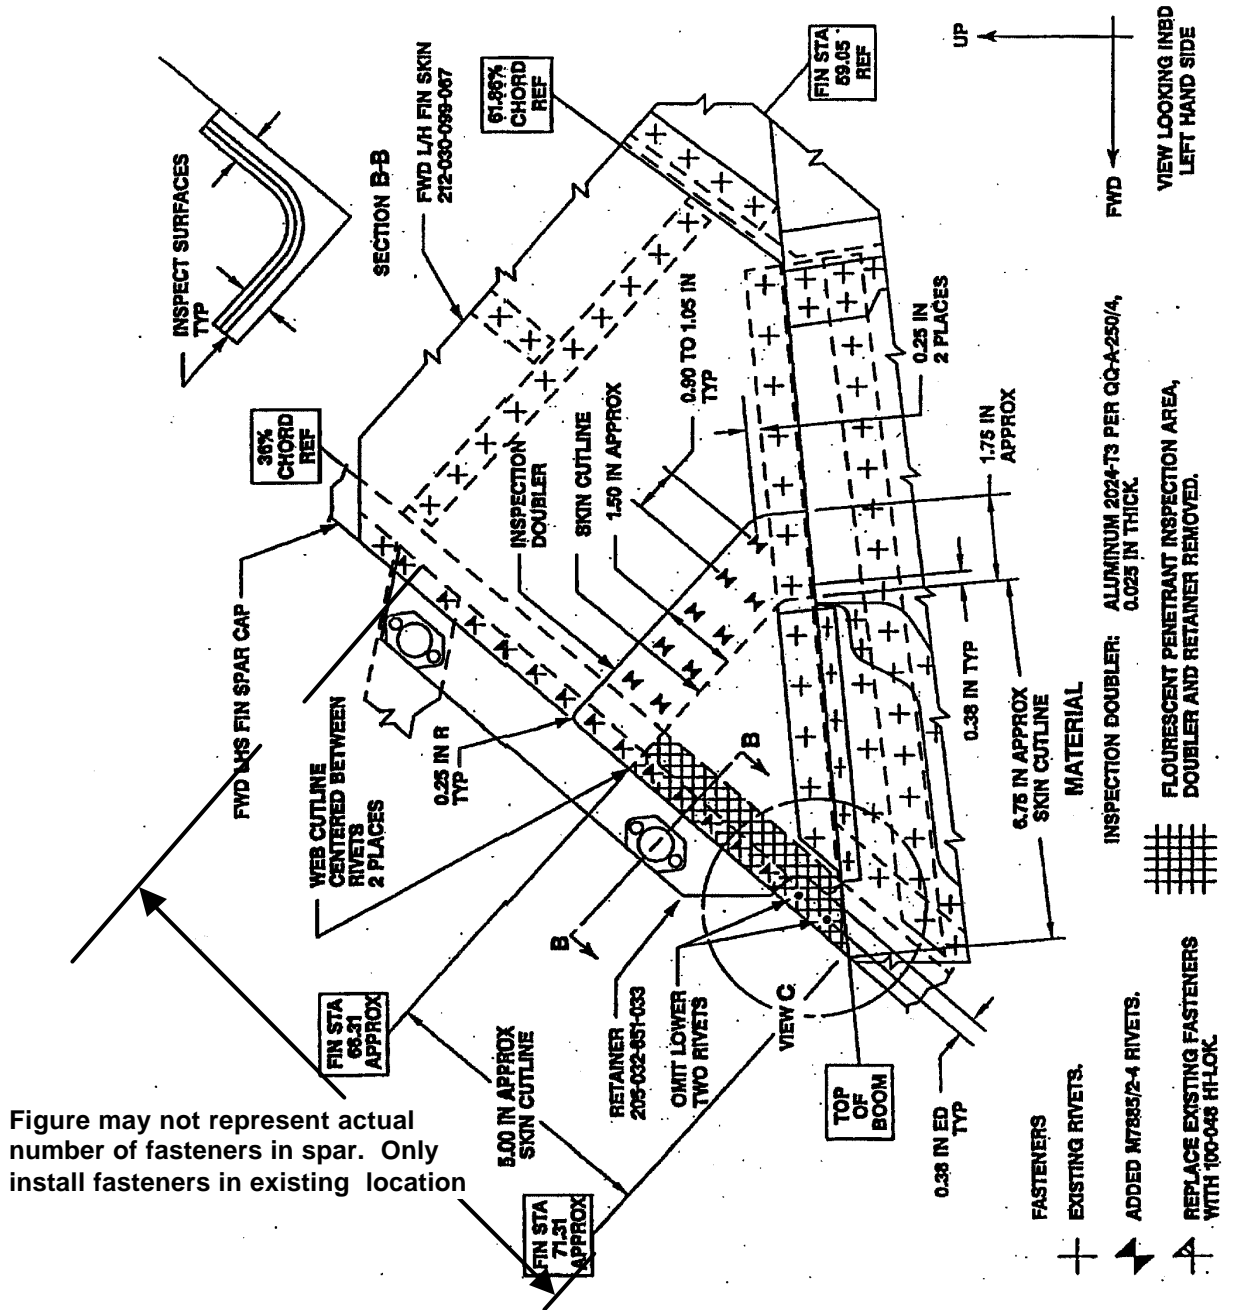
FIGURE 3. (SHEET 1 OF 2) - PART II: INSPECTION CONFIGURATION FOR 212-030-125-001 W/ RETROFIT KIT 212-704-087

Figure may not represent actual number of fasteners in spar. Only install fasteners in existing location

11. Fasten FWD L/H Fin Skin, Inspection Doubler and P/N 212-030-121-037 or P/N 212-030-121-033 retainer back to the spar assembly using Hi-Loks and blind rivets as shown in Figure 2 or Figure 3. Reinstall Clip and Radius Block (if existing) removed in Item 2.
12. Refinish reworked area as per instructions found in Standard Repair Manual except in area where protective coat of MIL-C-16173, Grade 2 was used.
13. Install the inspection door, intermediate gearbox cover and tail rotor driveshaft cover.
14. Make an entry in helicopter historical records indicating compliance with this bulletin.
