ALERT SERVICE BULLETIN
REVISION NOTICE
Bell Helicopter **TEXTRON**
A Subsidiary of Textron Inc.

SUBJECT: **REVISION "D" TO ALERT SERVICE BULLETIN 212-00-111 (TAIL ROTOR BLADE 212-010-750-009 THROUGH -129 TIP BLOCK MODIFICATION)**

NO. 212-00-111

SUBJECT: TAIL ROTOR BLADE P/N 212-010-750-009
THROUGH -129, TIP BLOCK RETENTION
MODIFICATION

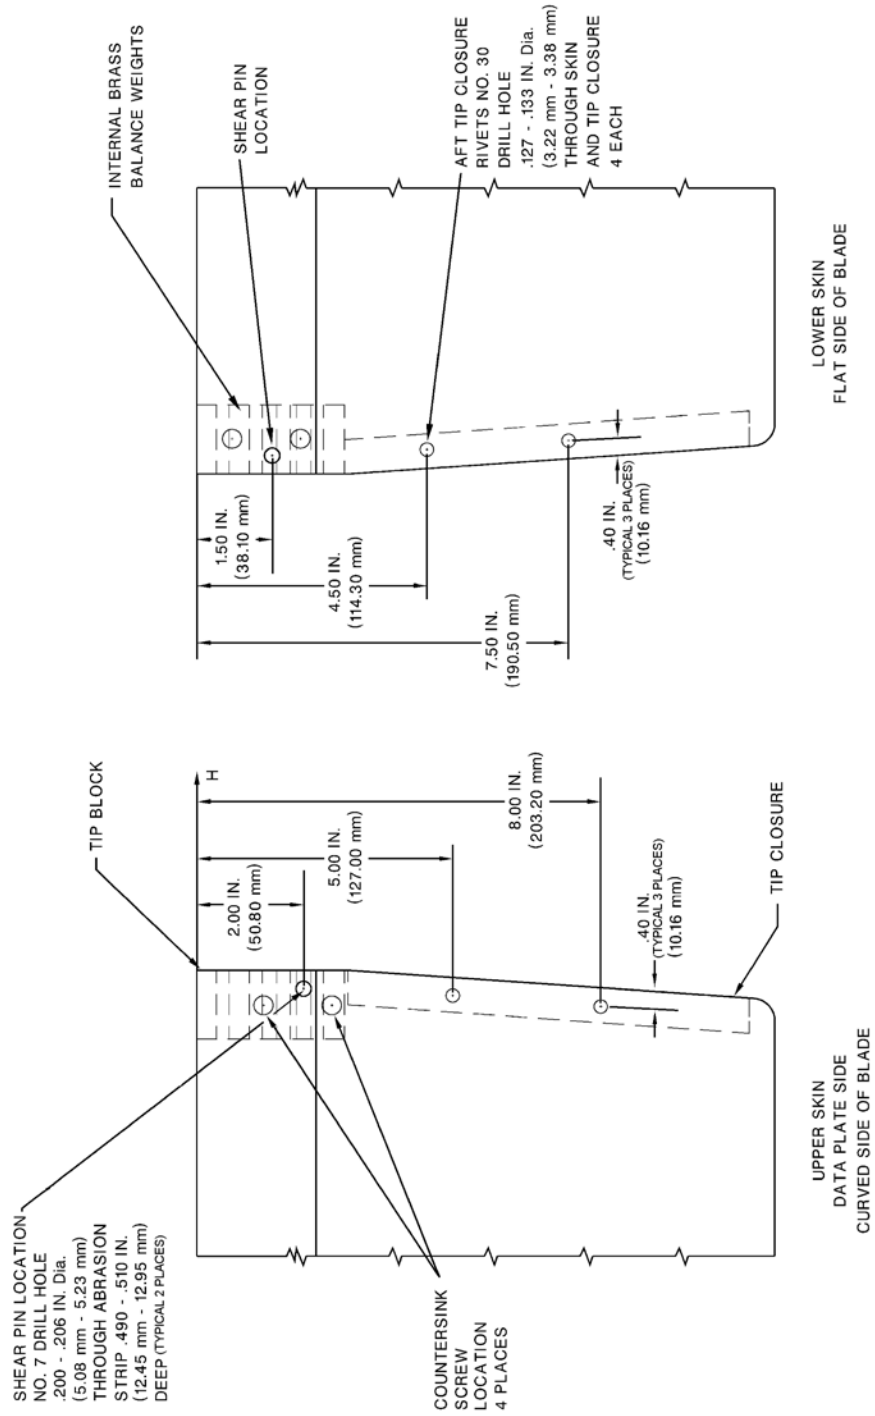
Figure 1
212-010-750-ALL
TAIL ROTOR TIP RETENTION MOD

Bell Helicopter has recently investigated the in-flight loss of a 212-010-750-105 tail rotor blade tip block. Investigation has revealed that the countersunk screws retaining the tip block were installed incorrectly resulting in little or no tip block retention. Additionally reports have been submitted of the loss of the tail rotor tip closure. Investigation revealed that there is a possibility of a poor adhesive bond in this area allowing for voiding and eventual closure loss.

1. Deleted
2. Inspect forward tip weight retention block and aft tip closure for voids. Remove any blade from service that exhibits voids in excess of CR&O limitations.
3. Inspect forward tip block attachment countersink screws. 4 locations. See Figure 1. Inspect to insure that the head of the countersunk screw is flush with the surface of the abrasion strip.
4. T/R blades that have the screws flush with the surface of the abrasion strip in all 4 locations do not require shear pin installation. T/R blades with one or more of the screws that are set below the surface of the abrasion strip or are covered with filler material may not provide acceptable retention of the tip block in the event of adhesive failure and will require shear pin installation. The limit is flush to 0.010 inch (0.0254 mm) high.
5. The aft tip closure rivet installation must be accomplished on all tail rotor blades.

1. Using a clean, sharp No. 7 drill bit, drill a **.50** inch deep shear pin installation hole as shown on Figure 1. The upper surface of the blade can be identified as the curved side of the blade and is same side as the data plate. Likewise the lower surface of the blade is the most flat side of the blade. The shear pin installation holes are located at 2.0 inches (projected) aft of the leading edge on the upper surface and 1.5 inches (projected) aft of the leading edge on the lower surface.

1. Using a clean, sharp no.30 drill bit, drill two rivet installation holes on both the upper and lower surface of the blade tip as shown in Figure 1. It is not necessary to remove the paint in the area.
