ALERT SERVICE BULLETIN

NO. 212-01-113

MODEL AFFECTED: 212

SUBJECT: CHIP DETECTOR ASSEMBLY, TEDECO B3703

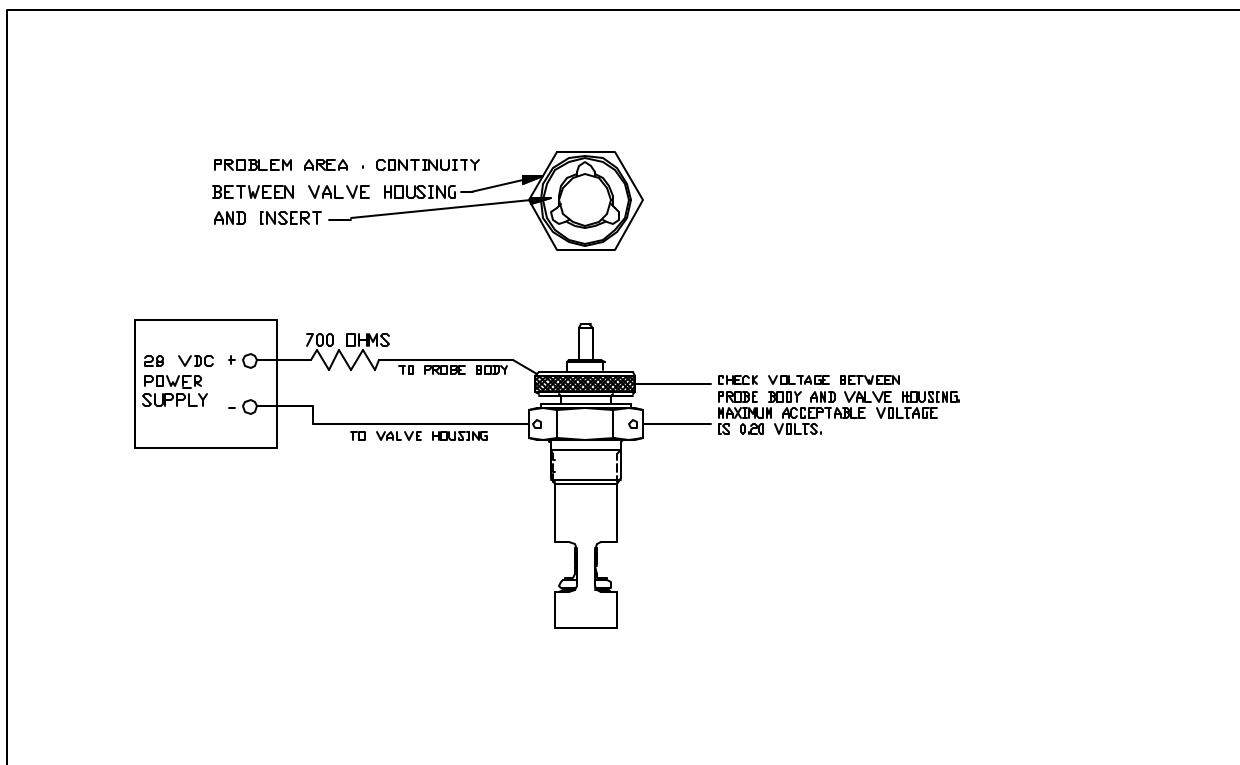
FIGURE 1

Units that are not installed in an aircraft should be tested per Procedure A. Units installed in aircraft should be tested per procedure B. These tests will determine if the unit is acceptable by verifying that the resistance between the probe body and the valve body is 5 ohms or less.

1. Connect the chip detector to a 28 Volt DC power supply using a 700 ohm, 2 watt resistor as shown in Figure 1.
2. Measure the voltage between the probe body and the valve body. The voltage drop must be 0.20 volts or less across the unit. If the voltage drop is larger than 0.20 volts, then return the unit to Tedeco (See 3. Part Replacement.)

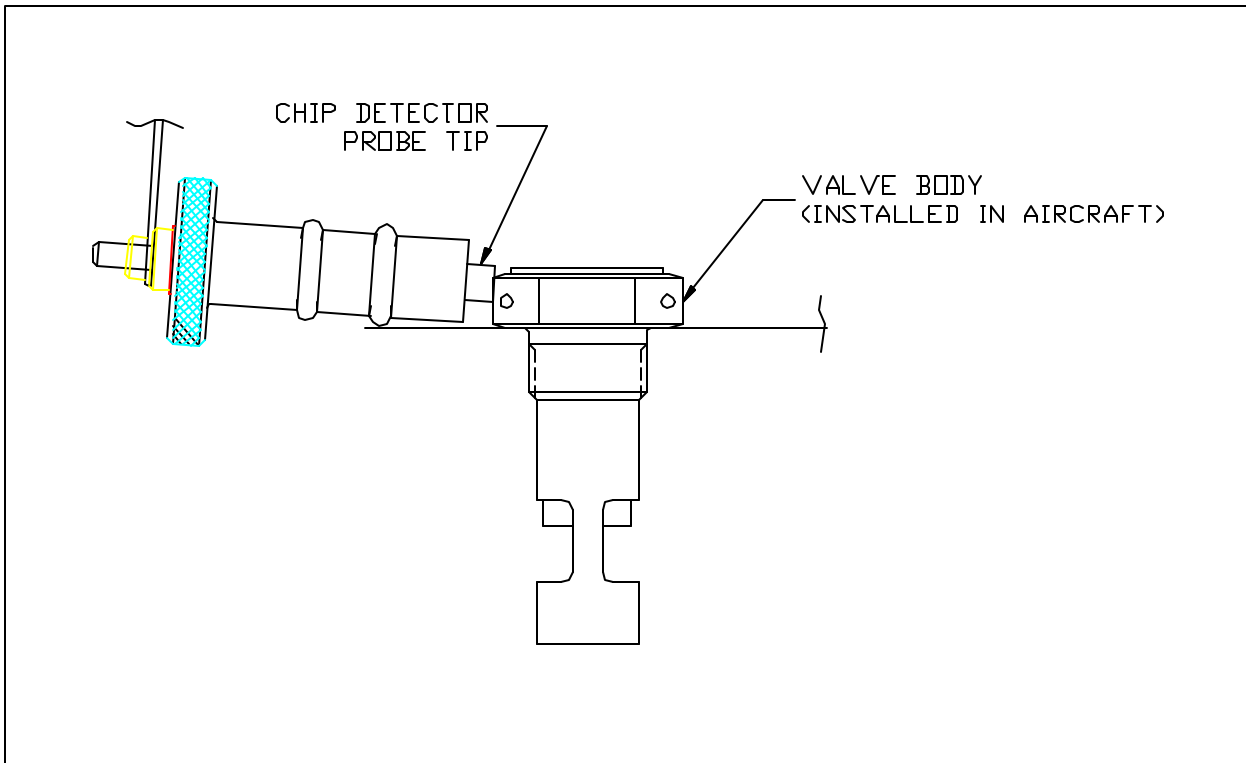
FIGURE 3

4. Hold the tip of the center stud of the chip detector probe firmly against the valve housing as shown in Figure 3 while checking chip indicator light in cockpit. The cockpit light should illuminate. Illumination of the light in this step isolates the electrical discontinuity to the valve insert. Repair the unit per the repair instructions in section 2 of this document.

If the light still does not illuminate during this check of the valve housing, there is an electrical discontinuity somewhere else in the circuit. Check the remaining electrical circuit between chip detector and cockpit indicator light.
