ALERT SERVICE BULLETIN

NO. 212-02-118

MODEL AFFECTED: 212

SUBJECT: TAIL ROTOR BLADE ASSEMBLIES P/N
212-010-750-113/-115 INSPECTION AND
REWORK OF.

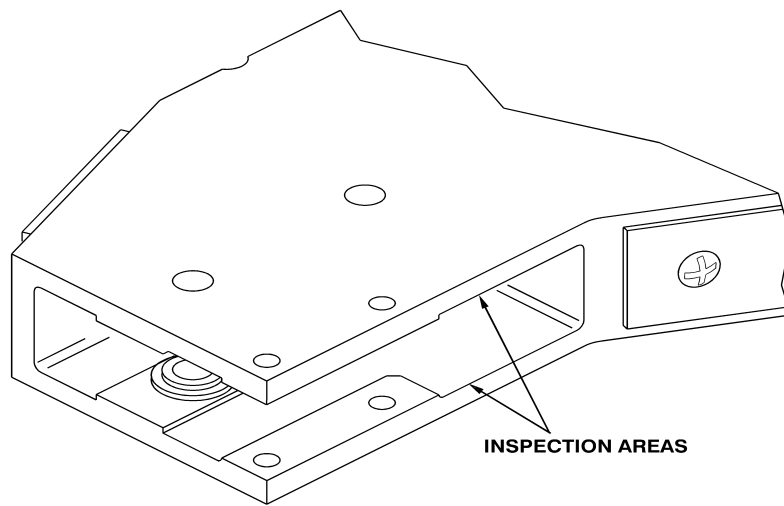
FIGURE 1

Bell Helicopter has discovered that certain serial number tail rotor blades may have been manufactured with mechanical damage located on the inside of the root cuff. The mechanical damage may be identified on the inside of the upper and lower grip plates. The exact location varies, but generally located outboard of the outboard blade bolt attachment hole. See figure 1 and 2.

Inspections Areas

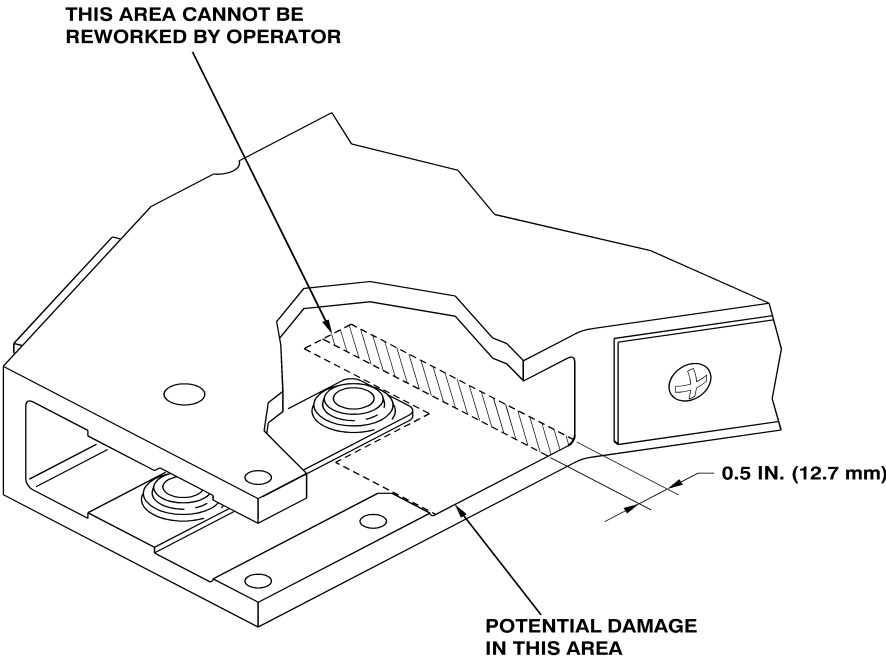
FIGURE 2

If the depth of the damage exceed 0.030 inch (0.762 mm) or the damage is located in the non-reparable area per figure 2, notify Product Support Engineering for further instruction.

Detailed Inspection

7. Blend any damage found to a maximum depth of 0.030 inch (0.762 mm). Blend over a length of at least 10 times the depth on all edges of the damage.
8. Surface finish of repair shall be similar to surrounding area.
9. Apply chemical film (C-100) to reworked area.
10. Refinish tail rotor blade assembly per Bell-212-CR&O.
11. Install pitch horn
12. Install tail rotor blade assemblies on aircraft.
13. Annotate records to indicate compliance with this bulletin.
