ALERT SERVICE BULLETIN
Bell Helicopter **TEXTRON**

NO. 212-04-120

MODEL AFFECTED: 212

SUBJECT: TAIL ROTOR PITCH HORN ASSEMBLY
P/N 212-011-708-105, REPLACEMENT OF.

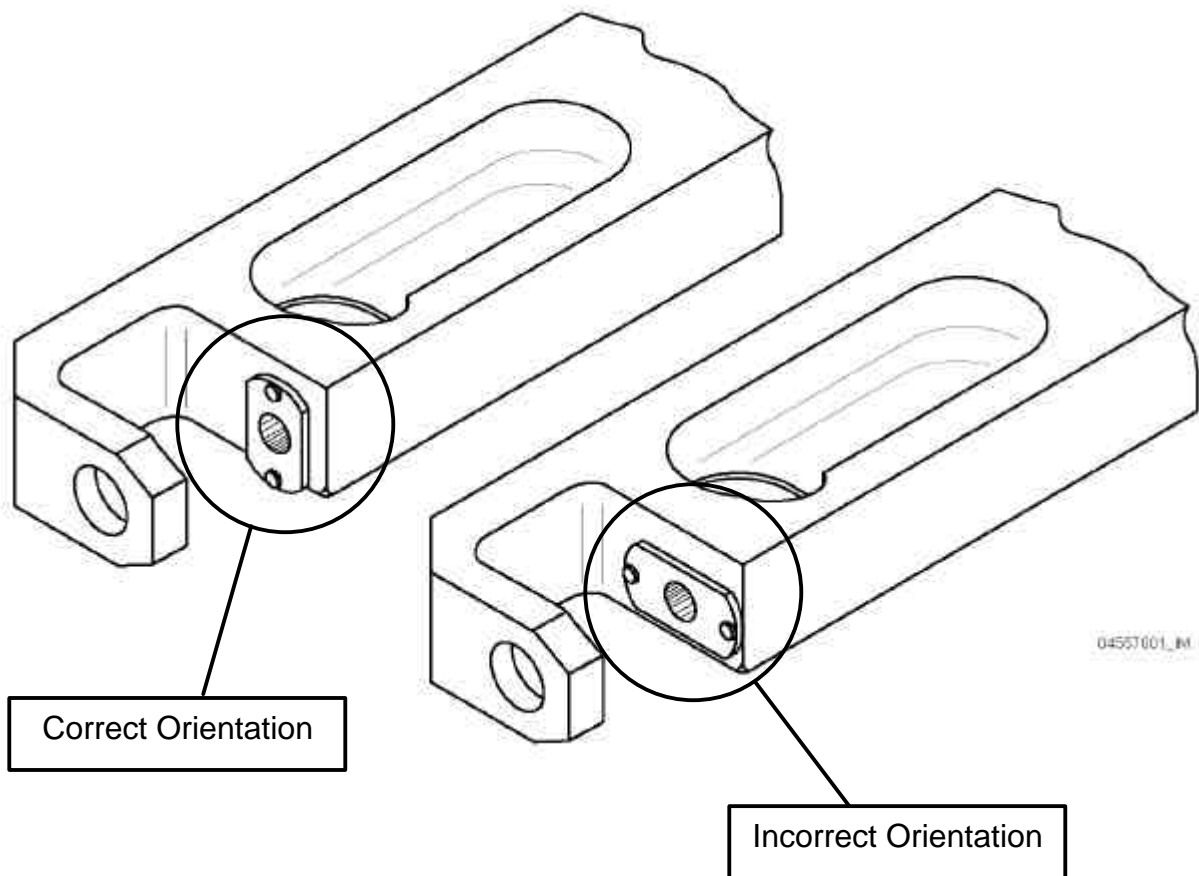
Bell Helicopter has found that subject Pitch Horns S/N TI-1 through S/N TI-113 may have incorrectly installed Bushings, which could cause the Pitch Links to contact the Bushings during Tail Rotor flapping. The resulting loads may cause excessive stress to the Pitch Horn, Pitch Link and attachment hardware between Pitch Links, Crosshead and Pitch Horn. Discrepant Pitch Horns shall be returned to Bell Helicopter, along with the mating Pitch Links and the attachment hardware. Any Pitch Horns bearing a letter "R" at the end of the affected serial number has been either reworked or found to conform, and therefore is not affected by this ASB.

Figure 1
Correct Orientation of Pitch Horn Bushing

1. Review historical service records and physically identify T/R pitch horn serial numbers installed on aircraft and held in spares inventory.
2. For each horn found to be within the serial number block, verify position of bushing using Figure 1. If bushing is found properly positioned, add a letter "R" at the end of the serial number, using a vibrating stylus (For example: TI-113R).

3. If bushing is found incorrectly positioned in accordance with Figure 1, remove discrepant pitch horns, mating pitch links and attaching bolts (20-057-5-14D & NAS6605H20) and return to Bell Helicopter for credit. Remove any chordwise

4. Re-assemble Tail Rotor Hub & Blade Assembly as required by replacing discrepant parts with new and/or serviceable pitch horns, pitch links and attachment hardware between pitch horn and pitch link and crosshead to pitch link. Dynamic balance as required after installation.
5. All discrepant pitch horns serial number TI-1 through TI-113 that have never seen service on an aircraft may be reworked at Bell Helicopter. Reworked pitch horns will have a letter "R" at the end of the serial number.
6. Annotate historical records to show compliance with this bulletin.
