ALERT SERVICE BULLETIN

NO. 214-03-66

MODEL AFFECTED: 214B/214B-1

SUBJECT: TAIL ROTOR BLADE, P/N 214-015-750-005, -109, AND -113, TIP CLOSURE INSPECTION

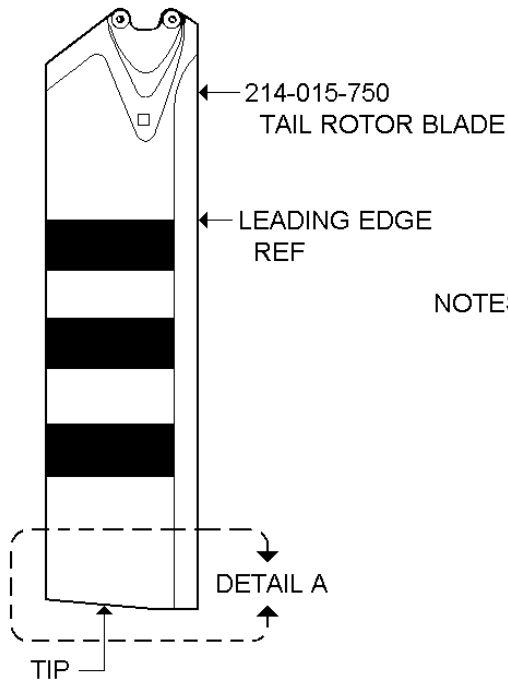
FIGURE 1

- a. Visually inspect for cracks or voids in the tip closure to skin and in the tip closure to tip block bond lines. Cracks or visible edge voids are cause for removal of the blade.

- b. Tap inspect for voids between the upper and lower skins and the tip closure along the length and width of the closure:
 - 1) Tap using a large coin (20 mm diameter minimum) with a tapping frequency of 3-6 taps/second, making sure that the entire area shown in Figure 1 is inspected.

- 3) Map any void areas to determine size.
 - c. Voids between the skin and tip closure which are 0.38 inch spanwise width by 3.0 inch chordwise length, and smaller, are acceptable as long as they are not within 0.12 inch of the skin edge. Voids larger than those noted or within 0.12 inch of the skin edge are cause for removal of the blade. Voids within one inch of each other shall be considered as one void.

TAP INSPECTION AREA UPPER AND LOWER SKIN.
 5. MAXIMUM ALLOWABLE VOID DIMENSIONS. VOIDS WITHIN 1.0 INCH OF EACH OTHER SHALL BE CONSIDERED AS ONE VOID.
 6. VOIDS MAY NOT BE WITHIN 0.12 INCH OF SKIN EDGE.

4. Contact BHT Product Support Engineering at facsimile 817-280-2635 or email psemil214@bellhelicopter.textron.com for disposition of blades removed from service as noted above.
