ALERT SERVICE BULLETIN
Bell Helicopter **TEXTRON**
A Subsidiary of Textron Inc.

NO. 214-06-68
DATE Aug 11, 2006
PAGE Page 1 of 7

MODEL AFFECTED: 214B/214B-1

SUBJECT: **TAIL ROTOR DRIVESHAFT HANGER ASSEMBLY BEARING, P/N 214-040-606-101, ONE TIME INSPECTION.**

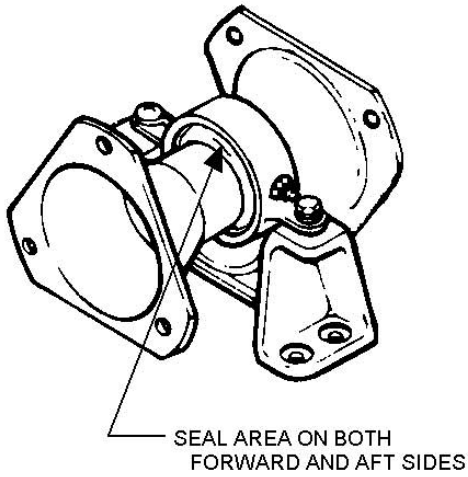
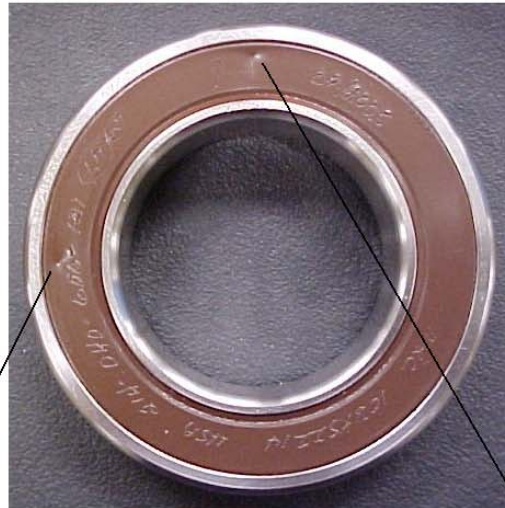
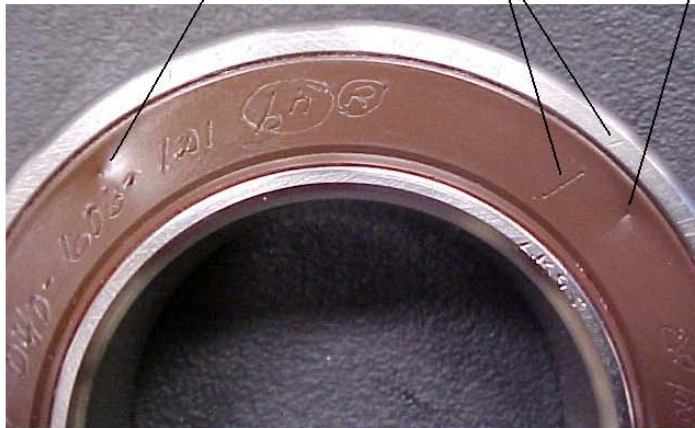
FIGURE 1

During a routine overhaul, an operator found P/N 214-040-606-101 bearings with unusual dents, or dimples, along the outer diameter of the bearing seal faces. Investigation by Bell Helicopter has determined these are the result of a defective bearing manufacturing process. In service, dented or dimpled seals could contact the bearing cage and eventually result in bearing failure.

**214-040-600
TYPICAL HANGER BEARING ASSEMBLY**

1. Inspect both seals of each bearing in each affected hanger assembly.

4. Do not mistake scribed index line for damage. There will be one index line per seal. Index line on the bearing outer race will not be visible with bearing installed in the hanger.

Dent/Dimple

Scribed Index Line Typical

2. With a clean cloth, gently remove accumulated grease and dirt from the bearing seal faces and, using a mirror and a strong light, inspect all affected P/N 214-040-600-001, -005, -101, -103, -107, and/or –109 tail rotor driveshaft hanger assembly bearings for damaged seals as shown in Figures 1 and 2.
 - a. Tail rotor driveshaft hanger assemblies with damaged bearings installed may not be continued in service until serviceable bearings have been installed.
 - b. Remove affected assemblies and forward to an overhaul facility for bearing replacement.

- c. All bearings with damaged seals which have been removed from hanger assemblies are not airworthy and are not repairable.
3. Inspect all installed P/N 214-040-600-113 and/or –117 tail rotor driveshaft hanger bearing assemblies for damaged P/N 214-040-606-101 bearing seals in accordance with paragraph 2 above.

3. Do not remove bearings from hanger assembly for inspection. Remove installed bearings only if damaged seals are found.

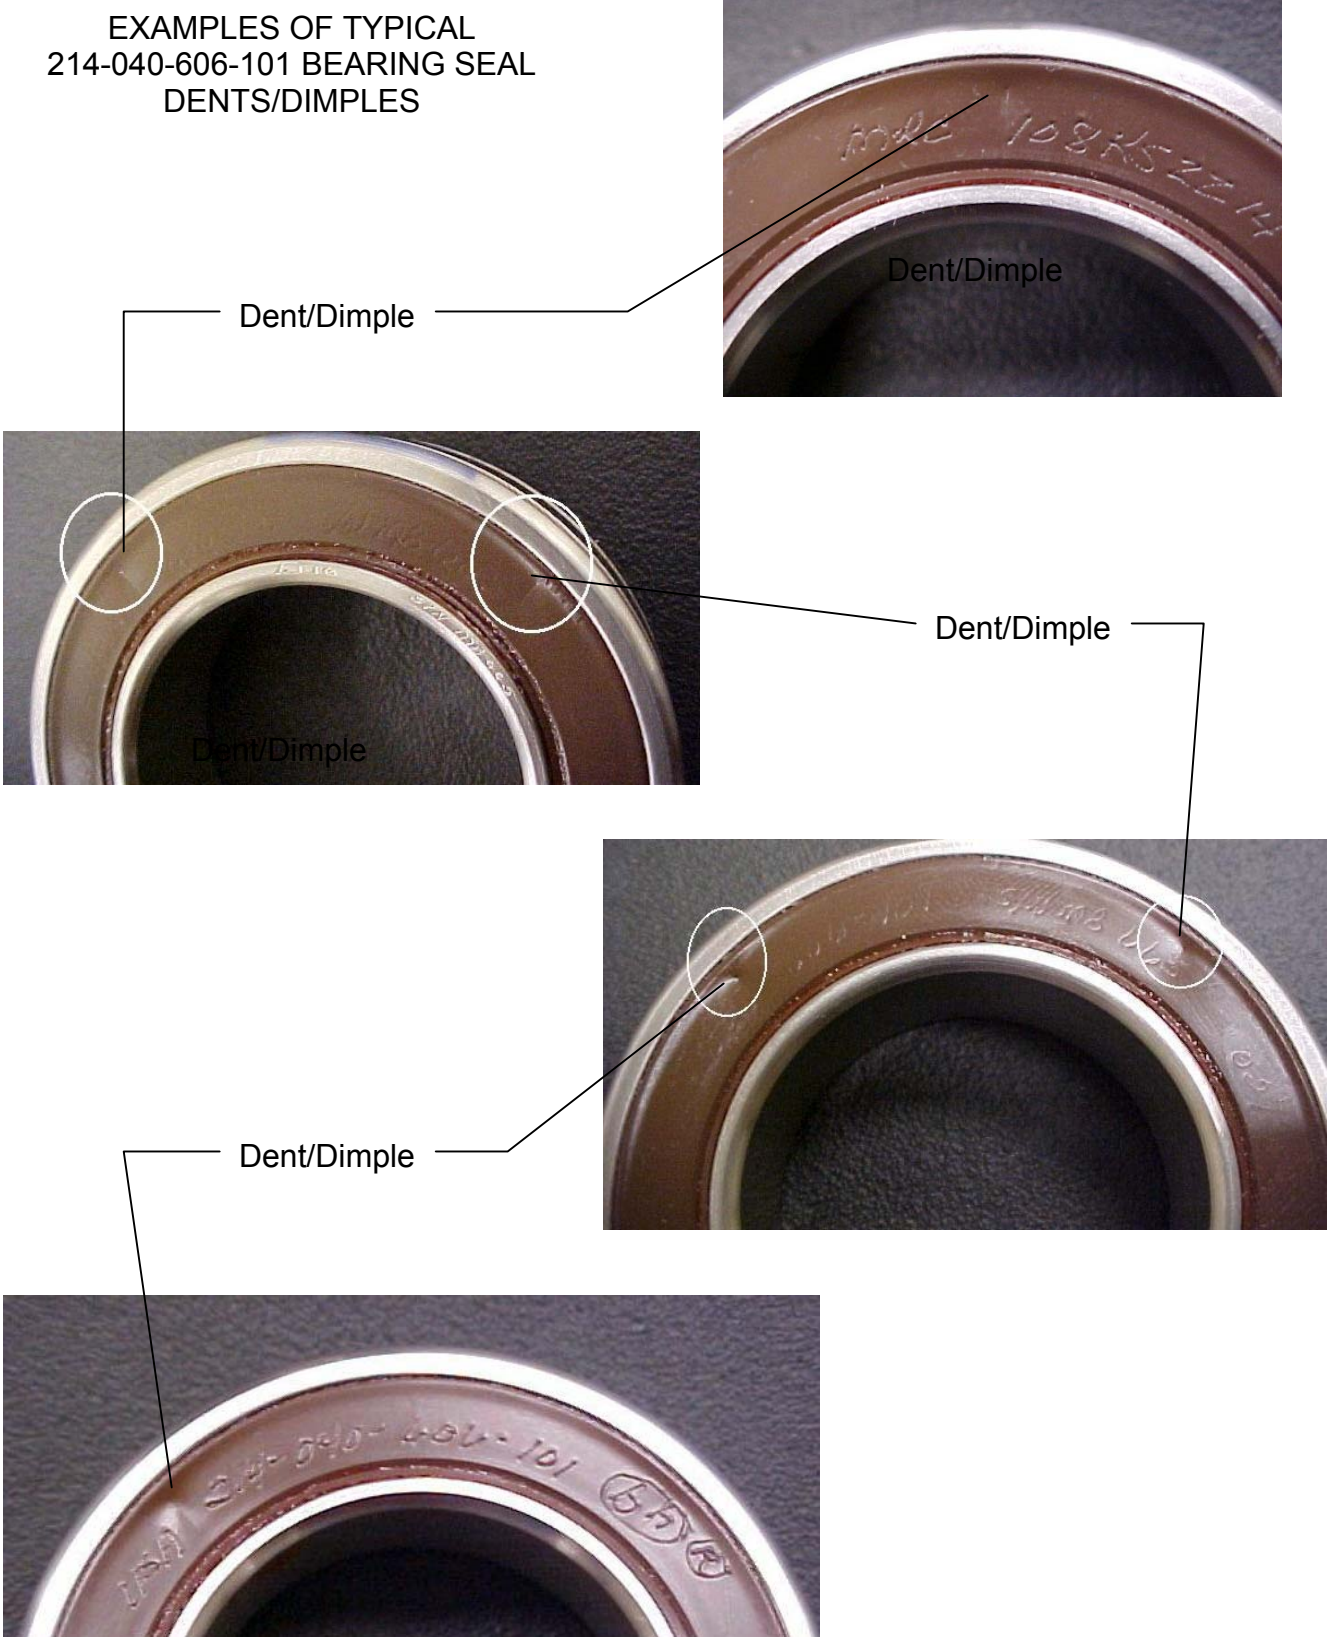
FIGURE 2

5. Dents, or dimples, can be very pronounced or subtle. See Figure 2 for examples of each.

EXAMPLES OF TYPICAL
214-040-606-101 BEARING SEAL
DENTS/DIMPLES
