ALERT SERVICE BULLETIN

**SUBJECT: REVISION "A" TO ALERT SERVICE BULLETIN 214ST-93-62:
EMERGENCY FLOAT SYSTEM PNEUMATIC HOSE ASSEMBLY
REPLACEMENT AND CALENDAR LIFE ASSIGNMENT**

NO. 214ST-93-62

SUBJECT: EMERGENCY FLOAT SYSTEM PNEUMATIC HOSE ASSEMBLY REPLACEMENT AND CALENDAR LIFE ASSIGNMENT

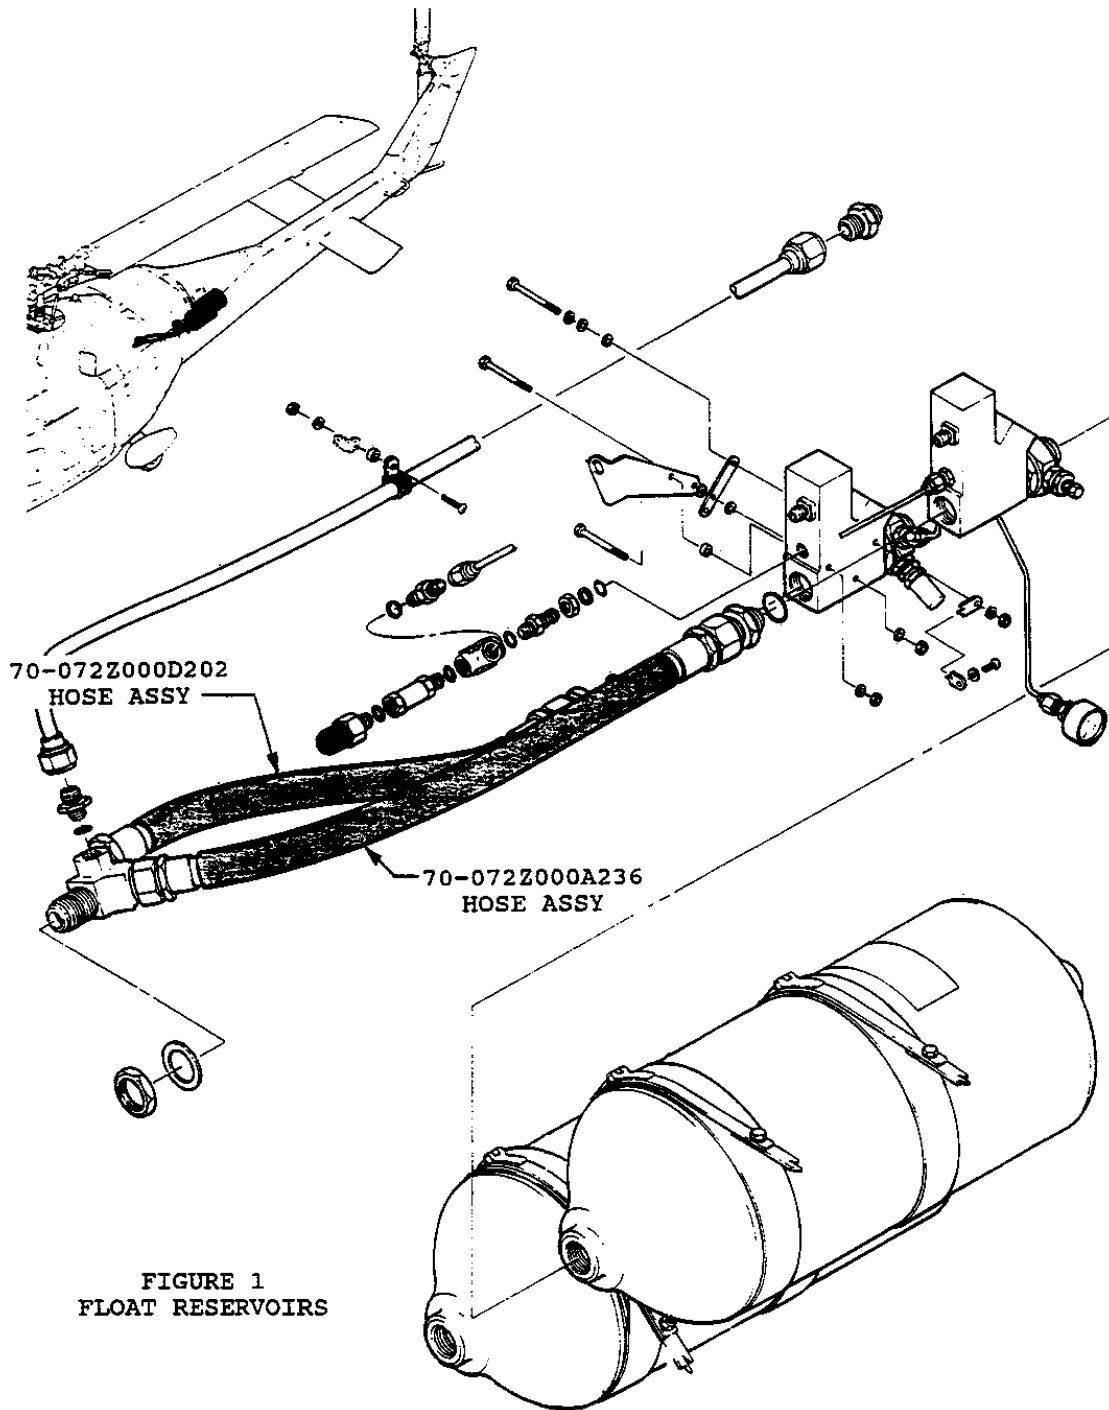
Two reports have been received of float system pneumatic hose failure during routine manual inflation inspection.

Investigation of the failed hoses indicates the liner material is susceptible to deterioration due to age and that the rate of deterioration is affected by environmental severity, particularly heat.

1. Gain access to and remove and replace the hose assemblies noted in Figure 1. Refer to 214ST Maintenance Manual Chapters 6, 32 and 53 as necessary for access and removal instructions.

1. Originally two suppliers were qualified by BHT for manufacture of the hose assemblies noted in Figures 1, 2, and 3. Hoses manufactured by one of those suppliers, Preece, Inc., FSCM (Federal Supply Code for Manufacturer) 21392, are no longer approved for use by BHT.
2. Hose part numbers noted in Figures 1, 2, and 3 which were manufactured by Preece, Inc., as determined by the data tag attached to each hose, are to be removed from service in accordance with Parts II and III of this bulletin or six years after initial installation, whichever occurs first. Any hoses that may be in spares stock are considered non-airworthy and are not to be installed.
