ALERT SERVICE BULLETIN

NO. 214ST-97-78

MODELS AFFECTED: 214ST

SUBJECT: SELF-LOCKING BARREL NUT,
P/N NAS577B-10A ONE TIME INSPECTION.

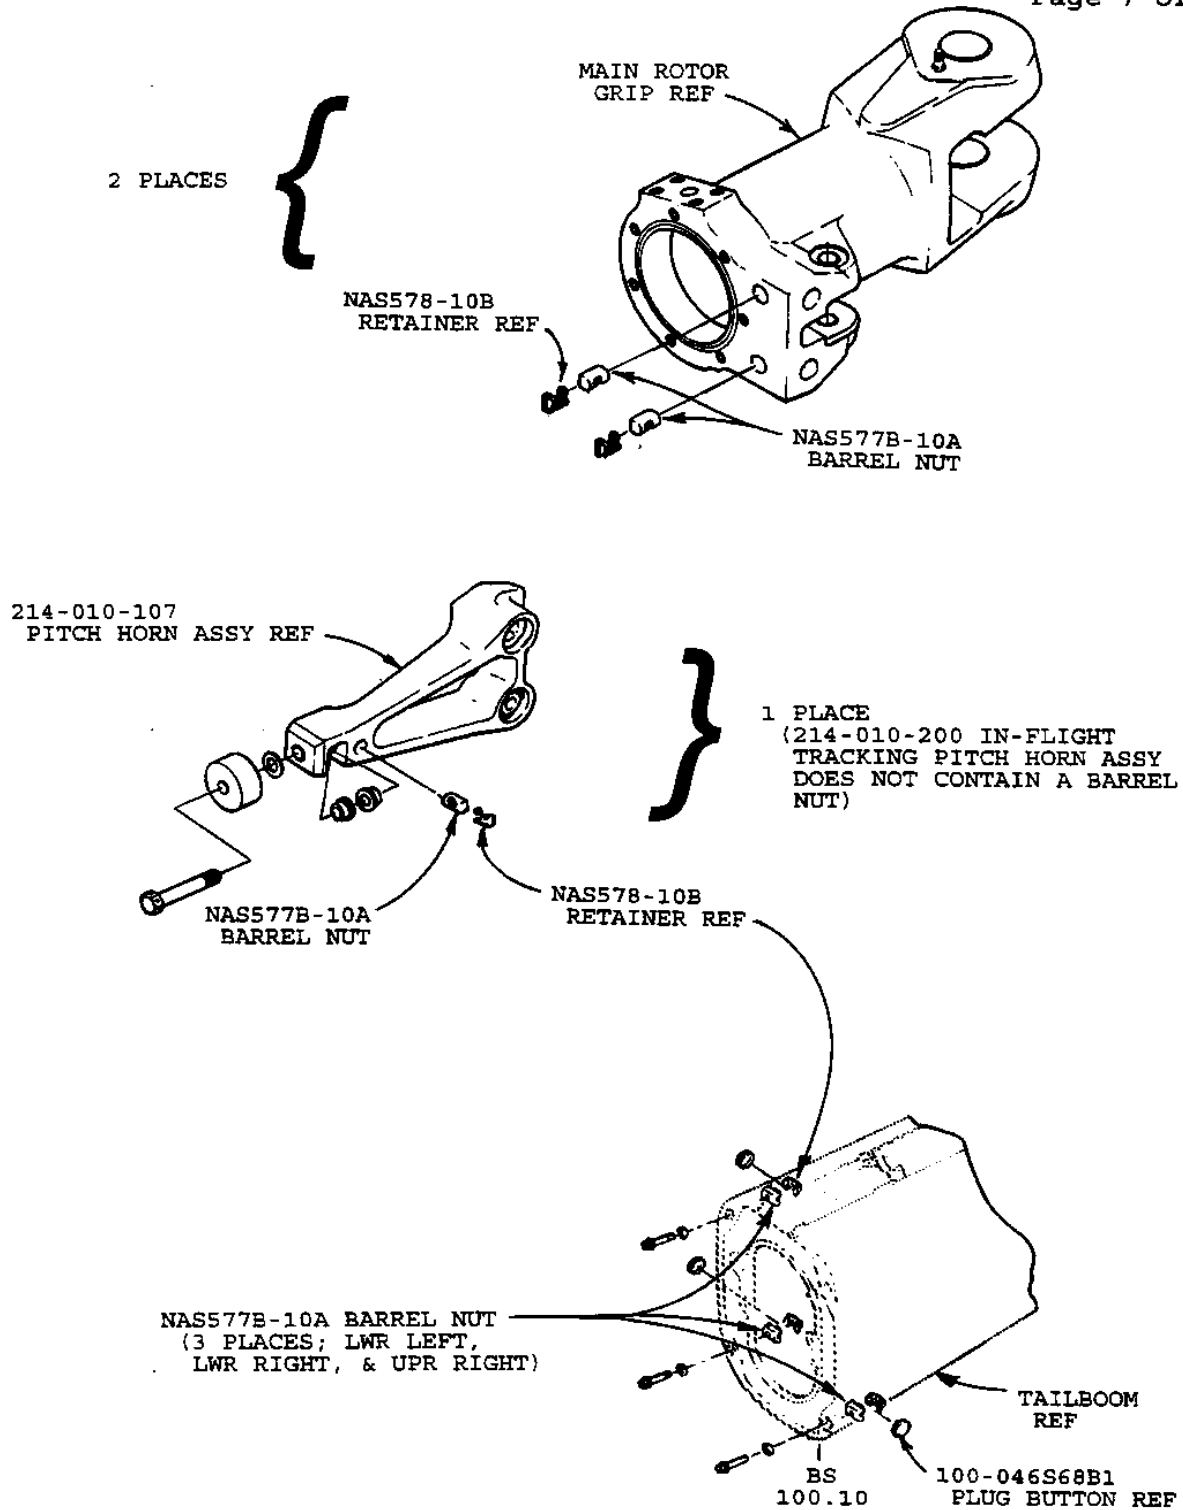
FIGURE 1
NAS577B-10A BARREL NUT LOCATIONS

During disassembly of another Bell Helicopter model for shipment, a barrel nut, P/N NAS577B-10A, was found cracked through the threaded portion of the nut. These nuts are also used in the 214ST helicopter. Laboratory analysis determined the failure to be the result of hydrogen embrittlement introduced during manufacture. Bell Helicopter has determined that the failed nuts were received as a part of two manufacturing lots, #2632690 and #2632680, from Kaynar Technologies Inc. These nuts may have been installed in spare main rotor hub, grip, pitch horn, and/or tailboom assemblies; and, may also have been supplied as individual spares.

Kaynar P/N NAS577B-10A barrel nuts have been fabricated with either a "thick" or "thin" bearing surface flange. Suspect barrel nuts have the "thin" flange while the "thick" flange configuration nuts are considered serviceable.

1. Gain access to the component/assembly/barrel nut being inspected. Refer to Figure 1 for P/N NAS577B-10A applications. The following inspections also apply to all P/N NAS577B-10A barrel nuts which may be on hand as individual spares.

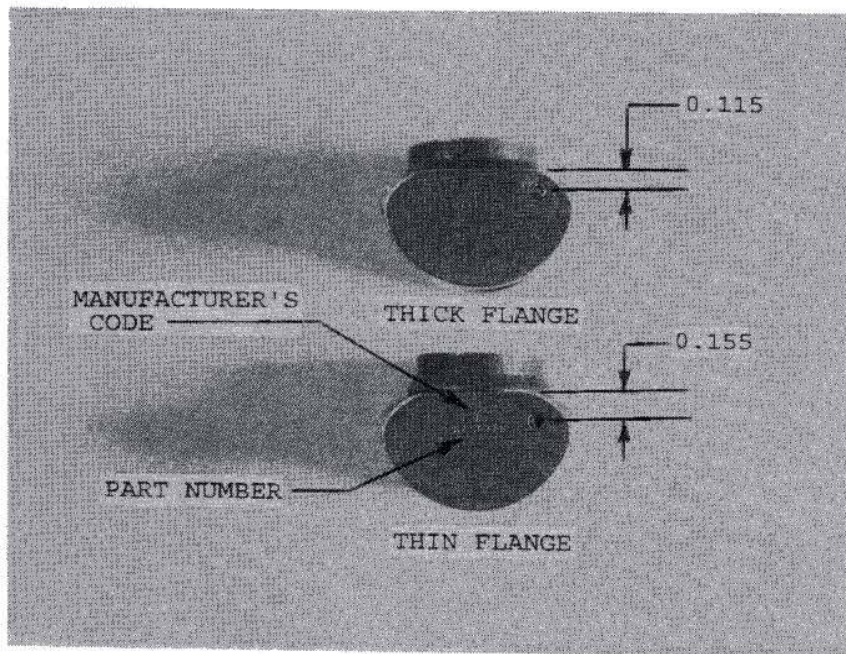
FIGURE 2
NAS577B-10A BARREL NUT
(NAS578 RETAINER NOT SHOWN)

- a. Viewing the end of the barrel nut, inspect the barrel for the presence of a manufacturer's mark. Kaynar nuts are identified by the presence of a "K", depressed above the basic part number, **NAS577B** (refer to Figure 2). For installed barrel nuts, if the part number or manufacturer's mark can not be seen; or are not legible, the barrel nut must be removed from the component (see caution note above). If any manufacturer's identifying mark is found other than "K", the barrel nut is considered serviceable and no further action is required.

- b. If the "K" marking is found, measure the distance from the center of the roll pin securing the nut in the barrel to the flat surface of the barrel (refer to Figure 2). If the edge distance is approximately .115 inch, the nut is considered serviceable, no further action is required. If the dimension is approximately .155 inch, remove the barrel nut from service and replace with a serviceable barrel nut.

- c. Inspect barrel nuts, removed as unserviceable in paragraph 1.b. above, for:
- 1) cracks using a 10 power magnifying glass. Should a crack be found in an installed nut, its corresponding bolt must also be replaced.

- 2) evidence of lubrication residue in the threaded portion of the nut and its corresponding bolt. If lubrication residue is found in the threads of either the barrel nut or bolt, both the barrel nut and bolt must be replaced.
 - d. Should a cracked nut be found at the right hand upper tailboom attach location, also replace the opposite (upper left) barrel nut and bolt upon reassembly. Inspect both upper tailboom and fuselage longeron fittings for obvious damage or deformation.
2. Following inspection, reassemble as necessary ensuring that both bolt and barrel nut threads are clean and free of any lubricant or corrosion compound. Annotate compliance with this ASB in helicopter and/or component historical records.
