ALERT SERVICE BULLETIN

NO. 222-00-86

Model 222 and 222B

HYDRAULIC ACTUATOR SUPPORT P/N 222-040-125-001, INSPECTION OF

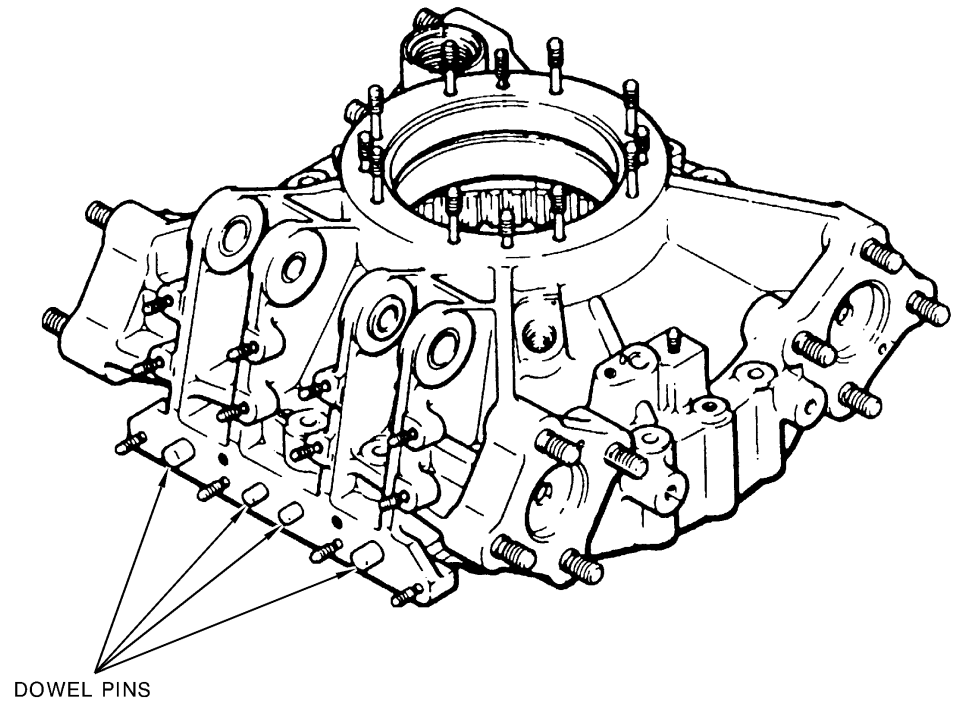
**Transmission Top Case
Assembly P/N 222-040-061-101
through 105
Figure 2**

- c) Inspect the dowel pins in transmission case for damage, fretting, corrosion and looseness. The large outboard pins should measure 0.500 inch minimum and protrude 0.55 inch from the surface of the case. The small inboard pins should measure 0.375 inch minimum and protrude 0.45 inch from the surface of the case. Refer to Figure 2
