ALERT SERVICE BULLETIN

NO. 222-99-85
DATE 12/16/99
PAGE 1 of 4

MODEL AFFECTED: 222 and 222B

SUBJECT: TAIL ROTOR PITCH CHANGE BEARINGS P/N 222-312-753-103, INSPECTION OF; AND TAIL ROTOR BLADE ATTACHING HARDWARE, REPLACEMENT OF

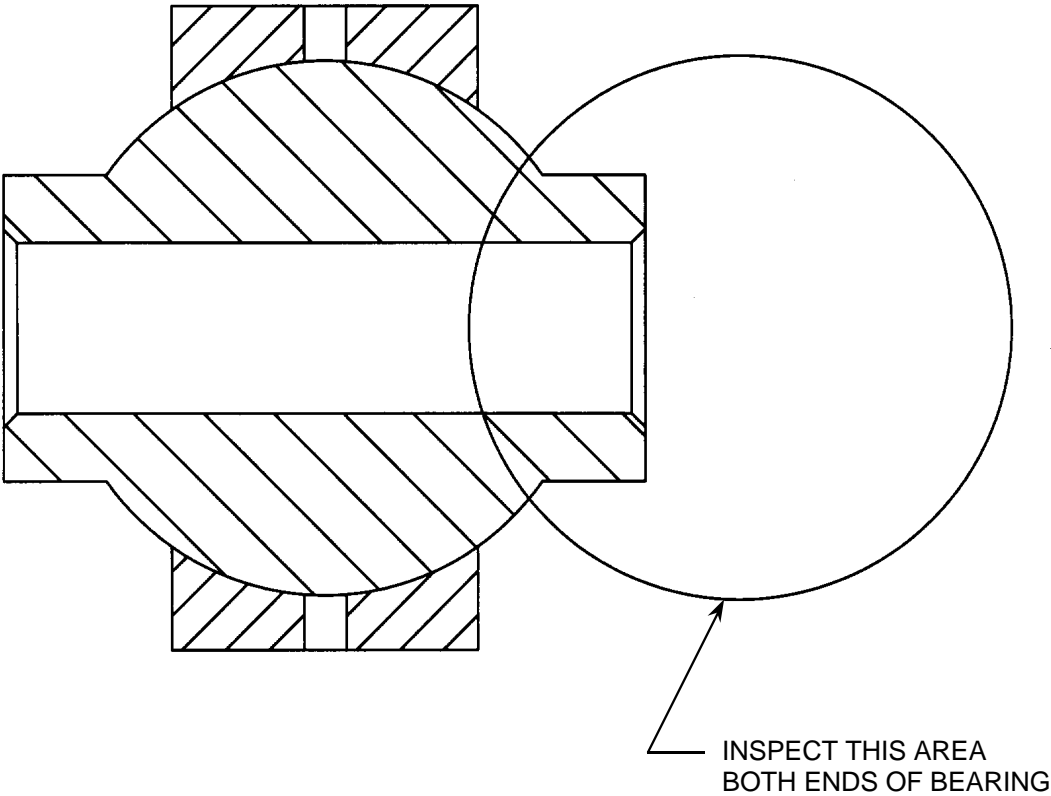
FIGURE 1

Bell Helicopter has received reports of cracked bearings, P/N 222-312-753-103, installed in tail rotor blade assemblies. Investigation revealed that the cracks in the pitch change bearings were the result of stress corrosion cracking caused by loss of torque of the tail rotor blade attaching bolts/nuts.

3. Visually inspect each bearing inner member neck area (full 360 degrees) for cracks. Refer to figure 1. If crack(s) are found in a bearing, the replacement of both bearings in that blade are required. Refer to BHT-222-CR&O-3.

BEARING
222-312-753-103
