**ALERT SERVICE BULLETIN**

NO. 222U-00-57

**MODEL AFFECTED:** Model 222U

**SUBJECT:** HYDRAULIC ACTUATOR SUPPORT P/N 222-040-125-001, INSPECTION OF

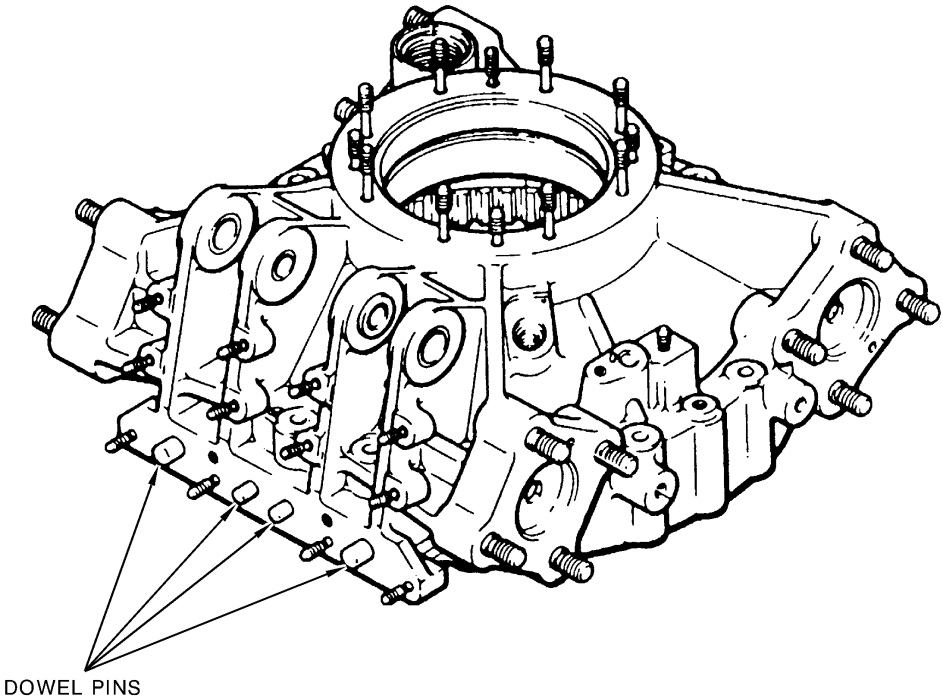
**Transmission Top Case Assembly**  
**P/N 222-040-061-101 through 105**  
**Figure 2**

- c) Inspect the dowel pins in transmission case for damage, fretting , corrosion and looseness. The large outboard pins should measure 0.500 inch minimum and protrude 0.55 inch from the surface of the case. The small inboard pins should measure 0.375 inch minimum and protrude 0.45 inch from the surface of the case. Refer to Figure 2
