ALERT SERVICE BULLETIN

NO. 230-00-18

MODEL AFFECTED: Model 230

SUBJECT: HYDRAULIC ACTUATOR SUPPORT P/N 222-040-125-001, INSPECTION OF

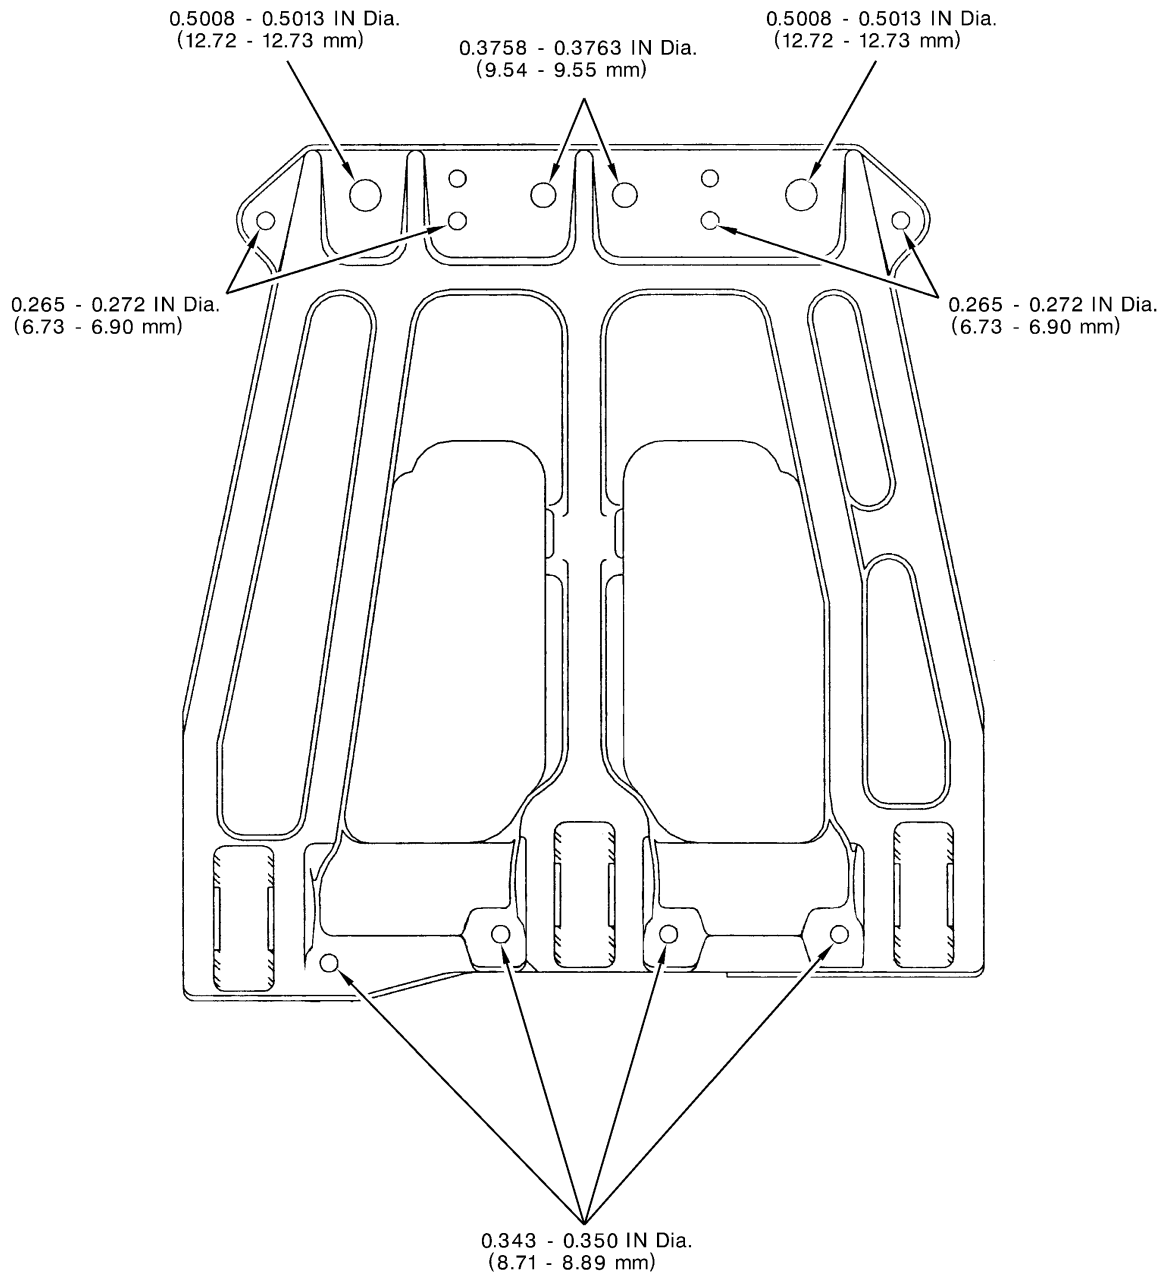
Hydraulic Actuator Support Assembly
P/N 222-040-125-001
Figure 1

4. If two or more of the nuts within the upper row of the support attaching nuts move below 40 in.lb torque or two or more of the nuts within the lower row of the support attaching nuts move below 90 in.lb torque, remove the hydraulic actuators support from the transmission for further inspection and repair. Refer to BHT-230-MM-6, Chapter 63 and BHT-230-CR&O-2, Chapter 63 for removal instructions. Discard nuts and washers.
5. If required, inspect the support P/N 222-040-125-001 in accordance with instructions in BHT-230-CR&O-2, Chapter 63. The holes at the lower and upper end of the support were manufactured to the dimensions shown in Figure 1.

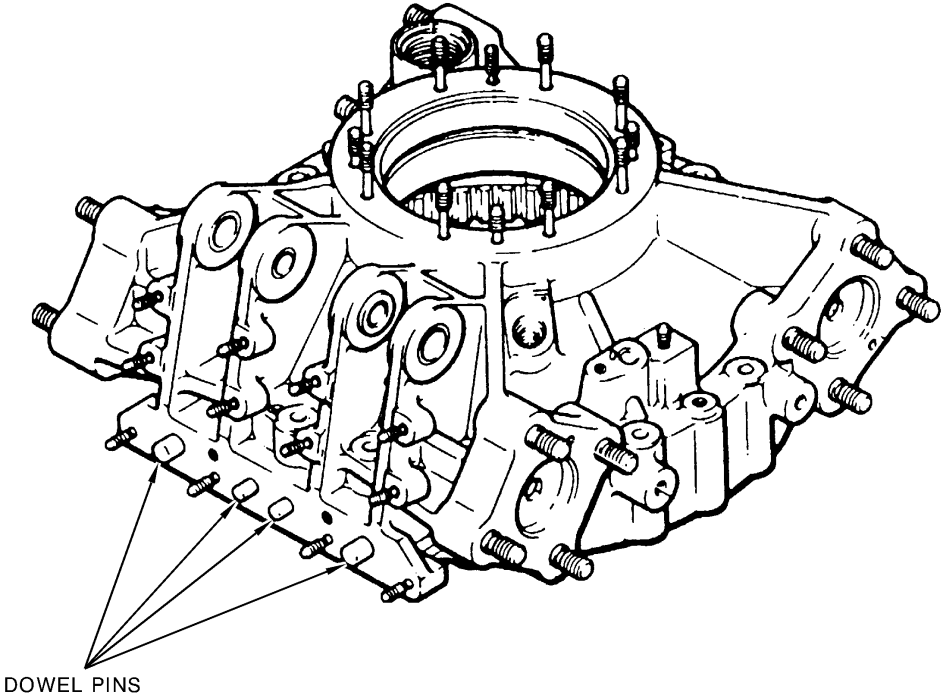
Transmission Top Case Assembly
P/N 222-040-061-105
Figure 2

- c) Inspect the dowel pins in transmission case for damage, fretting, corrosion and looseness. The large outboard pins should measure 0.500 inch minimum and protrude 0.55 inch from the surface of the case. The small inboard pins should measure 0.375 inch minimum and protrude 0.45 inch from the surface of the case. Refer to Figure 2
