**ALERT SERVICE BULLETIN**

**NO.** 230-01-20

**MODEL AFFECTED:** 230

**SUBJECT:** UPPER FUEL ENCLOSURE, RIGHT SIDE,  
ADDITION OF DRAIN PROVISION

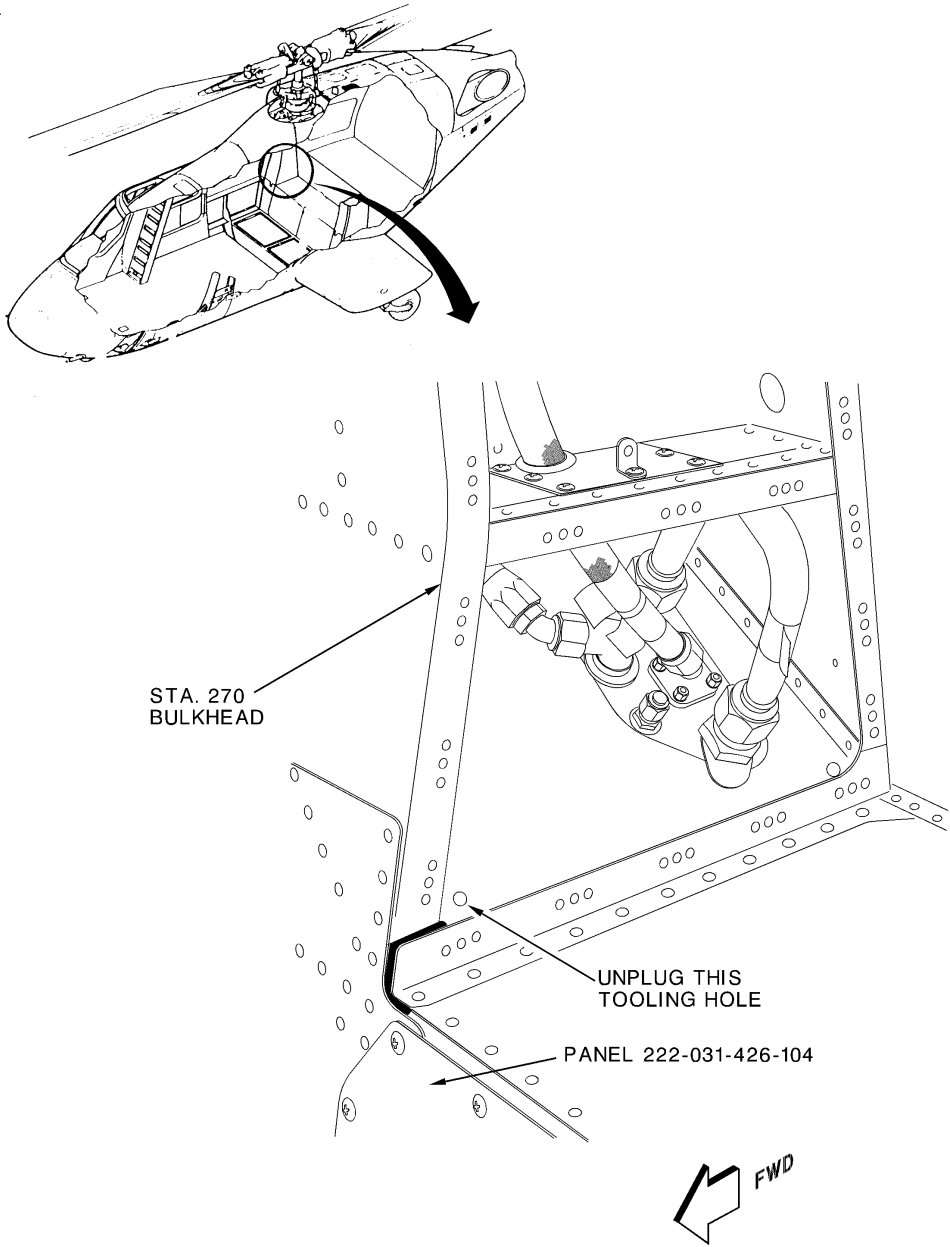
FIGURE 1

Bell Helicopter Textron has determined that a condition exists that could result in an accumulation of fuel or water in the right hand upper fuel enclosure area located at approximate STA 268.03 to STA 281.87 and W.L. 53.50.

Tooling hole is located at approximate STA 271.00, B.L. 22.25, W.L. 54.00 in panel assembly P/N 222-031-470-103

This bulletin provides the procedures to remove the sealant from the existing forward tooling hole located in panel assembly P/N 222-031-470-103 to provide enclosure drainage provision.

2. Remove fuel cell access panel P/N 222-031-426-104 located on the lower R/H side of STA 270 bulkhead. Refer to Figure 1 and refer to BHT-230-MM-5, chapter 53.

5. Locate forward tooling hole in panel assembly P/N 222-031-470-103 and unplug hole using a plastic scrapper and a pin punch or a similar object. Refer to Figure 1.
6. Reposition fuel cell upper right hand side into airframe cavity.
7. Install access panel P/N 222-031-426-104 with sealant MIL-S-8784CLB2. Refer to BHT-230-MM-5, chapter 53.
8. Install the seat cushions and seat backs on the rear passenger seats. Refer to BHT-230-MM-3, chapter 25.
9. Annotate helicopter records to reflect compliance with this bulletin.
