**ALERT SERVICE BULLETIN**  
**Bell Helicopter** **TEXTRON**  
A Subsidiary of Textron Inc.

**NO.** 230-04-31  
**DATE** AUG-27-04  
**PAGE** 1 of 7

**MODEL AFFECTED:** 230

**SUBJECT:** TAIL ROTOR BLADE P/N 222-016-001-123 AND  
-131, INSPECTION OF

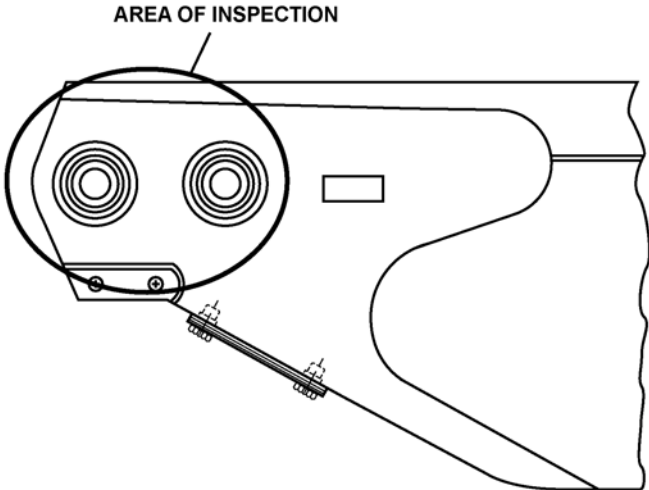
222-016-001-123

Bell Helicopter has received three reports of cracked tail rotor blades. The cracks in two blades, started at the outboard feathering bearing bore and ran chordwise towards the leading edge on one blade and towards the trailing edge on the other blade. In the third blade, the crack started at the inboard feathering bearing bore and ran spanwise towards the inboard end of the blade. In all cases, the cracks were detected during scheduled inspections. Investigation revealed that the cracks originated from either a machining burr or a corrosion site in the bearing bore underneath the flanged sleeves.

- a. Wipe down both surfaces of each blade around the blade feathering bearings using aliphatic naphtha (C-305) or detergent (C-318) or equivalents. Refer to Figure 1.
- b. Closely examine the cleaned surface, on both sides of the blade, paying particular attention to the area around both bearings. If no crack is found in the paint, the inspection is complete until next inspection.
- c. If a crack is found in the paint, maintenance personnel must proceed with step 2.

- a. Wipe down both surfaces of each blade around the blade feathering bearings using aliphatic naphtha (C-305) or detergent (C-318) or equivalents. Refer to Figure 1.
  - b. Using a 10X power magnifying glass, closely examine the cleaned surface, on both sides of the blade, paying particular attention to the area around both bearings.
  - c. If no crack is found in the paint the inspection is complete until next inspection.
  - d. If a crack is found in the paint, proceed with step 2.
2. Remove the tail rotor blade from the helicopter (refer to BHT-230-MM-7, Chapter 64).
