**ALERT SERVICE BULLETIN**

**NO.** 407-01-39

**MODEL AFFECTED:** 407

**SUBJECT:** BRACKET 407-040-321-101/-103, INSPECTION OF.

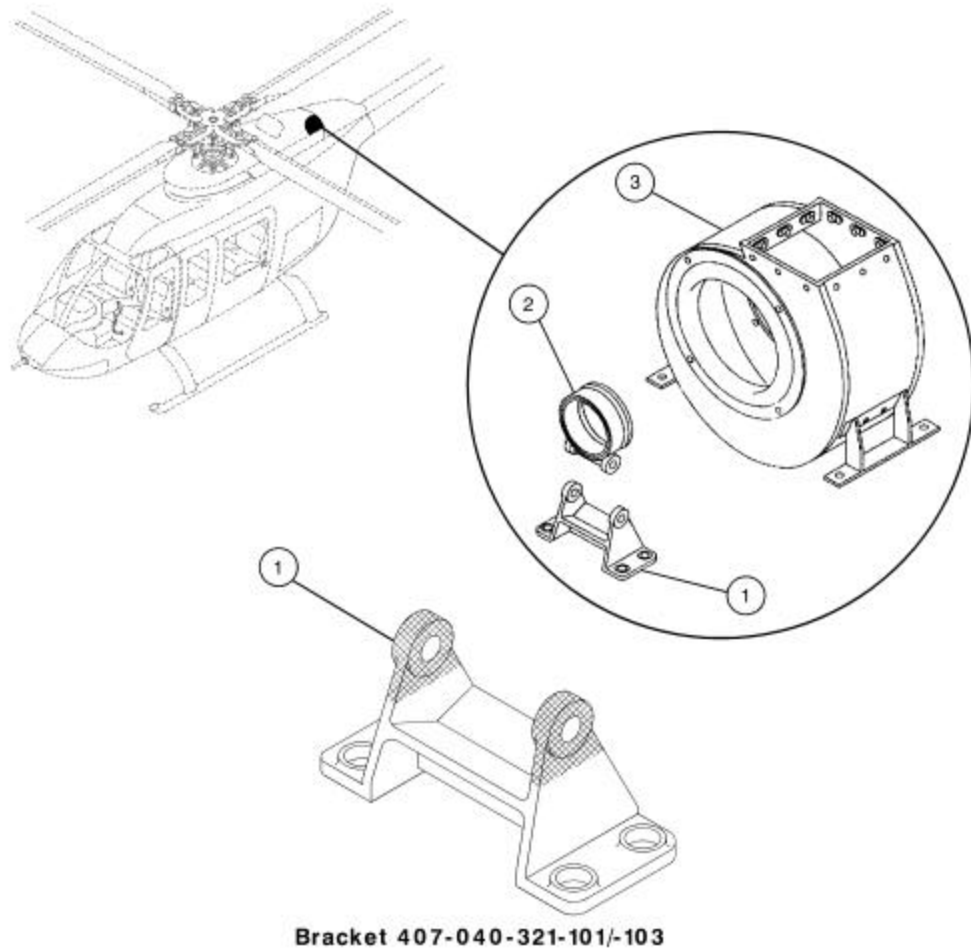
**Figure 1. Inspection of the Bracket**

Bell Helicopter has received reports of cracks in the forward bearing hanger support 407-040-321-101. None of the incidents has resulted in the loss of tail rotor drive or tail rotor control.

3. Use a mirror and visually inspect the bracket (1) for cracks in the areas shown in Figure 1.
4. If no crack is detected, return the aircraft to service.
5. If a crack is detected, replace the affected support. Notify Bell Helicopter Product Support Engineering that you have detected a cracked support.

- 1. Do a visual inspection of the exposed surface of the shaded area. Dismantling of bearing hanger and the support is not required.
