ALERT SERVICE BULLETIN

NO. 407-02-56

MODEL AFFECTED: 407

SUBJECT: TAIL ROTOR BLADES 407-016-001-101 and 406-016-100-119 ONE TIME LEAK CHECK

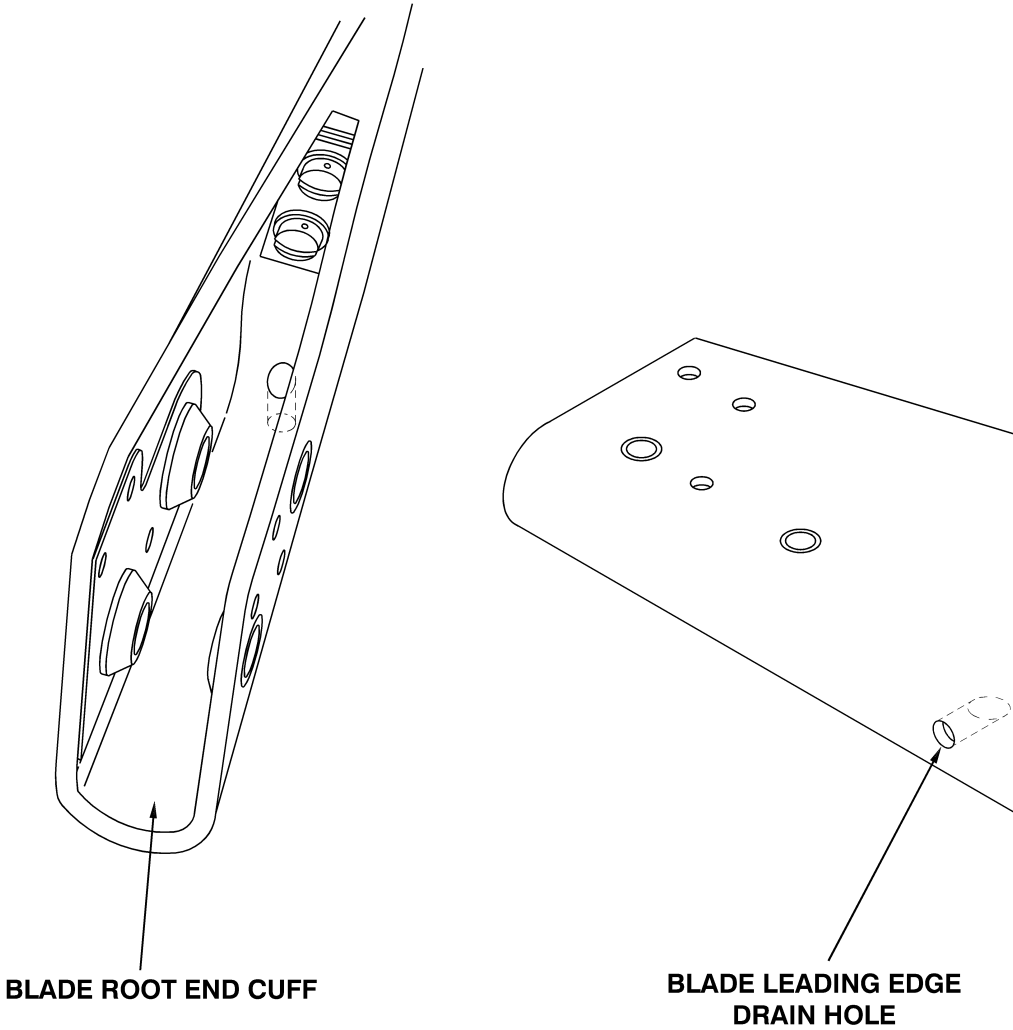
Figure 1. Areas for particular attention during inspection

Bell Helicopter has received reports of a significant increase in tail rotor vibration level recorded during scheduled tail rotor balance checks. It was found that the vibration increase was due to water entering in one of the tail rotor blades.

4. Wipe the blade dry and perform a thorough inspection of the blade. Look for any pin hole or bond line separation that could be the potential for water entry. Pay particular attention in the root end cuff and around the leading edge drain hole (Figure 1).

11. Gently rotate blade back and forth to allow a thorough inspection of all the blade surfaces. Pay particular attention to the root end cuff and around the leading edge drain hole. Refer to the Figure 1.

1. Repair any defect located in the blade root end cuff as follows:
 - a. Thoroughly clean the area around the leak point using aliphatic naphtha solvent (C-305). Do not allow solvent to enter the leak point. Wipe dry with a clean lint-free cloth.
 - b. Apply sufficient AMS-S-8802 sealant (C-308) to the leak point to completely seal the defect. Sealant should extend a minimum of 0.250 inch around the defect in all directions.
 - c. Cure the sealant per manufacturer's instructions.
 - d. Do the leak check again as per PART II c. of this bulletin after the repair to ensure the blade does not leak.
 - e. Prime and paint touch-up the repaired area is optional.

2. Repair any defect located on the exterior surface of the blade or in the leading edge drain hole as follows:
 - a. Sand the area to be repaired by hand with 220 grit sand paper. Do not sand into the fiberglass.

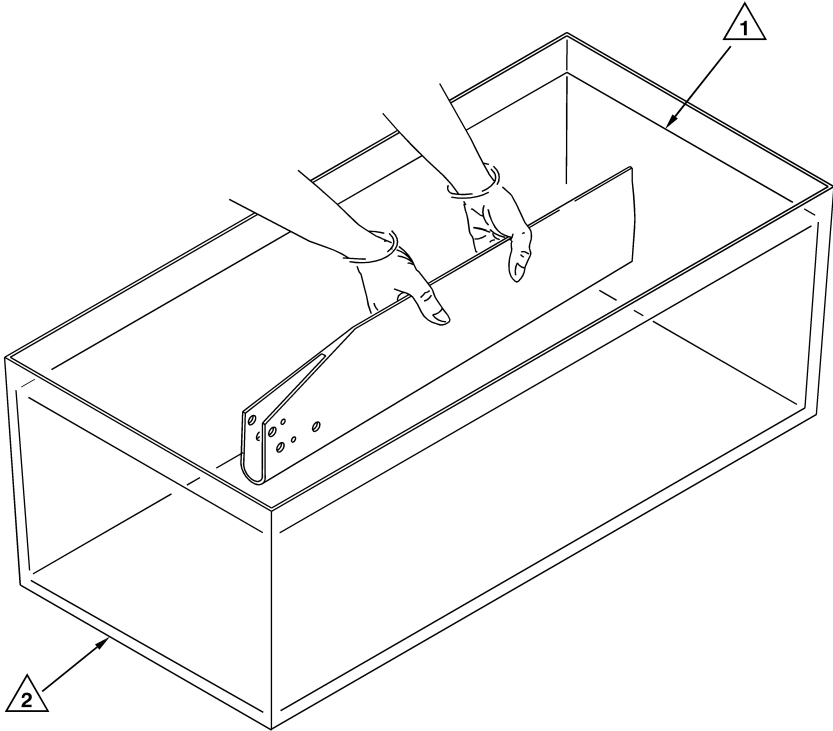
Figure 2. Water tightness check

10. With the blade under water, check for air leaks that will be indicated by a steady stream of fine bubbles originating from a single point.

7. Fill the water tank with clean clear water. For best results the water should be maintained at 60°C to 80°C (140°F to 175°F).
8. Wearing protective gloves, place the cool blade into the heated water. The blade will float so it will be necessary to manually submerge the blade.

12. The blade should be left in hot water for a minimum of 1 minute and a maximum of 2 minutes.
13. If an air leak is found on a new uninstalled blade do PART III.
14. If an air leak is found on a used uninstalled tail rotor blade send the tail rotor blade to a Bell Helicopter Approved Blade Repair Facility for evaluation and repair.
15. If no air leak is found on a new or used uninstalled tail rotor blade the tail rotor blade is acceptable to release from this inspection procedure. Make an entry in the tail rotor blade Historical Record to show that this Alert Service Bulletin has been completed.
16. If an air leak is found on a tail rotor blade that was installed on a helicopter refer to TABLE 2 to determine the next action.
17. If no air leak is found on a tail rotor blade that was installed on a helicopter the blade is serviceable. Refer to TABLE 2 to determine the next action.
