**ALERT SERVICE BULLETIN**

**SUBJECT: REVISION "B" TO ALERT SERVICE BULLETIN 407-03-57: (TAIL ROTOR GEARBOX CASE 406-040-406-109, /-113 OIL FEED HOLE FOR DUPLEX BEARING 406-040-432-103, ADDITION OF**

**NO.** 407-03-57

**SUBJECT:** TAIL ROTOR GEARBOX CASE 406-040-406-109, /113 OIL FEED HOLE FOR DUPLEX BEARING 406-040-432-103, ADDITION OF. **A**

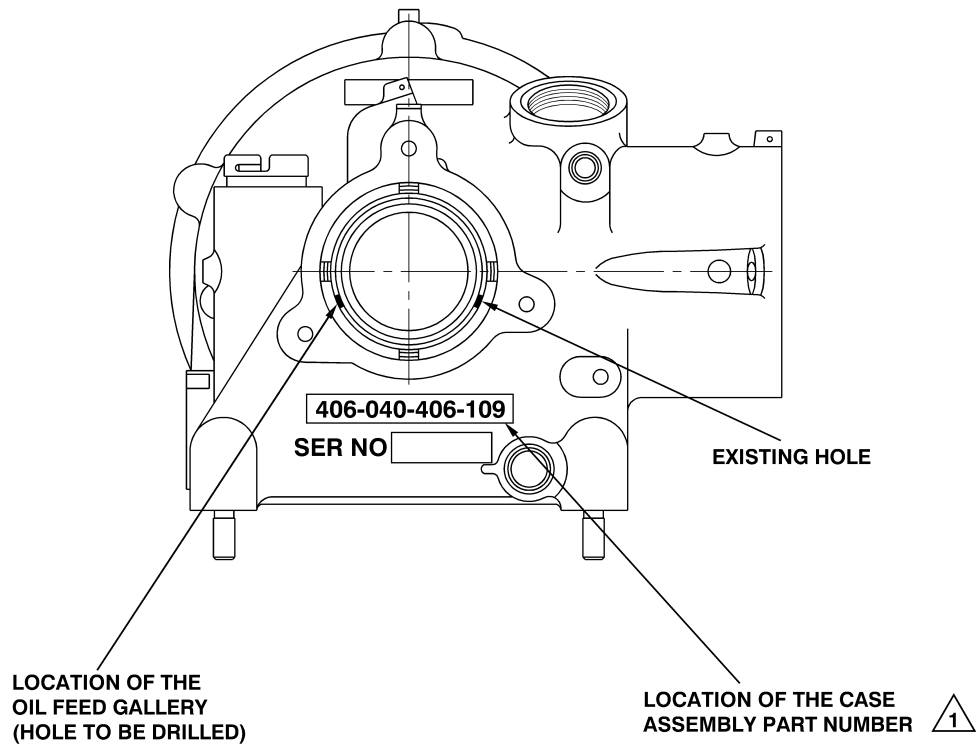
**Figure 1. Location of the oil feed hole**

It has been determined that the oil feed gallery for duplex bearing 406-040-432-103 can be missing from the tail rotor gearbox case 406-040-406-109 and -113. Even though this duplex bearing is splash lubricated, this situation reduces the oil supply required to lubricate the duplex bearing 406-040-432-103 and can result in a bearing failure if not corrected.

5. Remove the pitch change mechanism (BHT-407-MM, Chapter 67).
6. Remove the duplex bearing outer race output nut (BHT-407-CR&O, Chapter 65).
7. Check if the tail rotor gearbox case has an oil feed gallery as shown in Figure 1 of this bulletin.
  - a. If the case has an oil feed gallery, this bulletin is completed, continue with Step 8 below. Use a vibrating stylus and re-identify the case assembly as follows:

Tail rotor gearbox cases 406-040-406-109 and 406-040-406-113 are affected by this bulletin.

- b. If the oil feed gallery is missing from the case, do PART II of the ACCOMPLISHMENT INSTRUCTIONS within the compliance time.
8. Install the output duplex bearing outer race nut (BHT-407-CR&O, Chapter 65).

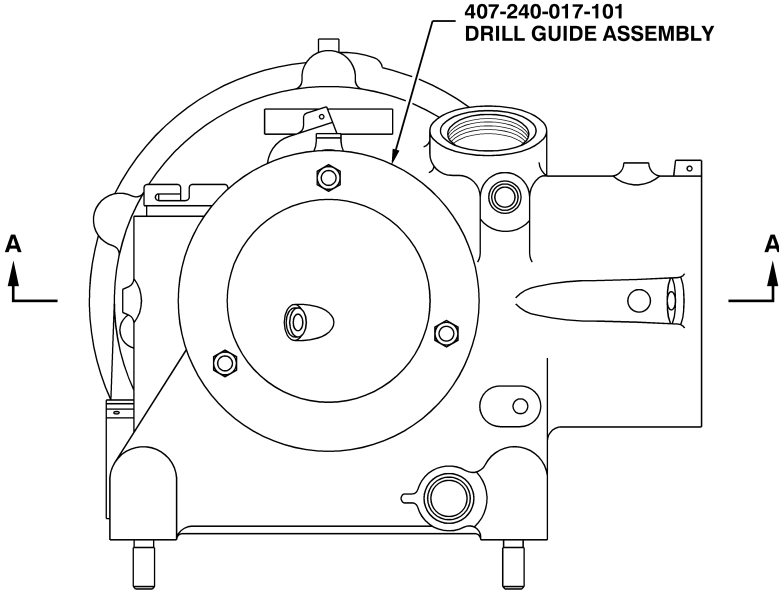
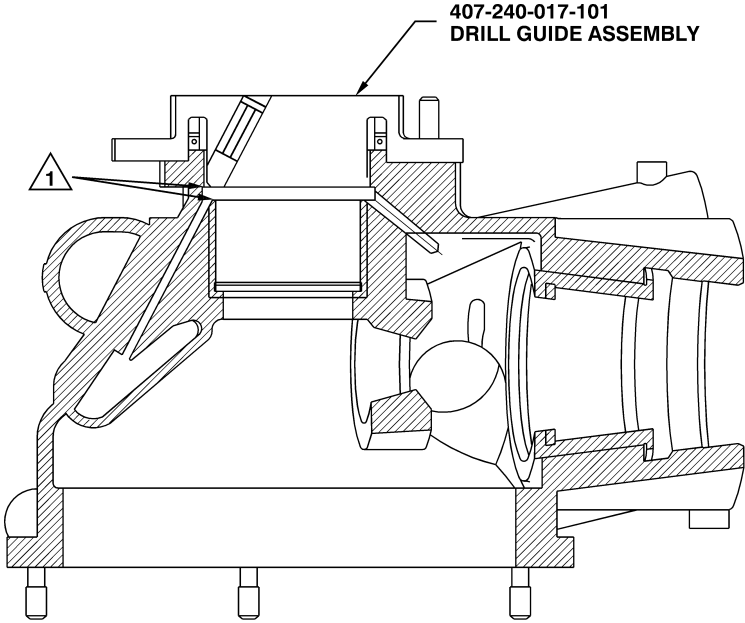
**Figure 2. Rework of the tail rotor gearbox case**

Duplex bearing liner can be nicked as the gallery is drilled.  
This is not detrimental to the liner. Use a Swiss file and remove sharp edges.

3. Clean the gearbox case. Make sure that paint or sealant is fully removed from the gearbox surface that contacts with the drill guide.
4. Install the drill guide tool 407-240-017-101 on the gearbox case assembly and attach with the existing hardware (Figure 2).

5. Position and set a drill stop  $4.50 \pm 0.030$  inches ( $114.3 \pm 0.76$  mm) from the point of a short fluted twist drill bit. Lubricate drill with cutting oil and drill the oil feed gallery in the gearbox case.

6. Remove the drill guide tool 407-240-017-101.
7. De-burr the sharp edges of the hole.
8. Fully clean the gearbox case. Make sure that no unwanted material stays in the cavities.
