SUBJECT: **REVISION "A" TO ALERT SERVICE BULLETIN 407-04-66:
(FREEWHEEL AFT BEARING CAP 406-040-509-101, INSPECTION
AND REWORK OF)**

NO. 407-04-66

MODEL AFFECTED: 407

SUBJECT: Freewheel aft bearing cap 406-040-509-101, inspection and rework of

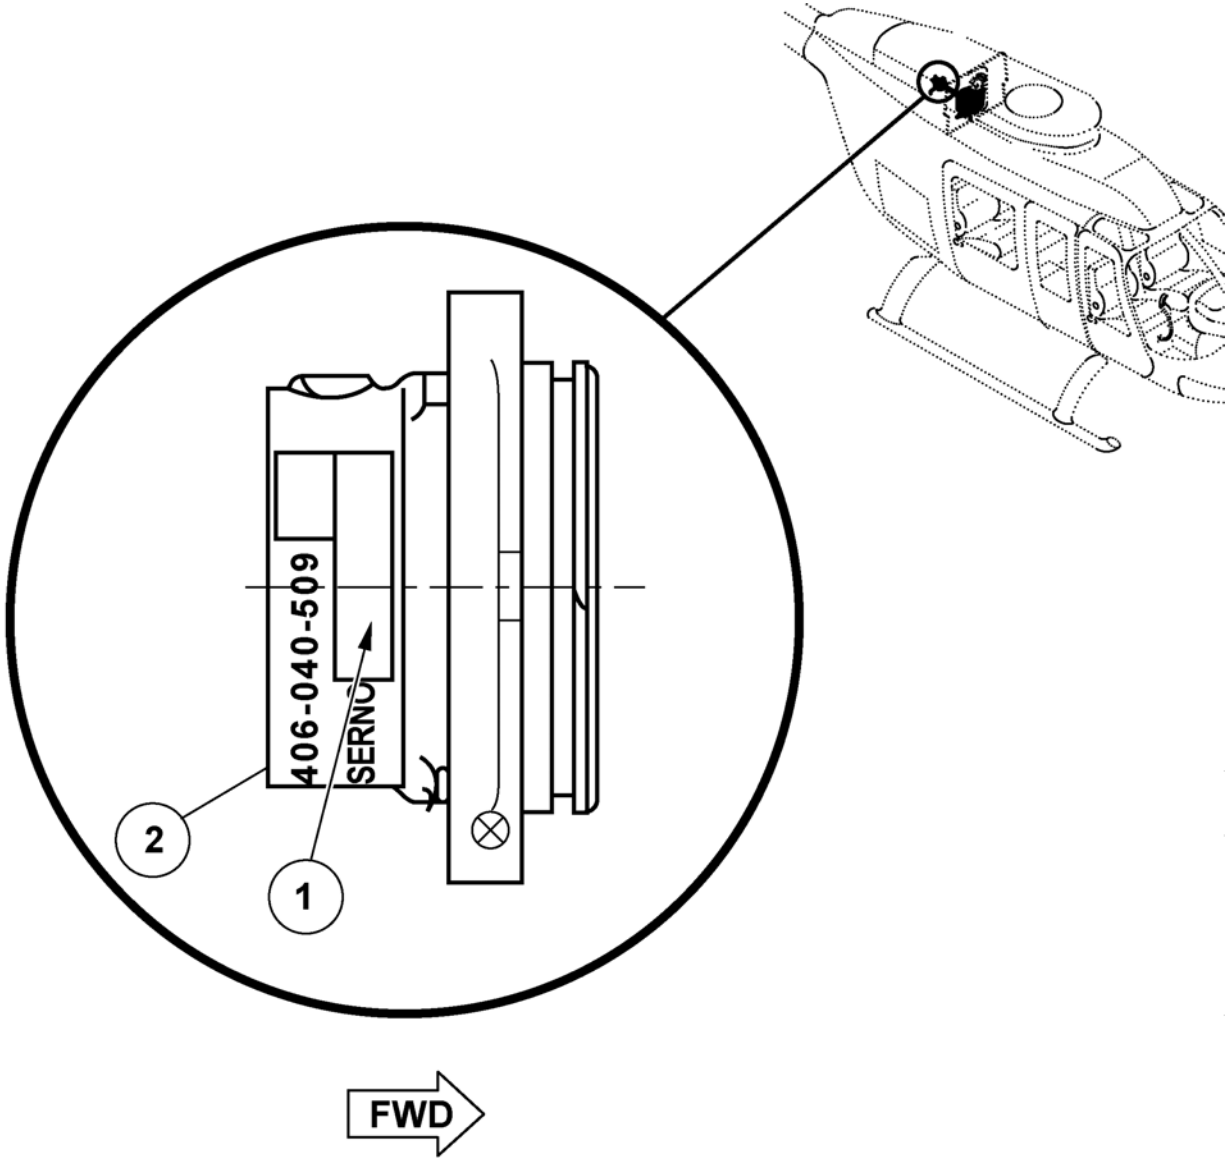
Figure 1. Location of the lubrication channel and the serial number

1. Open the engine access doors.
2. Locate the serial number (1, Figure 1) of the freewheel aft bearing cap (2).
 - a. If the cap serial number is not listed in the HELICOPTER AFFECTED section, no further action is required. Close the access doors and continue with Step 3.
 - b. If the cap serial number is listed in HELICOPTER AFFECTED section, refer to the COMPLIANCE section and accomplish either PART II or III of this bulletin as directed. Contact Product Support Engineering Light Helicopters with the P/N, S/N, TSN, and TSO of the aft bearing cap and freewheel assembly.

- 1. Cap serial number is located on the R/H side
- 2. Aft bearing cap (406-040-509-101)

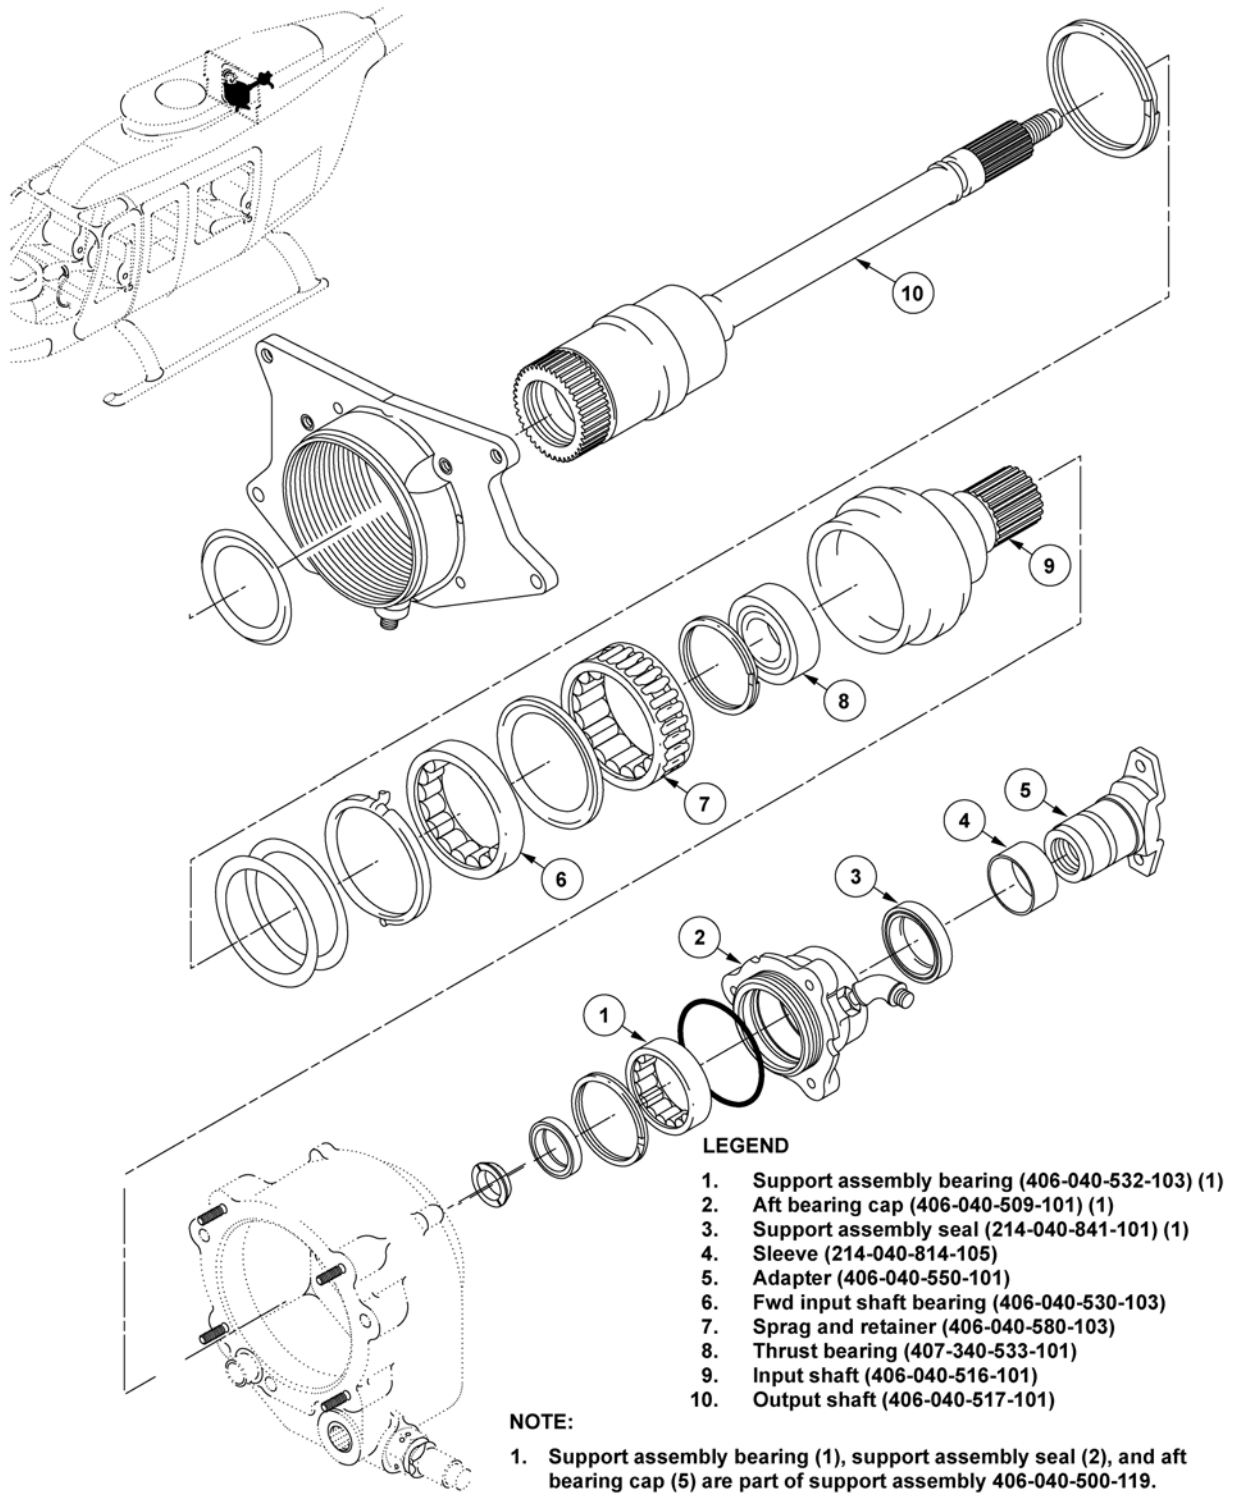
Figure 2. Parts affected by the missing lubrication channel

Bell Helicopter has found that some freewheel aft bearing caps are missing the lubrication channel intended to allow oil flow into the aft bearing support assembly. These caps may have been delivered on production aircraft or as spares.

3. Remove the aft adapter (5, Figure 2) and aft bearing cap (2) (BHT-407-MM, Chapter 63).
4. Remove bearing (1) from the aft bearing cap (2) (BHT-407-MM, Chapter 63).

5. Remove and discard the support assembly seal (3).
6. Inspect support assembly bearing (1) for condition (BHT-407-CR&O). Replace bearing if defective .

2. Disassemble the freewheel assembly (BHT-407-CR&O, Chapter 63-30).
3. Discard the sprag and retainer (7, Figure 2), the output shaft (10), and the aft seal (2).
4. Visually inspect the remaining freewheel part details for condition (BHT-407-CR&O, Chapter 63-30).

2. Remove freewheel assembly (BHT-407-MM-6, Chapter 63).
 3. Disassemble the freewheel assembly (BHT-407-CR&O, Chapter 63-30).
 4. Discard the sprag and retainer (7, Figure 2) and the output shaft (10).
