**MODELS AFFECTED:** 407

**SUBJECT:** WARNING HORNS: FADEC FAIL, ENGINE OUT, AND LOW ROTOR RPM - REPLACEMENT OF.

**HELICOPTERS AFFECTED:** 407, Serial Numbers 53000 through 53194.  
[Serial Number 53195 and subsequent will have the intent of this bulletin completed before delivery.]

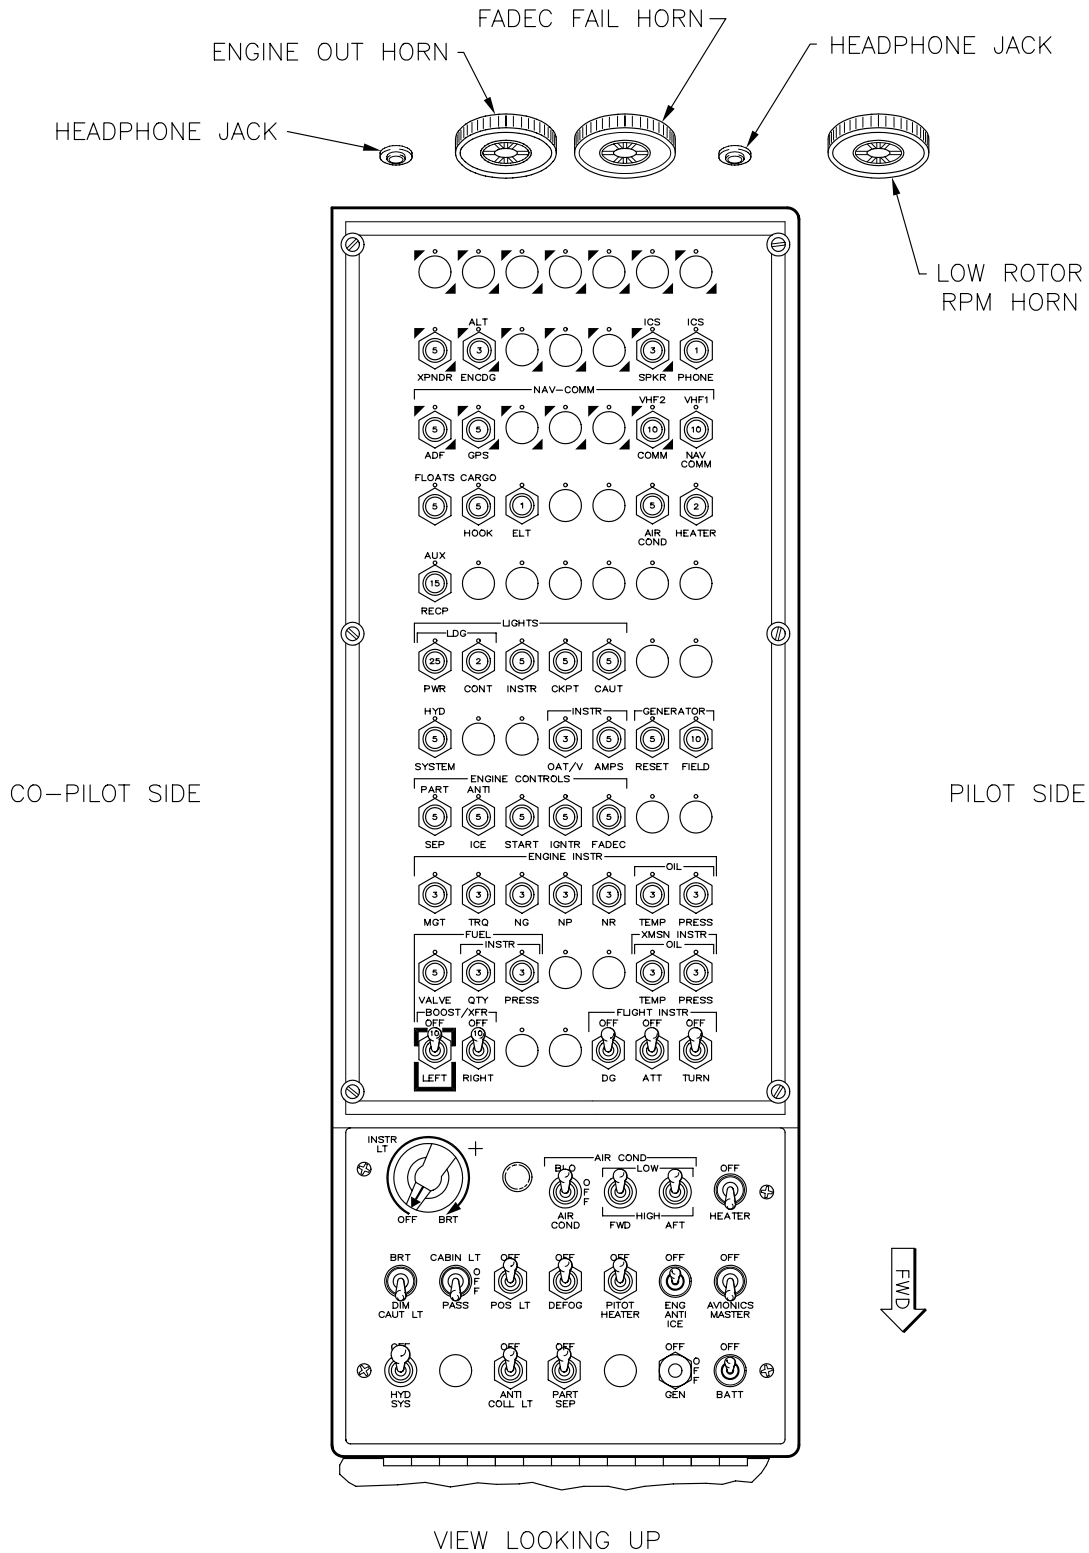
Figure 1. Warning horns location

**DESCRIPTION:** Bell Helicopter has found that there is a need to make the sound of the FADEC FAIL horn different and the sound of the ENGINE OUT AND LOW ROTOR RPM horns louder.

2. Get access to the warning horns aft of the overhead circuit breaker panel.
