**SUBJECT:** REVISION "A" TO ALERT SERVICE BULLETIN  
407-98-17: VERTICAL FIN ASSEMBLY P/N  
206-020-113-223A, 223B, OR -223S,  
INSPECTION AND REWORK OF.

**MODELS AFFECTED:**

407

VERTICAL FIN ASSEMBLY P/N  
206-020-113-223A, 223B, OR -223S,  
INSPECTION AND REWORK OF.

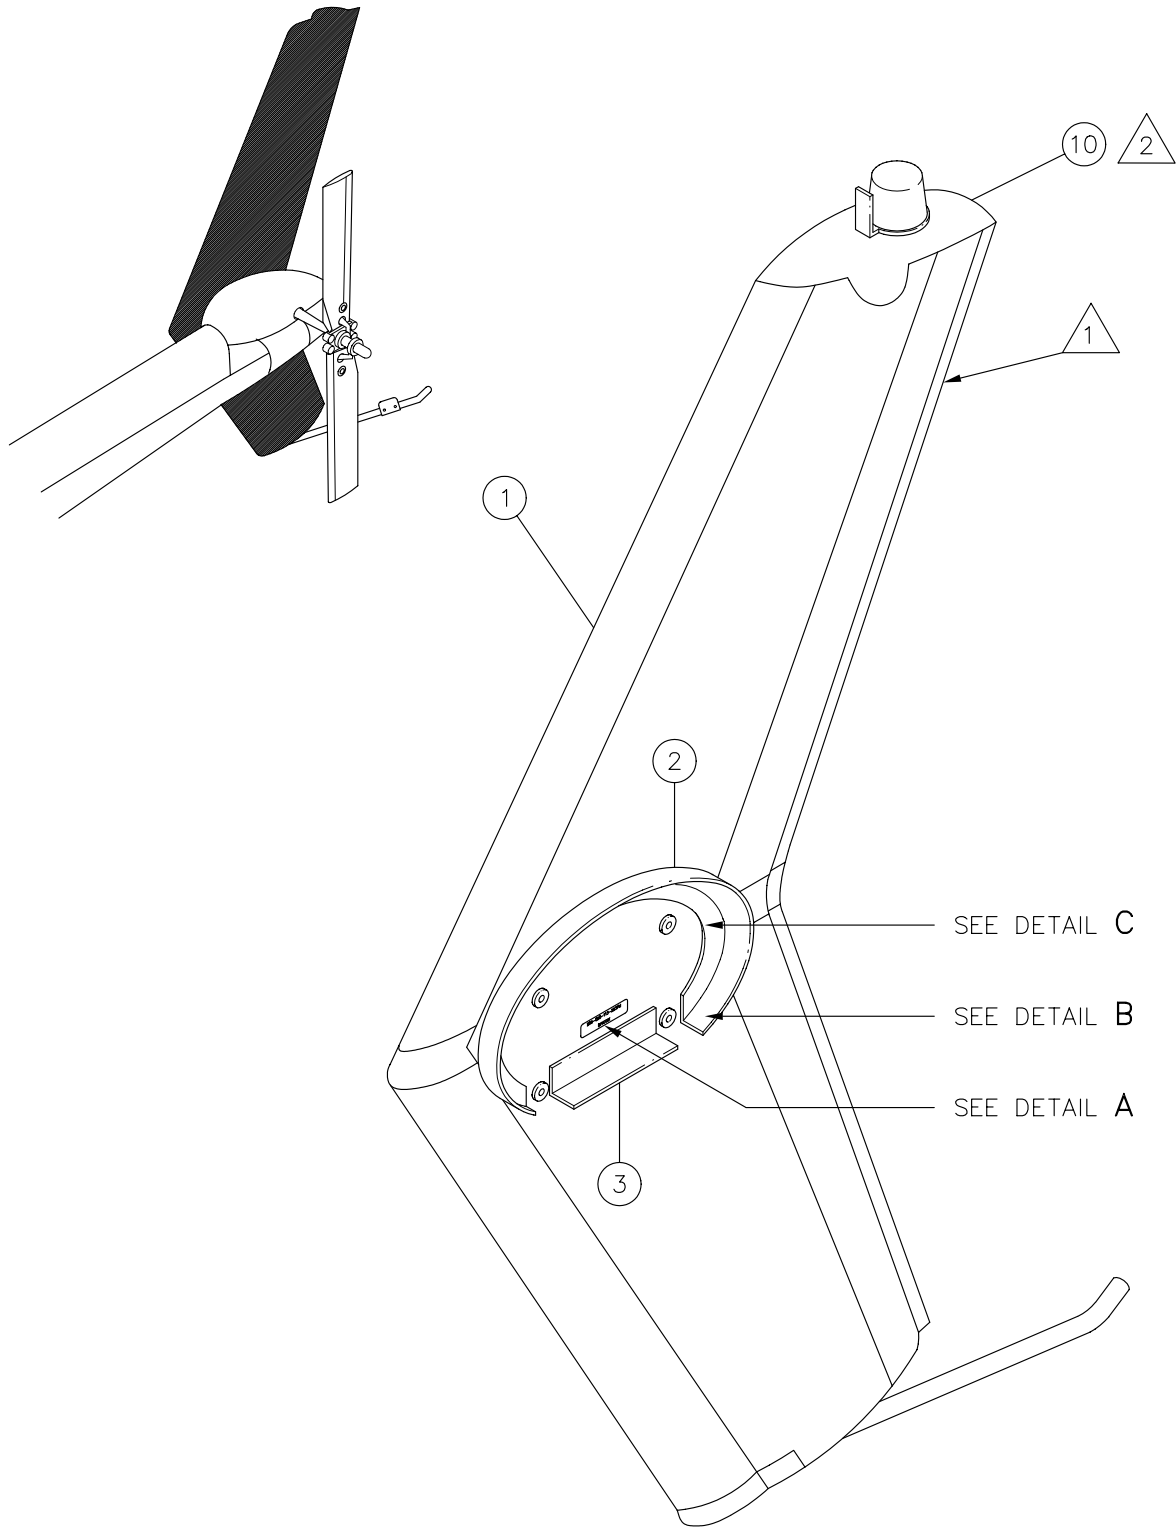
Figure 1. Inspection of the Vertical Fin (Sheet 1 of 3)

Bell Helicopter found that some vertical fin assemblies P/N 206-020-113-223 can have damage on the inboard skin caused during production. Such damage (reduced skin thickness) can decrease the strength of the vertical fin.

2. Examine the area around the aft lower insert (4, Figure 1, Detail B) as follows:
  - a. Remove the five rivets that hold former (3) in position. Remove former and keep for subsequent installation.
  - b. Remove six rivets from the aft end of former (2) and carefully lift the former to permit access for sanding and inspection.

- c. Use abrasive paper to remove paint and primer from areas A and B shown in Detail B. Do not remove metal. Do not remove primer from the surface of the insert head.

- d. Examine the area for damage. The possible damage is in the vertical direction and immediately adjacent to the ends of the formers (2) and (3). Look for notches, scratches or grooves on the skin.

- e. If you find damage, refer to Part II of this bulletin.
3. Examine the area around the aft upper insert (5, Figure 1, Detail C) as follows:
  - a. Use abrasive paper to remove paint and primer 2.0 inches (50.8 mm) around the area of the aft upper insert (5) as shown in Detail C. Do not remove metal.

- b. Examine the fin (1) around the aft upper insert (5). Look for notches, scratches or grooves on the skin.
  - c. If you find damage, refer to Part II of this bulletin.

- d. Examine the head of the plug insert for abrasion or grind marks.
  - e. If you find damage, replace the insert (refer to BHT-206-SRM-1, Chapter 3).

1. Use abrasive paper, only by hand, to remove paint and primer around the damaged area(s) 1.0 inch (25.4 mm) in all directions. This step provides a surface to refer to when you measure the depth of the damage after blending.

2. Blend damage area(s) to a smooth finish (32 RMS or better). Abrasive cloth of grade 320 or finer will produce the required finish. Extend the blended area(s) 0.15 inch (3.81 mm) in all directions for each 0.010 inch (0.254 mm) of depth. Clean area fully with solvent (MEK or equivalent). Before the solvent dries, rub the area dry with a clean lint-free cloth.

3. Do a fluorescent penetrant inspection for the blended area(s) and examine for cracks (refer to BHT-ALL-SPM, Chapter 6).
4. If you find a crack, replace the vertical fin with a serviceable unit as given in Step 7.

7. If the depth of any of the damaged areas is more than 0.020 inch (0.508 mm), replace the vertical fin with a serviceable unit as follows:

8. If the depth of each blended area around the inserts (4) and (5) is 0.020 inch (0.508 mm) or less, do as follows:

- a. Remove the remaining sealant from faying surfaces of the fin (1) and formers (2) and (3). Clean the surfaces with a lint-free cloth made moist with solvent.

- b. Apply primer (C-204) to all bare metal surfaces.
  - c. Apply sealant (C-392) to the faying surfaces of the formers and fin (1).
  - d. While the sealant is still wet, use the holes made by the rivets that you removed to attach the former (3) to the fin (1) with rivets (M7885/6-4-02), and former (2) to the fin (1) with one rivet (M7885/6-4-02) and five rivets (M7885/6-4-01). Install the rivets made wet with sealant. Make a fillet of sealant around the edges of the formers.
