MODELS AFFECTED: 407

SUBJECT: DOOR LATCH ASSEMBLIES P/N 20898-401, -402, -405 AND -406, MODIFICATION OF.

HELICOPTERS AFFECTED: 407, Serial Numbers 53000 through 53228.

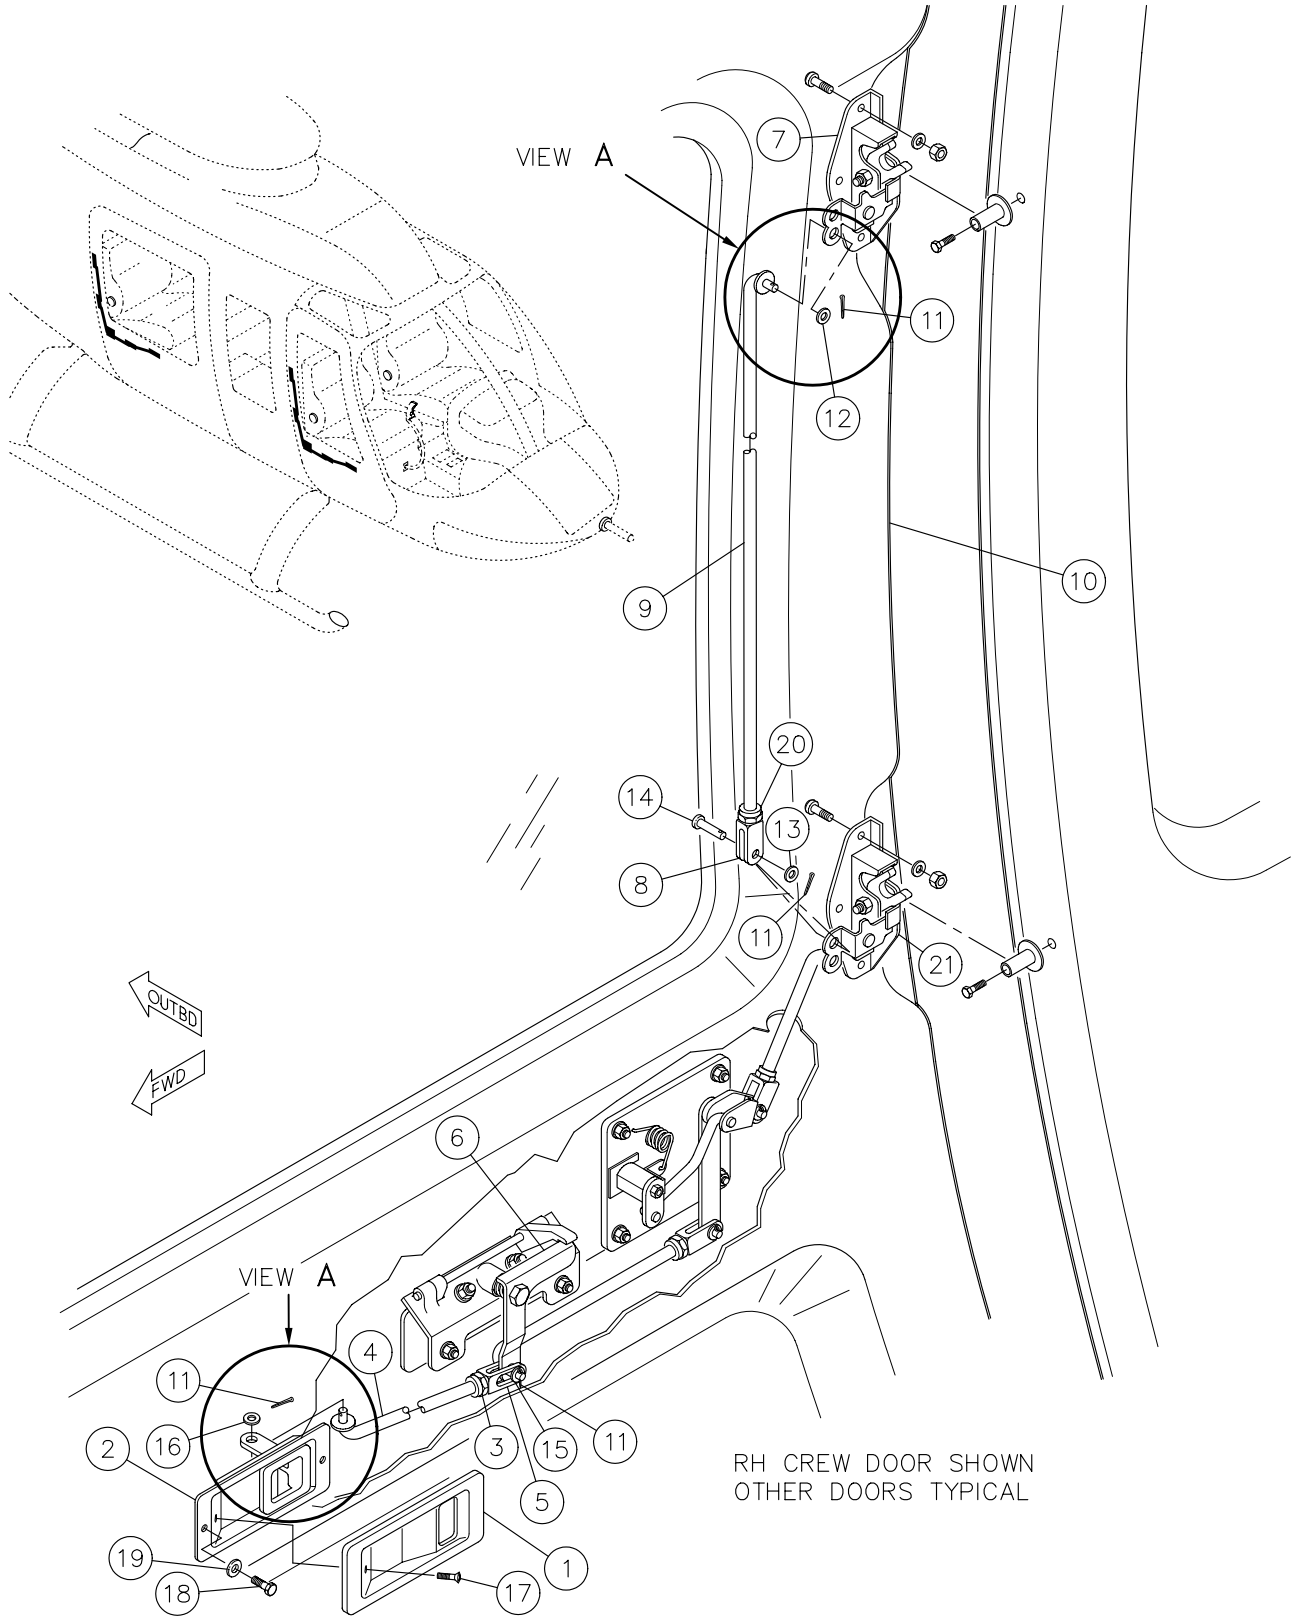
Figure 1. (Sheet 1 of 2)

DESCRIPTION: Bell Helicopter was sent reports that rod assemblies accidentally disengaged from the door handle. The person in the helicopter could then not open the door. This Alert Service Bulletin is sent to make a modification to the attachment of two rod assemblies in each crew and passenger door latch assembly.

1. Get access to the interior door handle (2, Figure 1).
2. Remove the screws (18) and washers (19) that attach the interior door handle (2) to the door structure (10).

3. Disconnect the rod assembly (4) from the bellcrank (6).
4. Pull out the interior door handle (2) to permit access to the rod assembly (4) that is connected to the interior door handle (2). Remove the tie down strap and the clip (View A) that attach the rod assembly (4) to the handle. Disconnect the rod assembly (4) from the interior door handle (2). Discard the clip.

5. Use a locally made fixture to measure the length of the rod assembly (4).
6. Remove the threaded clevis (5) and the jamnut (3) from the initial rod assembly (4). Discard the rod.

7. Install the jamnut (3) and the threaded clevis (5) to the new rod. Adjust the new rod assembly to the same length as the initial rod assembly and tighten the jamnut (3).

8. Connect the clevis end of the new rod to the bellcrank (6) with the initial hardware, but use a new cotter pin.
9. Connect the bent end of the new rod assembly to the interior door handle (2) with the washer (16) and cotter pin (11). Make sure that the cotter pin (11) is bent so that it cannot catch on adjacent parts of the latch or door.

10. Install the interior door handle (2) on the inner side of the door with two screws (18) and two washers (19).
