**MODELS AFFECTED:** 407

**SUBJECT:** **ENGINE FAIRING, RH DOOR HINGE AND HOLD-OPEN MECHANISM – MODIFICATION OF.**

**HELICOPTERS AFFECTED:** 407 helicopters, S/N 53000 through 53330 and 53332 through 53345.

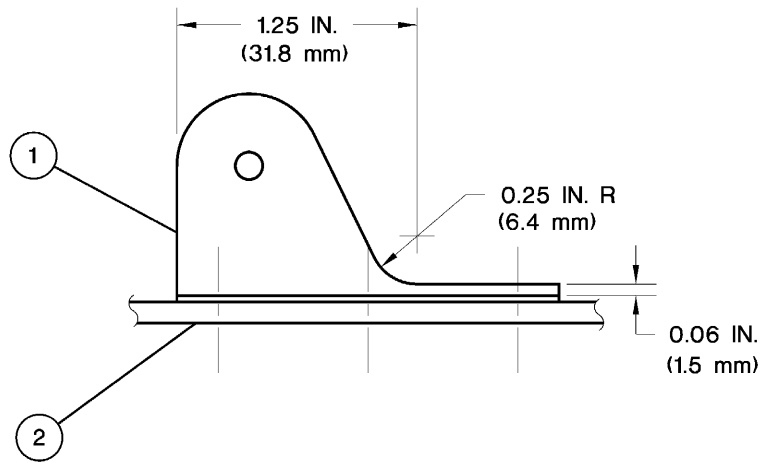
**Figure 1. Modification of Bracket**

Bell Helicopter has found that the engine access door hinge and hold-open mechanism can possibly touch and cause damage to the fuel line on the airframe fuel filter.

1. Remove the engine cowling (refer to BHT-407-MM-5, Chapter 53).
2. Use the supplied pattern (Figure 1) to transfer the new shape to the installed bracket.
3. Use aviation sheet-metal cutters, and cut the bracket as shown in Figure 1. Polish all sharp edges with a file or rotary grinder.
4. Install the engine cowling, that was removed in Step 1, on the helicopter (refer to BHT-407-MM-5, Chapter 53).
5. Change the location of the hinge pins for the hold-open mechanism on the right side only as shown on Figure 2.
6. Make sure that the fuel line (2, Figure 3) on the fuel filter assembly (1) is in the position shown (45° typical). If the line is not in the correct position, adjust the line.
7. Make an entry in the helicopter historical records to show that this Alert Service Bulletin has been completed.
8. Make an entry in the record of Alert Service Bulletin in the Maintenance Manual.
