**ALERT SERVICE BULLETIN**

SUBJECT: REVISION "A" TO ALERT SERVICE BULLETIN 407-99-27, V<sub>NE</sub>  
RESTORATION TO 130 KIAS, INTRODUCTION OF.

**NO.** 407-99-27

**SUBJECT:**  $V_{NE}$  RESTORATION TO 130 KIAS, INTRODUCTION OF.

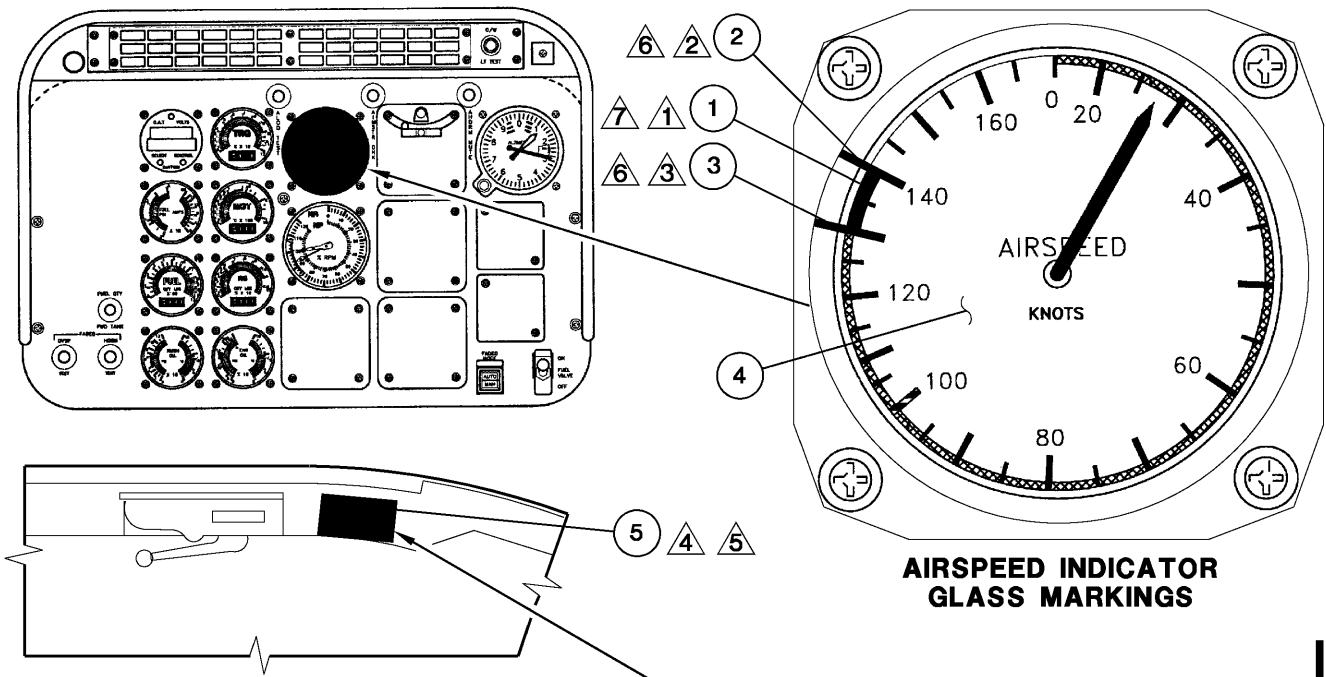
**Figure 1. New Airspeed Limitation Decal and Airspeed Indicator Glass Markings**

Revision A of this Alert Service Bulletin gives 407 owners and operators the instructions for changing the 407  $V_{NE}$  to 130 KIAS and removes the 5 KIAS cutback above 20°C OAT. The new airspeed limitation placards and the Flight Manual temporary revision needed to complete this revised bulletin are included.

1. Change the decal, Airspeed Limitations (5, Figure 1) as follows:
  - a. Remove the airspeed limitation decal found on the overhead trim panel near the windshield.
  - b. Lift one corner of the decal with a sharp knife and remove it.
  - c. Remove the decal adhesive that stays with aliphatic naphtha (C-305).
  - d. In the location of the removed decal, install the new adhesive-backed decal.
  - e. Apply edge sealer (C-349) to the edges of the decal.

2. Install temporary markings on the airspeed indicator glass face (4) as shown on Figure 1.
