ALERT SERVICE BULLETIN

NO. 412-00-100

MODEL AFFECTED: 412 & 412EP

SUBJECT: CAP ANGLE, P/N 212-030-191-001, INITIAL INSPECTION

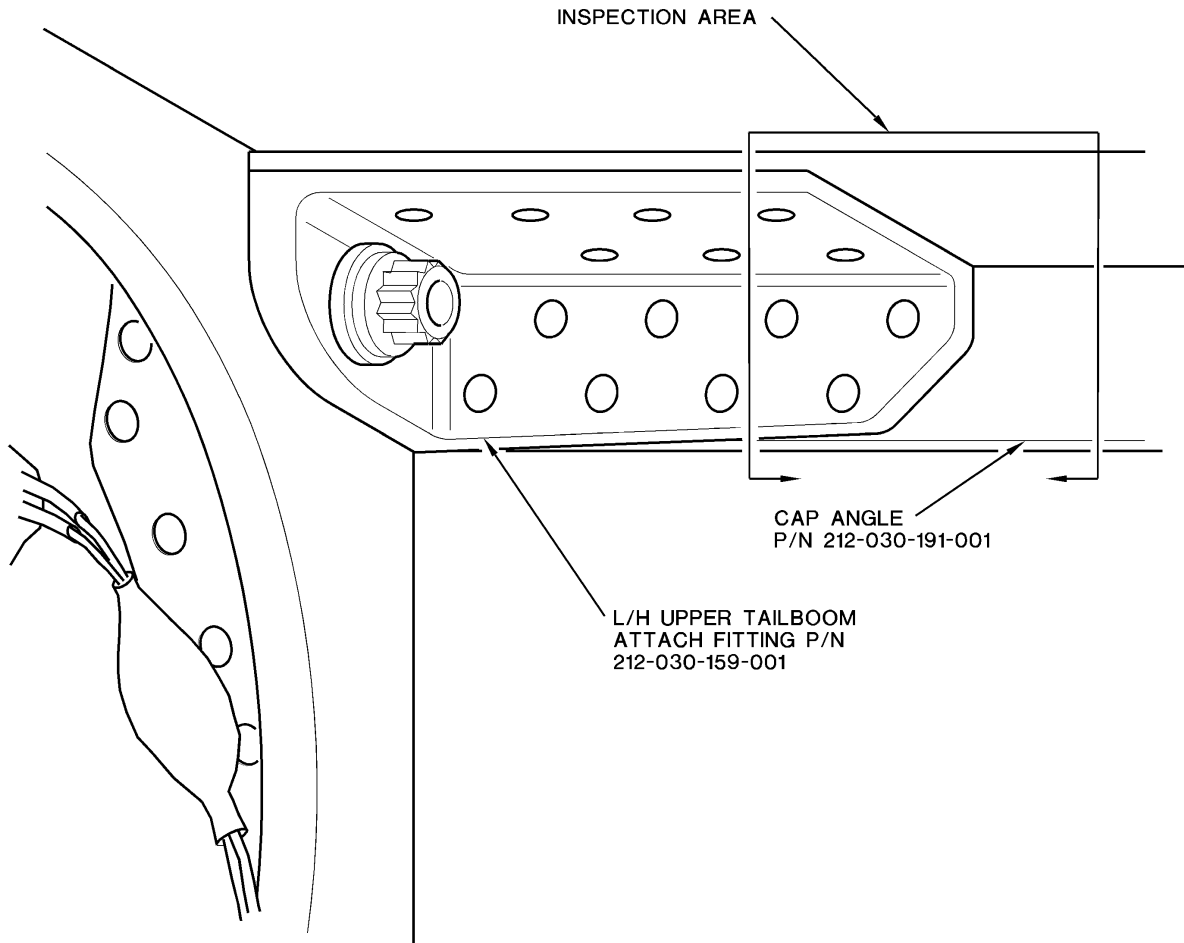
Bell Helicopter has recently completed an investigation of a fractured Upper Left Fuselage Tailboom Attachment Cap Angle, P/N 212-030-191-001. The fracture was the result of a fatigue crack, which originated from metal chips left between the bottom side of the cap and the upper side of the fitting, or between the cap angle and the adjacent structure. This has been determined to be the result of improper de-burring and cleaning during manufacture.

1. Gain access to the cap angle in the tail rotor servo compartment through the R/H aft fuselage door.
2. Inspect area noted on figure 1 of cap angle, P/N 212-030-191-001, with 10x magnifying glass.
3. If no cracks are found, return the aircraft to service.
4. If a crack is found, contact Product Support Engineering before further flight:
