ALERT SERVICE BULLETIN

NO. 412-01-107

MODEL AFFECTED: 412

SUBJECT: MAGNETIC BRAKE P/N 204-001-376-003, ONE TIME INSPECTION OF.

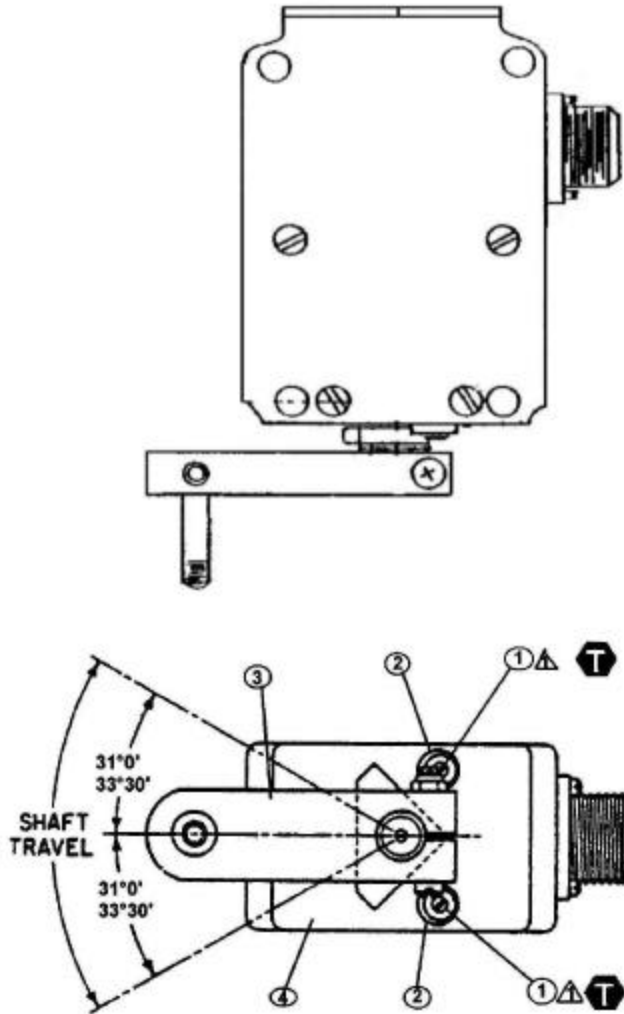
FIGURE 1

Bell Helicopter has recently received a report that magnetic brake P/N 204-001-376-003 adjustable stop screws P/N MS51959-3 had backed out which limited the travel of the arm assembly. Investigation revealed the stop screws had been installed without the proper adhesive. These Magnetic Brakes were manufactured by Memcor Truohm, Inc. under their P/N MP498-3. Magnetic Brakes P/N 204-001-376-003 made by other manufacturers are not affected by this bulletin.

If the inspection reveals that screw(s) (1) has disengaged, inspect arm assembly (4) for mechanical damage created by screw(s) (1). If mechanical damage is found, the depth shall not exceed 0.030 inch (0.762 mm). Acceptable damage may be smoothed and treated in accordance with the Standard Practice Manual Chapter 3 for Chemical Film. If damage is greater than 0.030 inch (0.762 mm) contact Product Support Engineering.

6. Remove screw(s) (1) and stop limit(s) (2) from magnetic brake (4).

7. Clean dried adhesive from magnetic brake (4) screw holes and screw(s) (1) with compressed air.
8. Apply adhesive (C-320) to screw(s) (1) threads and install in magnetic brake (4) hand tight.
9. Adjust the stop limit(s) (3) to achieve the arm assembly shaft travel as per dimension in figure 1.
10. Once shaft travel is obtained, torque screw(s) (1) 5 to 10 in-lbs (0.56 to 1.12 mm).
11. Apply torque seal inspection ink to screws (1) and to the stop limits (2).
12. Re-install anti-torque magnetic brake access panel.
13. Connect battery.
14. Make an entry in the helicopter historical records indicating compliance with this Alert Service Bulletin.
