ALERT SERVICE BULLETIN

NO. 412-01-108

MODEL AFFECTED: 412/412EP

SUBJECT: CHIP DETECTOR ASSEMBLY, TEDECO B3703

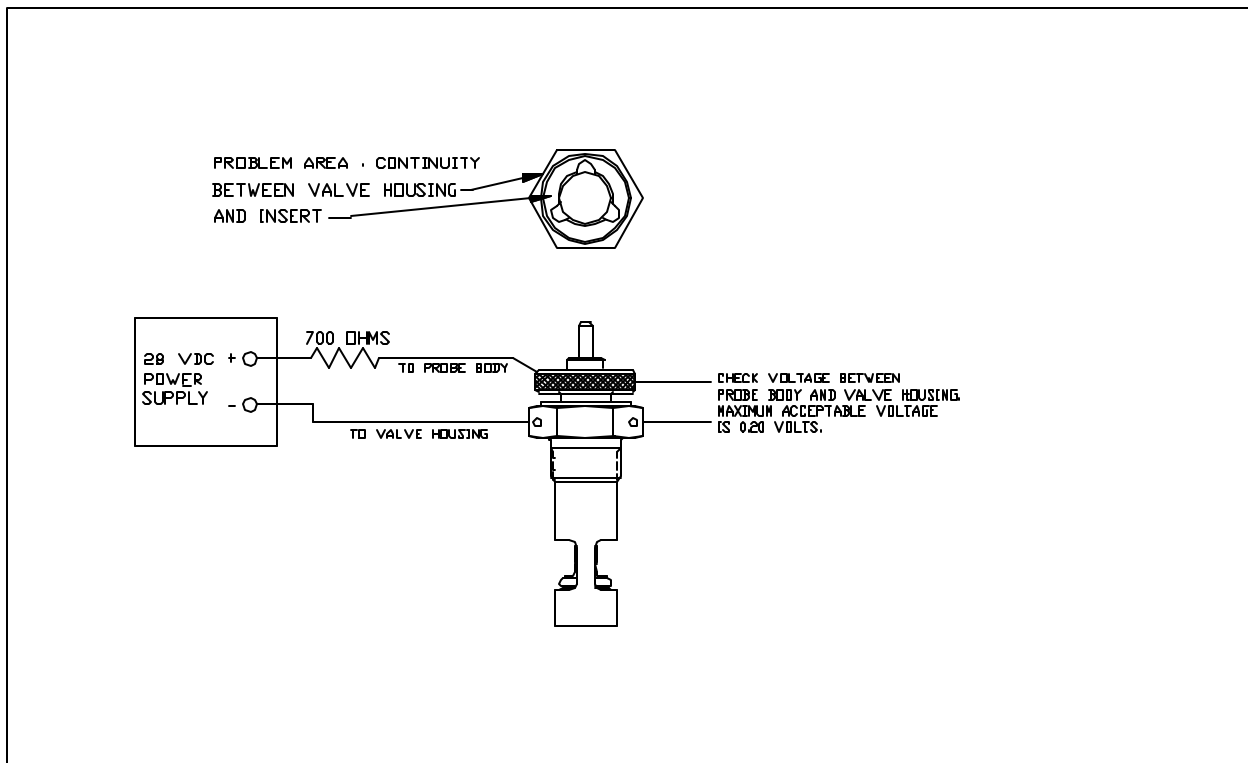
FIGURE 1

1. Connect the chip detector to a 28 Volt DC power supply using a 700 ohm, 2 watt resistor as shown in Figure 1.
2. Measure the voltage between the probe body and the valve body. The voltage drop must be 0.20 volts or less across the unit. If the voltage drop is larger than 0.20 volts, then return the unit to Tedeco (See 3. Part Replacement.)

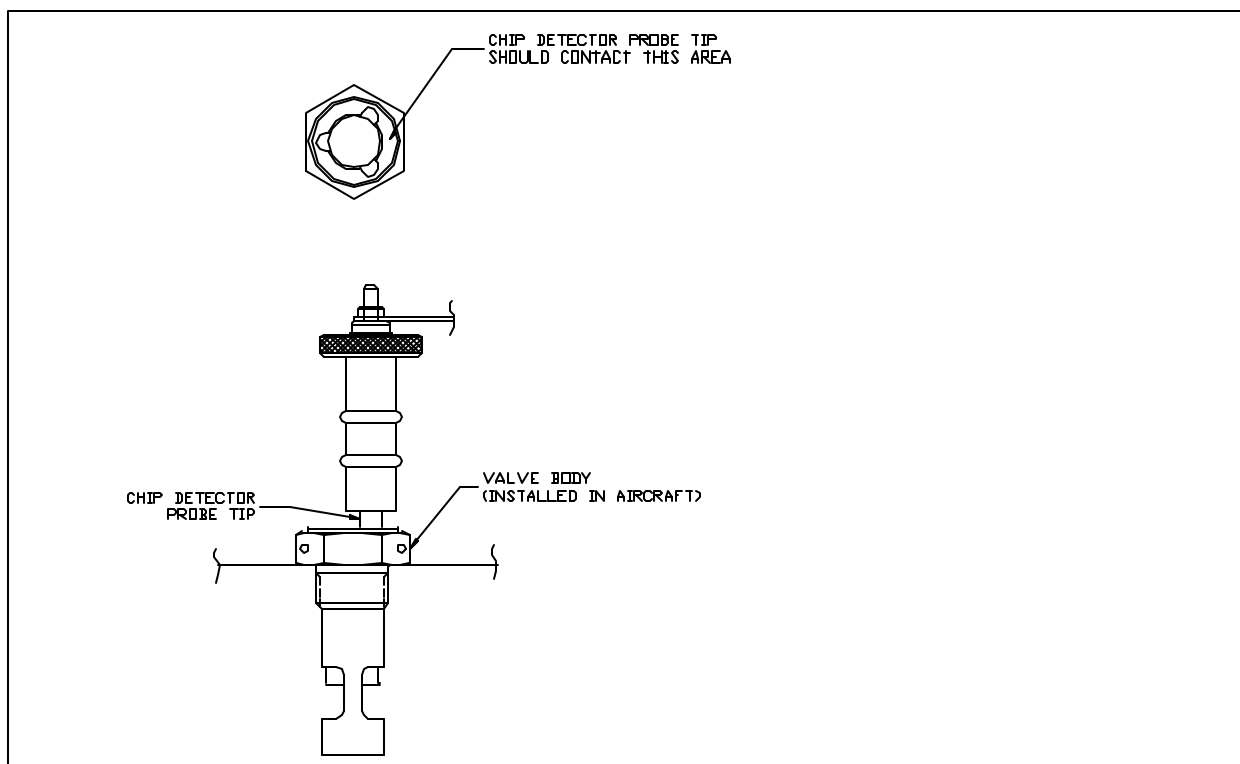
FIGURE 2

1. Ensure that electrical power is supplied to the chip detector.
2. Remove the chip detector probe from the self-closing valve.
3. Hold the tip of the center stud of the chip detector probe firmly against the steel insert as shown in Figure 2 while checking chip indicator light in cockpit. If the cockpit light illuminates, the unit is acceptable. If the light does not illuminate, then proceed to the next step.
