# ALERT SERVICE BULLETIN

NO. 412-02-111

**MODEL AFFECTED:** 412 / 412EP

**SUBJECT:** TAIL ROTOR BLADE ASSEMBLIES P/N  
212-010-750-011 / -113 / -115, INSPECTION AND  
REWORK OF.

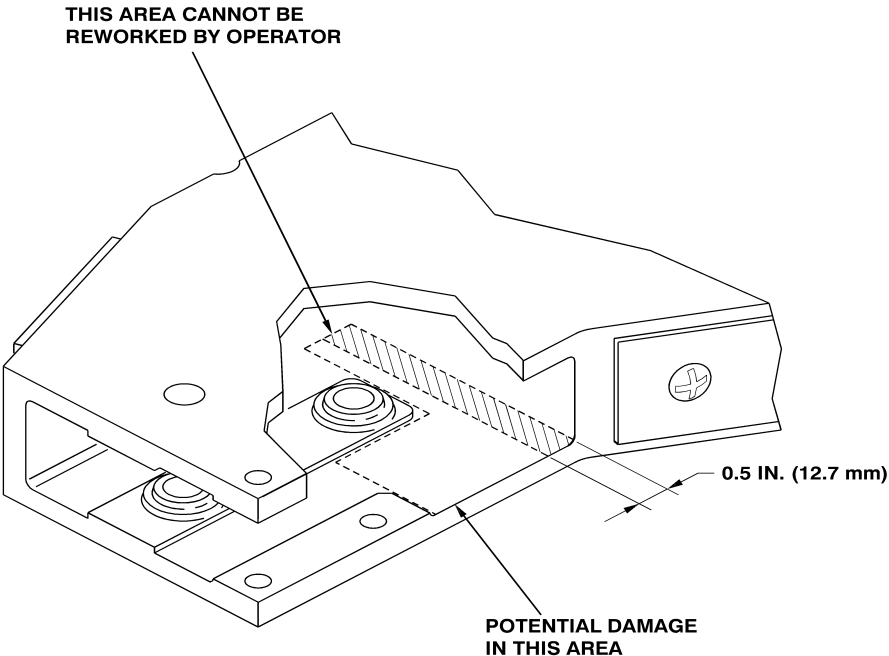
FIGURE 2

Bell Helicopter has discovered that certain serial number tail rotor blades may have  
been manufactured with mechanical damage located on the inside of the root cuff.  
The mechanical damage may be identified on the inside of the upper and lower grip  
plates. The exact location varies, but generally located outboard of the outboard  
blade bolt attachment hole. See figure 1 and 2.

If the depth of the damage exceed 0.030 inch (0.762 mm) or the damage is located in the non-reparable area per figure 2, notify Product Support Engineering for further instruction.

Detailed Inspection

7. Blend any damage found to a maximum depth of 0.030 inch (0.762 mm). Blend over a length of at least 10 times the depth on all edges of the damage.
8. Surface finish of repair shall be similar to surrounding area.
9. Apply chemical film (C-100) to reworked area.
10. Refinish tail rotor blade assembly per Bell-412-CR&O.
11. Install pitch horn
12. Install tail rotor blade assemblies on aircraft.
13. Annotate records to indicate compliance with this bulletin.
