ALERT SERVICE BULLETIN

**SUBJECT: REVISION "B" TO ALERT SERVICE BULLETIN 412-03-112:
(MAIN ROTOR SPINDLE ASSEMBLY 412-010-156-105, 412-010-190-
101 AND 412-010-190-105, INSPECTION OF.)**

NO. 412-03-112

MODEL AFFECTED: 412 & 412EP

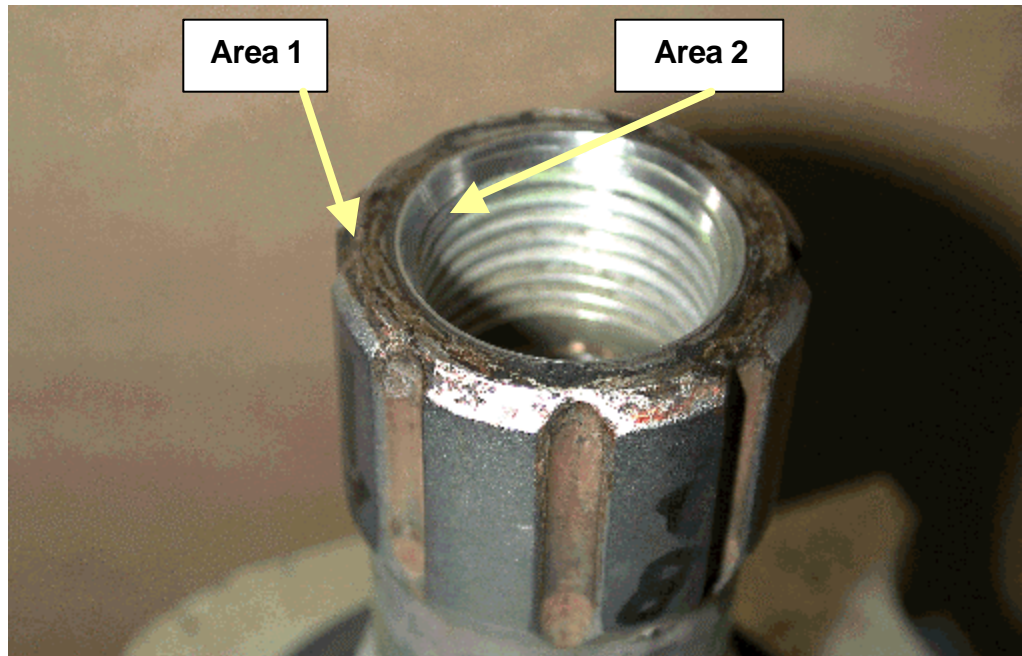
FIGURE 1

1. Clean pitch horn slotted joint of spindle, especially inboard face.
2. Conduct visual (10X) inspection of slotted joint, especially inboard face Areas 1 and 2 as shown in Figure 1. Detection of cracks is cause for rejection of the spindle.

Area 1 – Inboard flat surface adjacent to Area 2.

Area 2 – Inboard chamfer adjacent to internal threads.

Eddy Current inspect areas 1 and 2 of the spindle. It is common for the lift-off signal to change phase angle when moving from area 1 to area 2. This effect is mainly due to the ID contour of the chamfer.

- a. Inspect 100% only the areas as shown in figures 1.
- b. Balance the Eddy Current probe to each spindle area prior to performing an inspection of that area.
- c. Inspection of area 2 consists of only the inboard chamfer, and not the actual threads themselves.

Any indication interpreted as a crack shall be cause for rejection.

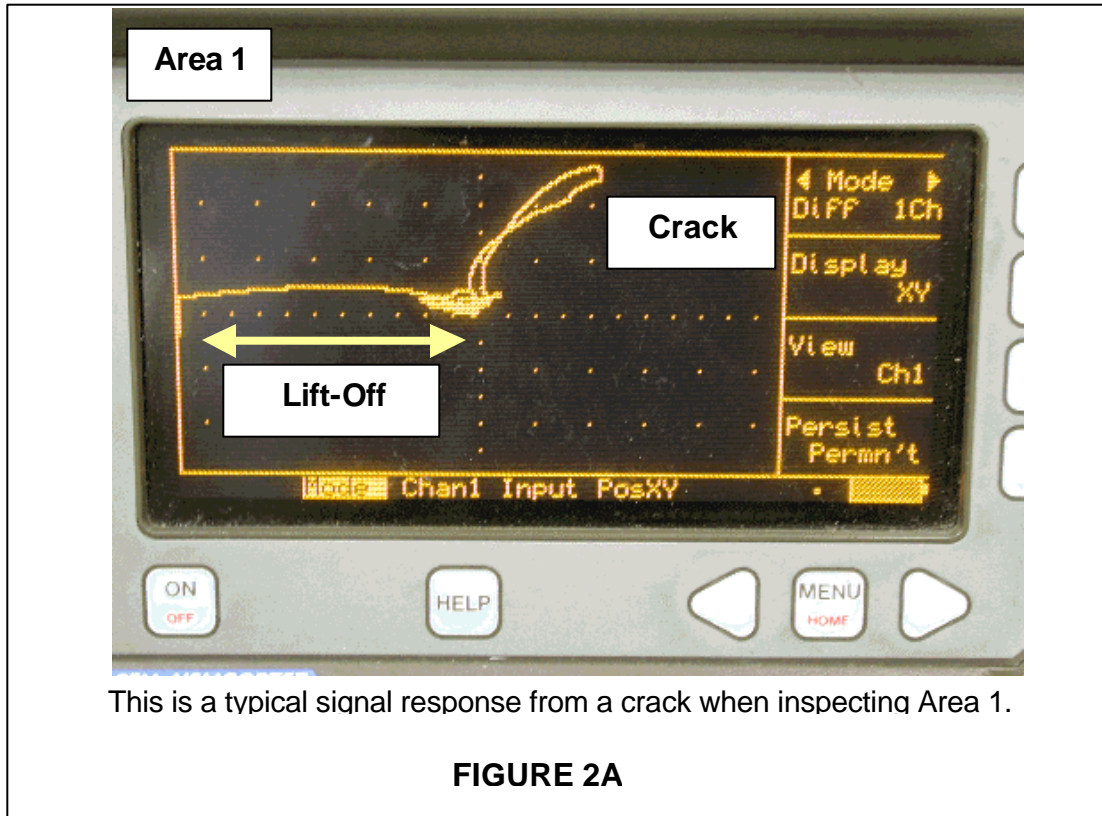
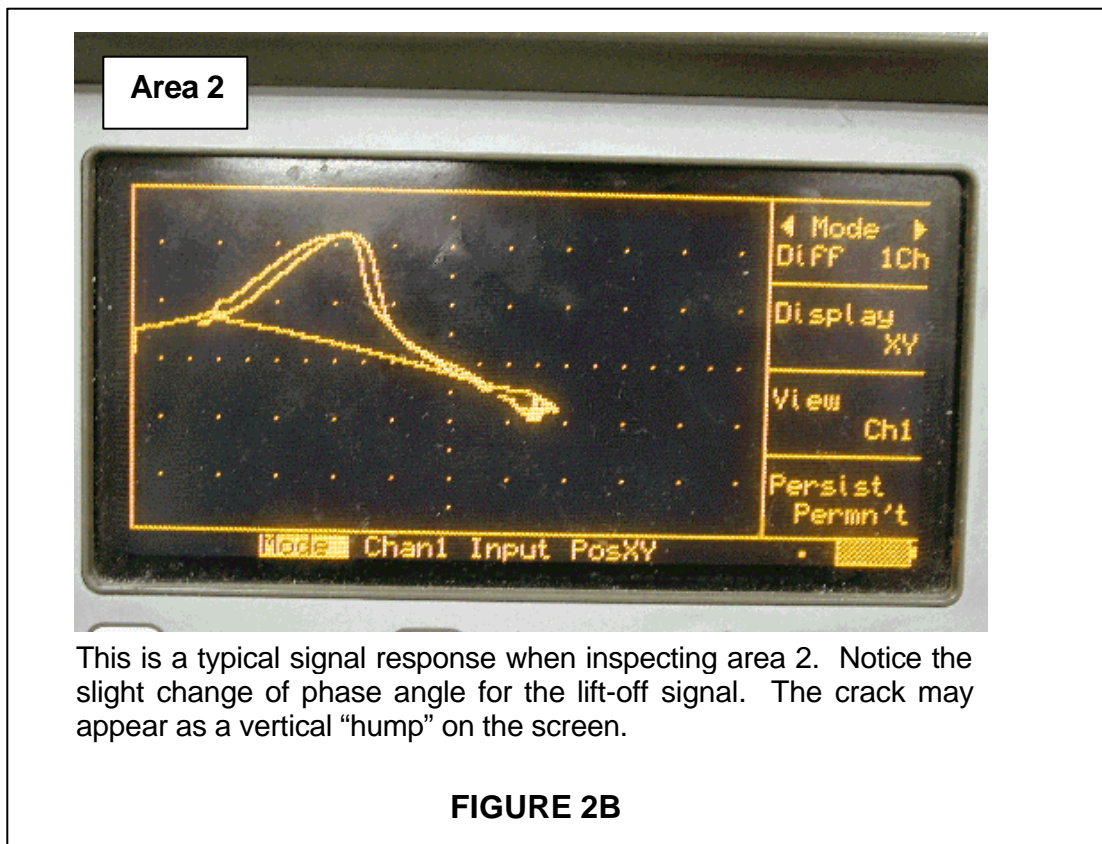
Some variations to the signals shown in figures 2a – 2b may exist. Proper interpretation of signal response is the responsibility of the personnel performing the inspection.

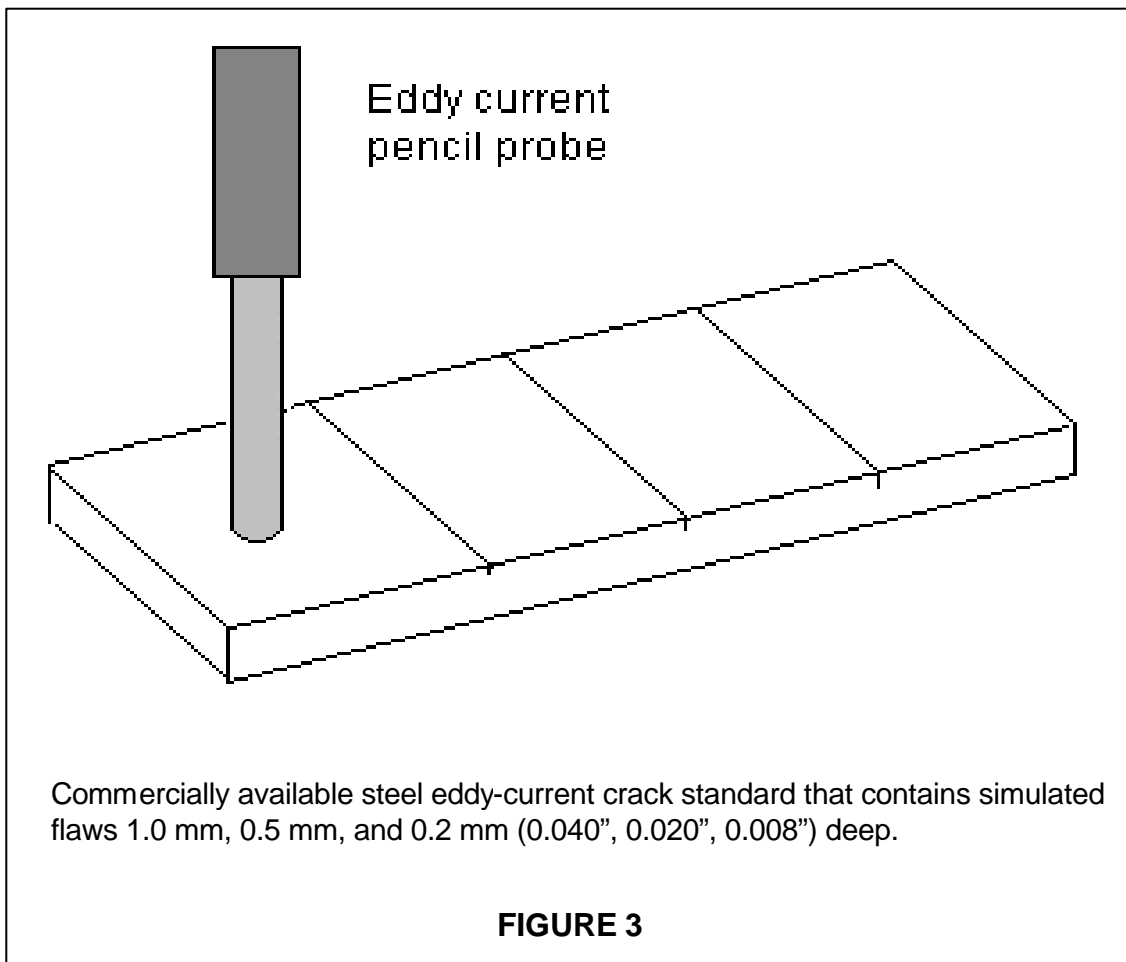
- a. Visually inspect the inboard end of the spindle for foreign material, debris, or any other contaminate that may interfere with the Eddy Current inspection.
- b. Using the Eddy Current probe, place the probe on the top of the standard (reference figure 3) and balance (null) the probe in a flaw free area of the standard.
- c. Place the probe on the standard and adjust the instrument phase so that the lift-off signal moves horizontally from the left side of the screen to the balance position. Slide the probe over the 0.008" simulated crack of the reference standard and verify the crack response moves in a vertical direction (see figure 2a).
- d. Adjust the signal amplitude using the gain control so the signal amplitude from the crack is about 1-2 divisions above the balance (null) point on the screen display.
