ALERT SERVICE BULLETIN
Bell Helicopter **TEXTRON**

NO. 412-05-115

SUBJECT: AERONAUTICAL ACCESSORIES, INC. ASB No. AA-03017 FOR EXTERNAL HOIST KITS P/N 412-130-XXX, 412-140-XXX OR 412-150-XXX.

ASB No. AA-03017

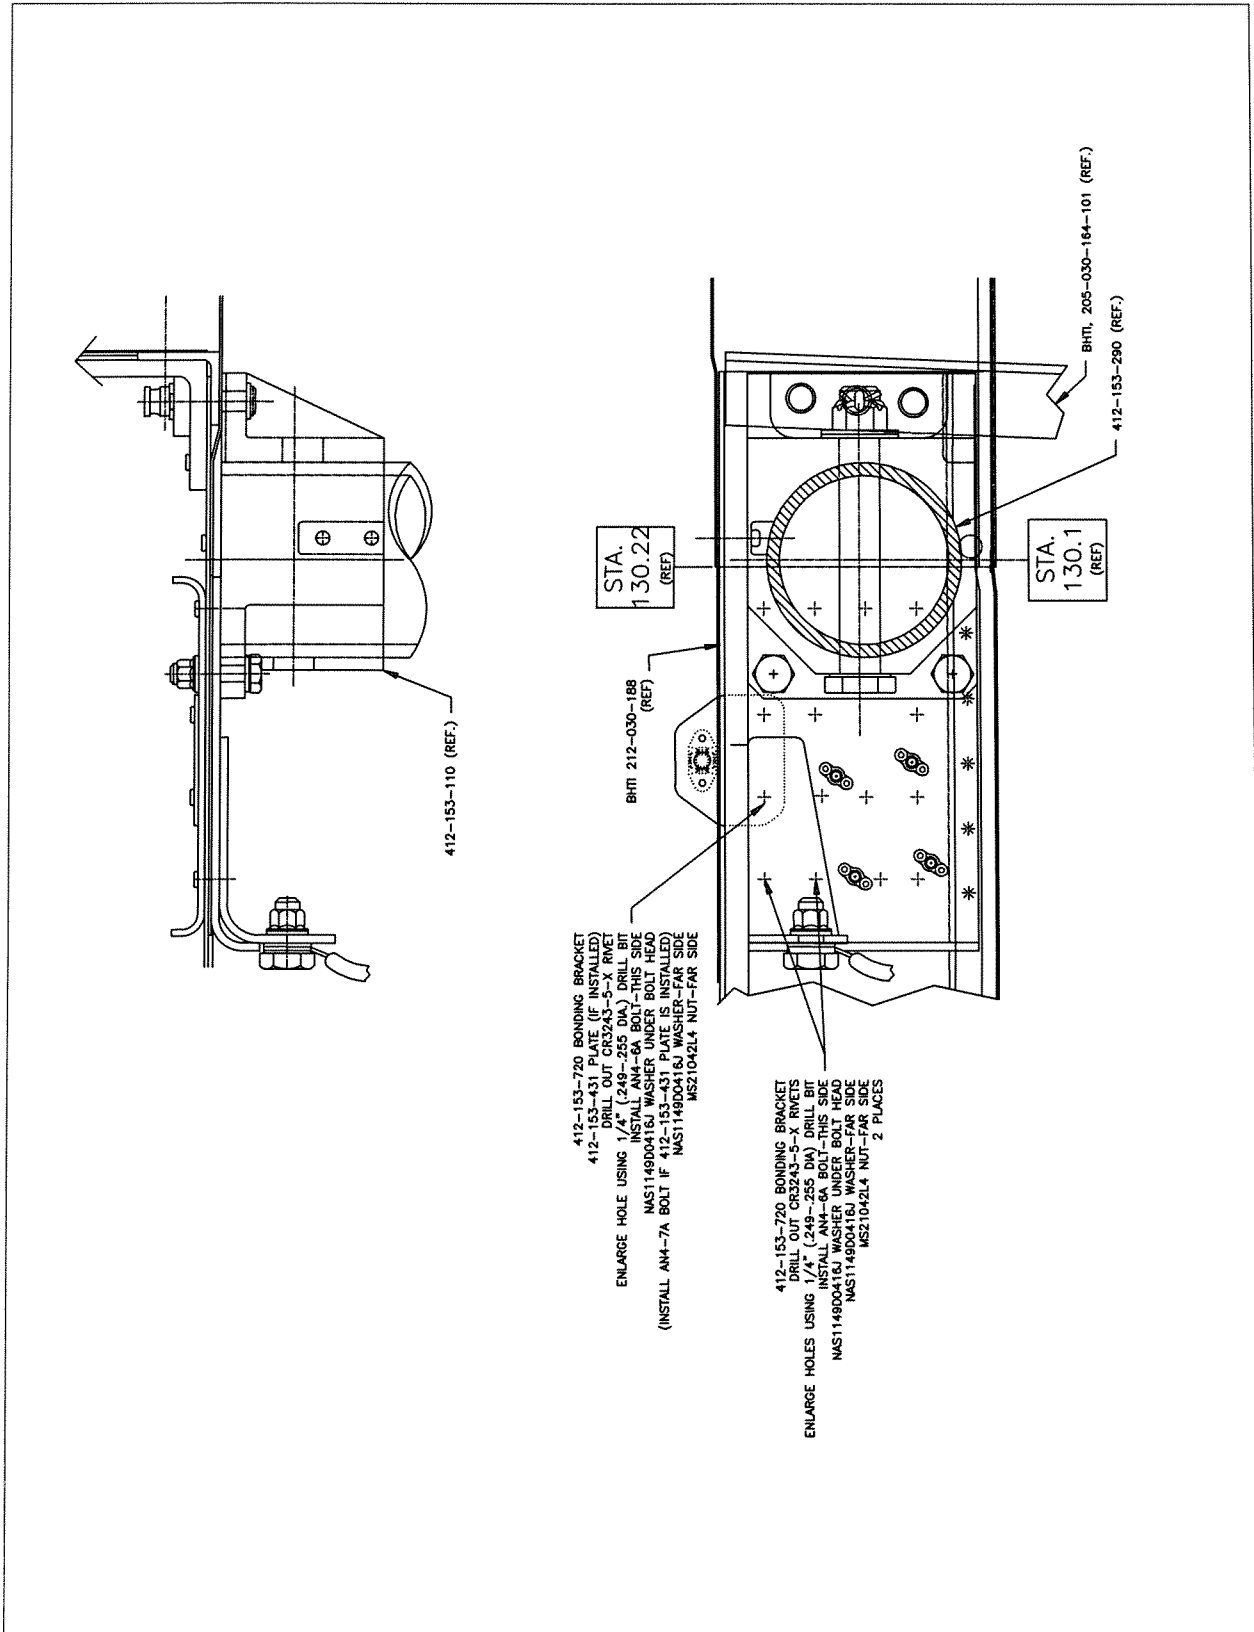
Figure 1

- SUBJECT:** External Hoist Kits
P/Ns 412-130-XXX, 412-140-XXX or 412-150-XXX
- MODELS AFFECTED:** Bell Helicopter Textron 412, 412EP, 412CF,
Agusta AB412, AB412EP with the subject External
Hoist Kit installed.
- COMPLIANCE:** This bulletin shall be complied within 50 flight
hours of receipt.
- DESCRIPTION:** This Alert Service Bulletin is being issued in
response to an incident of electrical interference
with basic aircraft equipment (i.e. AHRS Gyro,
Generator, instruments, etc). This bulletin
provides the procedures and identifies the
materials required to accomplish a modification to
improve electrical bonding to preclude electrical
interference. This document is FAA/DER
approved.
- MANPOWER:** Approximately 2.0 hours.

1. Locate Bonding Bracket (412-153-720) as shown in Figure 1.
2. Remove any existing blankets or trim to gain access to the area. Retain for reinstallation.
3. Drill out the three rivets attaching the Bonding Bracket to the airframe (Ref. Figure 1).

4. Increase the diameter of the three remaining holes by using a 1/4" (.249-.255 dia.) drill bit.

5. Using 100 grit sandpaper or dual action sanding, incrementally remove up to a maximum of .005 from the backside of the Bonding Bracket. Wipe the exposed surface with clean cheesecloth. The cheesecloth shall be either dry or wetted with isopropyl alcohol.

6. Apply a coating of chemical conversion coating (MIL-C-81706, Class 3 or equivalent) to the bond surface using a nonmetallic brush. Allow coating to remain on bond surface for 5 seconds maximum. This produces a light iridescent yellow finish on the bond surface.
7. Remove excess chemical conversion coating from the bond surface by blotting with a clean dry cheesecloth. Allow the bond surface to air-dry or gently wipe bond surface with cheesecloth.
8. Install Bolts, Washers and Nuts as shown in Figure 1.
