ALERT SERVICE BULLETIN

NO. 427-03-09

MODEL AFFECTED: 427

SUBJECT: TAIL ROTOR GEARBOX CASE P/N 406-040-406-109 OIL FEED PASSAGE, PRESENCE OF AND ADDITION OF.

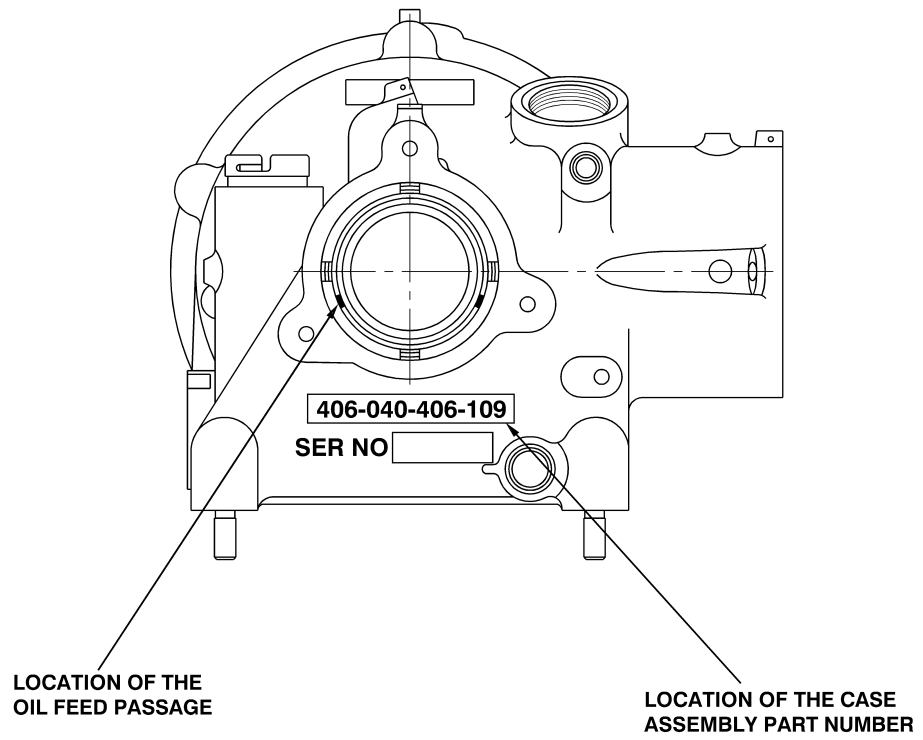
Figure 1. Location of part number and oil feed passage.

It has been determined that the oil feed passage for duplex bearing P/N406-040-432-103 might be missing from the tail rotor gearbox case P/N406-040-406-109. Through field evaluation it has been determined that the splash lubrication of the duplex bearing is sufficient to prevent abnormal bearing wear up to the 1800 hour overhaul period.

1. Refer to figure 1. Disassemble gearbox (BHT-427-CR&O) and identify the dash number for the gearbox case assembly.
 - a. If the case number is not a P/N 406-040-406-109 then the intent of this bulletin is already incorporated. Continue to step 3.
 - b. If the case number is P/N 406-040-406-109, continue with step 2.
2. Check for the presence of the oil feed passage. Refer to figure 1 for the location of the oil feed passage.
 - a. If the case has an oil feed passage then the intent of this bulletin has been incorporated. Using a vibrating stylus, re-identify the case as a **P/N 406-040-406-109FM**.
 - b. If the oil feed passage is missing, do part II of the ACCOMPLISHMENT INSTRUCTIONS.
3. Continue with Inspection and Reassembly as per BHT-427-CR&O.
4. Make an entry in component and helicopter technical records to show compliance with part I of this bulletin.

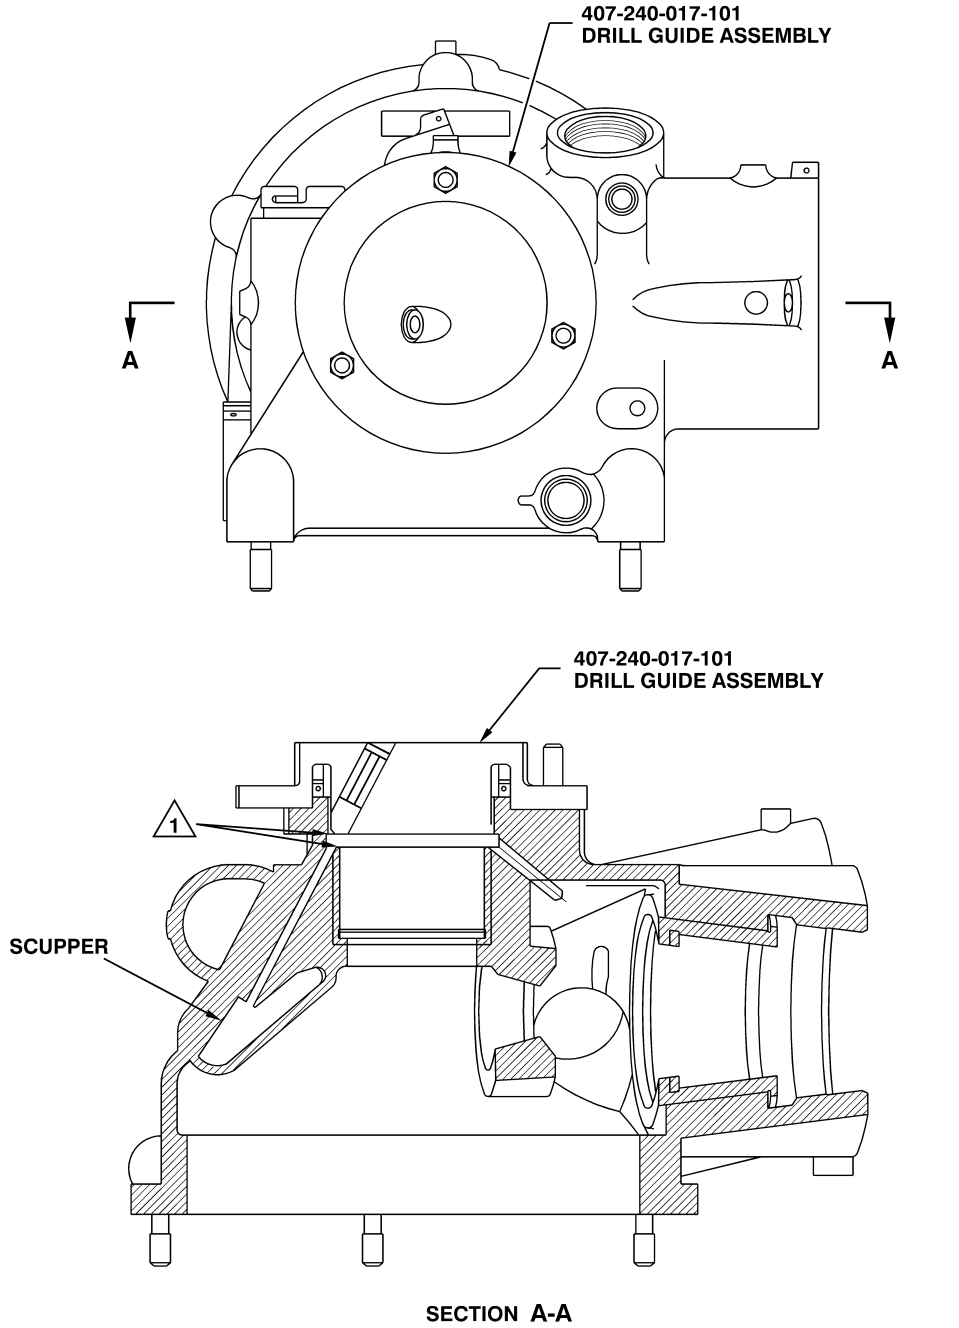
Figure 2. Rework of tail rotor gearbox case.

- 1 Duplex bearing liner can be nicked as the gallery is drilled. This is not detrimental to the liner. Use a Swiss file and remove sharp edges.

1. Refer to figure 2. Clean affected tail rotor gearbox case P/N 406-040-406-109.. Make sure that paint or sealant is fully removed from the gearbox surface that mates with the drill guide.

2. Install the drill guide tool P/N 407-240-017-101 on gearbox case and attach with the existing hardware.

3. Position and set a drill stop 4.50 +/- 0.030 inches from the point of a short fluted twist drill bit. Lubricate with cutting oil and drill the oil feed passage in the gearbox case.

4. Remove the drill guide P/N 407-240-017-101.
5. De-burr the sharp edges of the hole.
6. Clean the gearbox case. Make sure that no unwanted material stays in the cavities.
7. Apply corrosion preventative (DOW #19) (C-103) to reworked area. Refer to BHT-ALL-SPM chapter 3.
8. Using a vibrating stylus, re-identify the case as **P/N 406-040-406-109FM**.
9. Continue with inspection/overhaul and re-assemble gearbox using new P/N 406-040-432-103 bearing. Refer to BHT-427-CR&O chapter 65.
10. Make an entry in the component and helicopter technical records to show compliance with part II of this bulletin.
