ALERT SERVICE BULLETIN

SUBJECT: **REVISION "B" TO ALERT SERVICE BULLETIN 205-00-76: (MAIN ROTOR MAST 204-011-450-007/-105 INSPECTION AND RETIREMENT INDEX NUMBER RIN REDUCTION)**

NO. 205-00-76

SUBJECT: MAIN ROTOR MAST, P/N 204-011-450-007/ -105/ -113/ -119, INSPECTION AND RETIREMENT INDEX NUMBER (RIN) LIFE REDUCTION

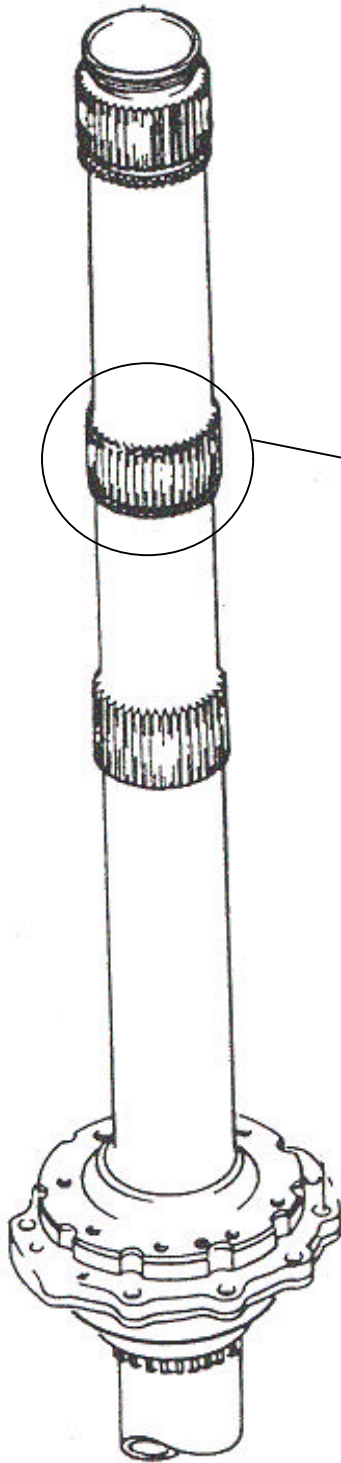
Figure 1
Main rotor mast 204-011-450-007/-105

Bell Helicopter has recently investigated an in-flight separation of a 212 Main Rotor assembly. The investigation revealed that the mast 204-011-450 failed at the snap ring groove that retains the stabilizer bar dampers.

An inspection is required on Main Rotor Masts 204-011-450-007/-105/-113/-119, serial number NFS-52720 and prior, NFS-61433 through NFS-61444 and NFS-61457 through NFS-61465 to determine the condition of the snap ring groove area. Main rotor masts NFS-52721 and subsequent do not require inspection. The inspection will check for the proper radius of the snap ring groove and for presence of burrs at the groove/spline intersection.

Inspect area for:

- At 100X minimum magnification
Minimum radius of 0.020 in the
upper and lower snap ring groove,
entire circumference
- At 200X minimum magnification
Burr in the snap ring groove/spline
intersection, all places

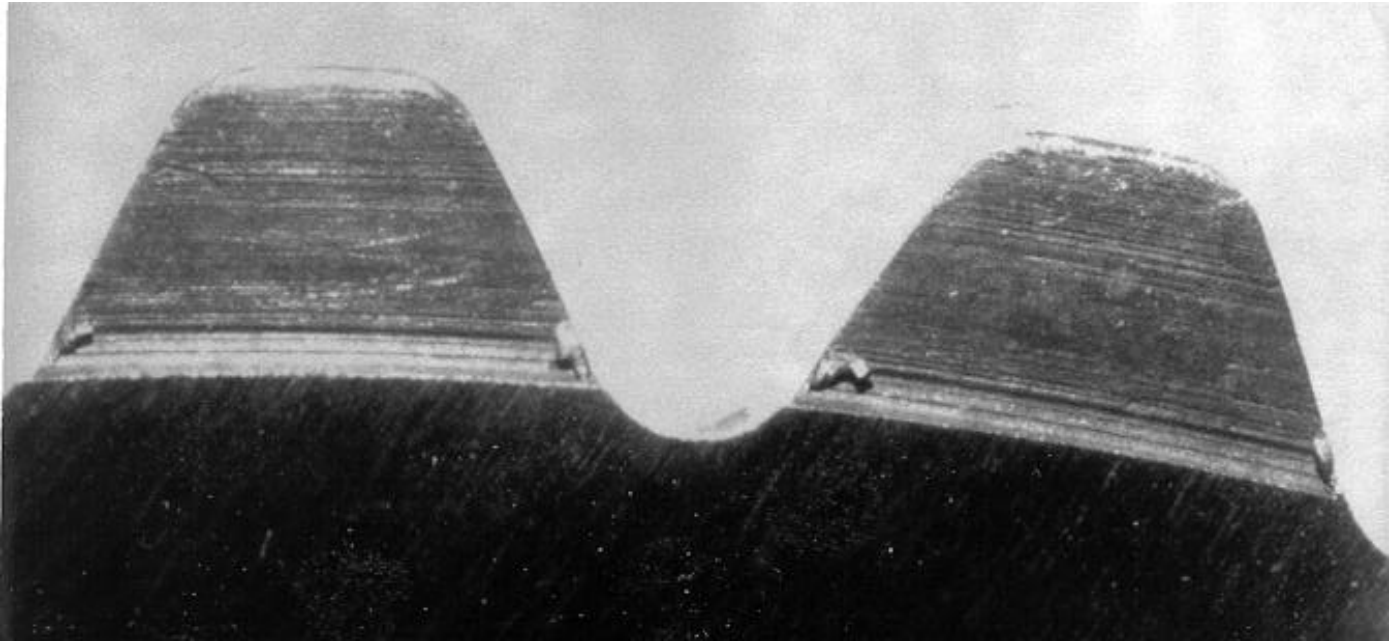
FIGURE 3

2. Inspect the mast snap ring upper and lower grooves for indications of burrs at all intersections with splines (see figure 3 view A-A, and figure 4). Any mast that has indications of a burr shall apply a 95,000 RIN penalty to the mast. Burr removal should not be accomplished.
3. Masts not exhibiting insufficient radius or burrs in the snap ring groove may continue in service until reaching the revised retirement of 265,000 RINs/15,000 hours.
4. Annotate Historical Service Records showing compliance with this bulletin.

Cutaway View looking down from inside snap ring groove

Typical burrs at snap ring groove/spline intersection
Burrs are to be inspected at 200X minimum magnification

Typical Burr at Snap Ring Groove

Inspection may result in RIN penalties for presence of a sharp radius or burrs. Indications of a sharp radius will result in a 165,000 RIN penalty. Indications of a burr will result in a 95,000 RIN penalty. If a sharp radius and burrs are found, only the 165,000 RIN penalty should be applied.
