**SUBJECT: REVISION "B" TO ALERT SERVICE BULLETIN 205B-00-30: (MAIN ROTOR MAST 204-011-450-007/-105 INSPECTION AND RETIREMENT INDEX NUMBER RIN REDUCTION)**

NO. 205B-00-30

**MODEL AFFECTED:** 205B

**SUBJECT:** MAIN ROTOR MAST, P/N 204-011-450-007/ -105, INSPECTION AND RETIREMENT INDEX NUMBER (RIN) LIFE REDUCTION

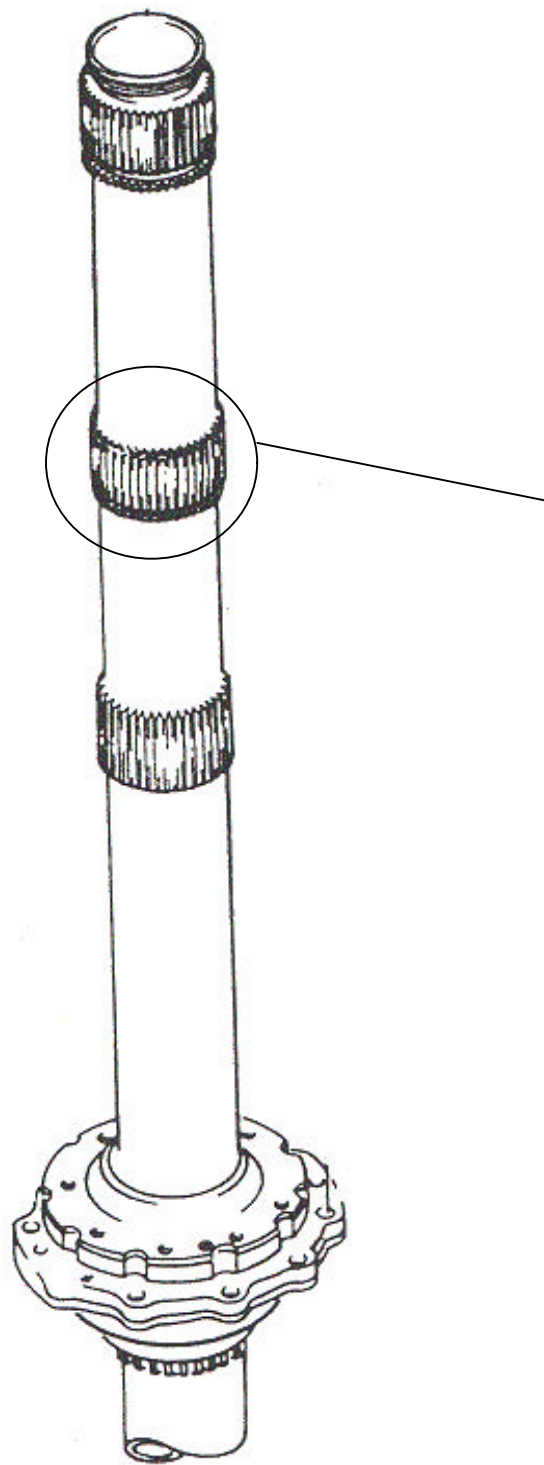
**Figure 1**

**Inspect area for:**

- At 100X minimum magnification  
Minimum radius of 0.020 in the  
upper and lower snap ring groove,  
entire circumference
- At 200X minimum magnification  
Burr in the snap ring groove/spline  
intersection, all places

Main rotor mast 204-011-450-007/-105

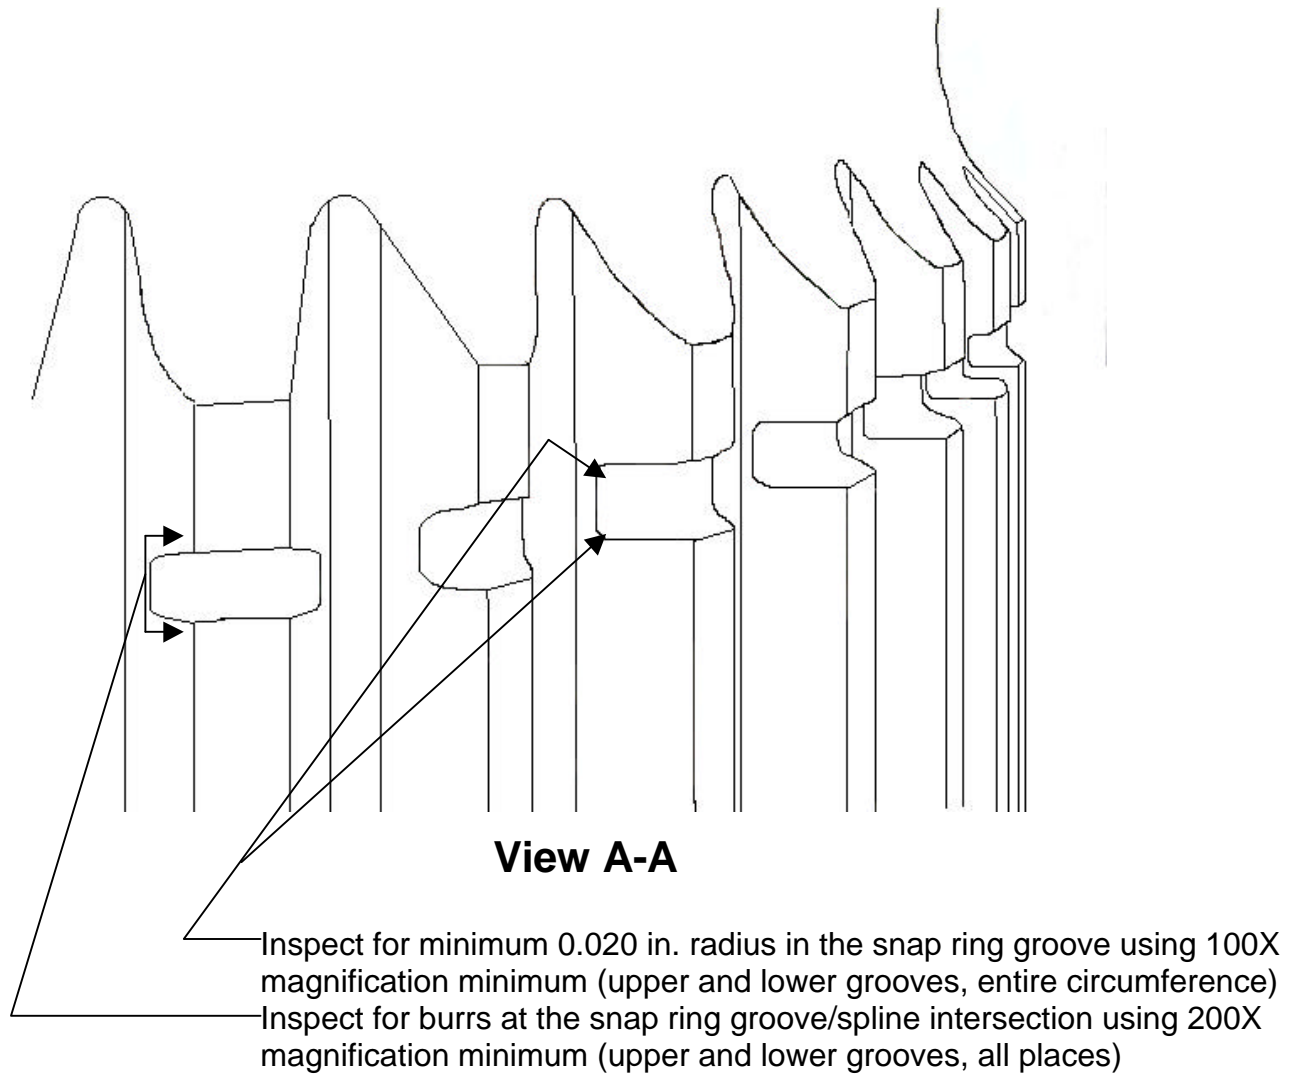
**Figure 2**  
Snap ring groove / spline intersection

- 1. Inspect the mast snap ring upper and lower grooves (entire circumference) for a minimum radius of 0.020 (figure 2, and figure 3 view A-A). Any mast that has indications of a radius less than 0.020 shall apply a 165,000 RIN penalty to the mast.
- 2. Inspect the mast snap ring upper and lower grooves for indications of burrs at all intersections with splines (see figure 3 view A-A, and figure 4). Any mast that has indications of a burr shall apply a 95,000 RIN penalty to the mast. Burr removal should not be accomplished.

3. Masts not exhibiting insufficient radius or burrs in the snap ring groove may continue in service until reaching the revised retirement of 265,000 RINs/15,000 hours.
4. Annotate Historical Service Records showing compliance with this bulletin.

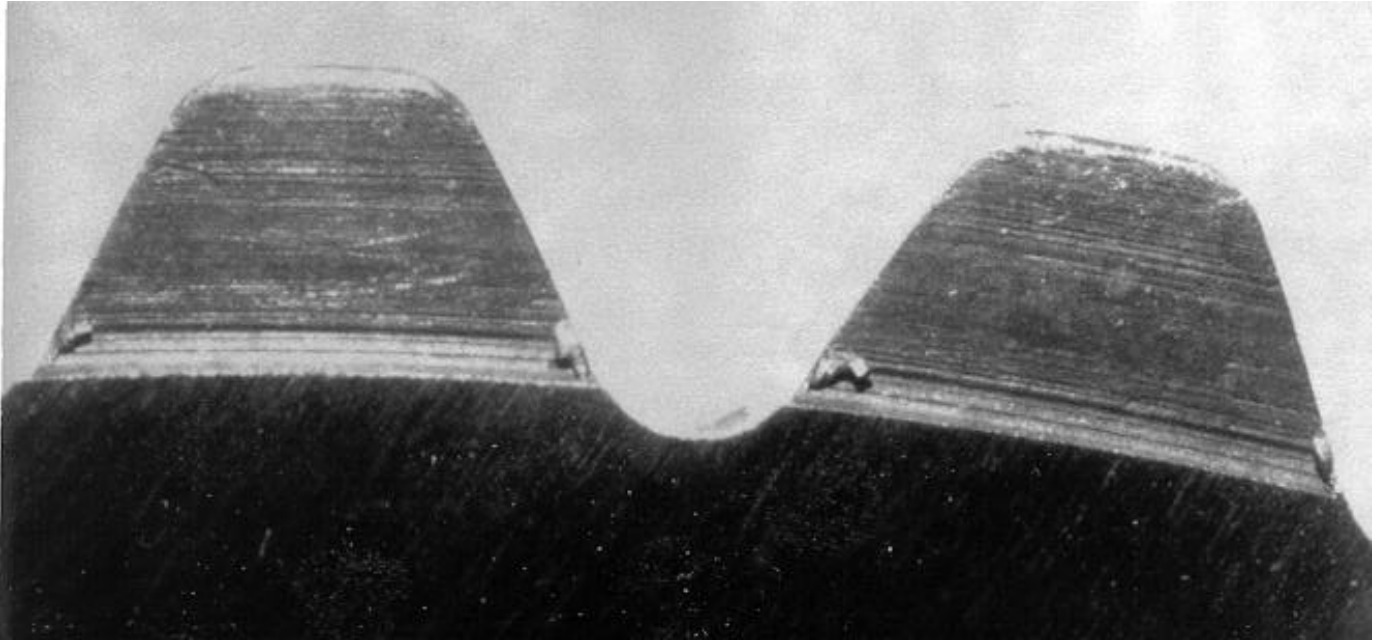
**FIGURE 3**  
Typical Burr at Snap Ring Groove

**Cutaway View looking down from inside snap ring groove**  
Typical burrs at snap ring groove/spline intersection  
Burrs are to be inspected at 200X minimum magnification
