ALERT SERVICE BULLETIN

NO. 412-00-105

MODEL AFFECTED: 412

**SUBJECT: MAIN HYDRAULIC SERVO ACTUATOR ROD
END LOCK WASHER, INSPECTION AND
REPLACEMENT OF**

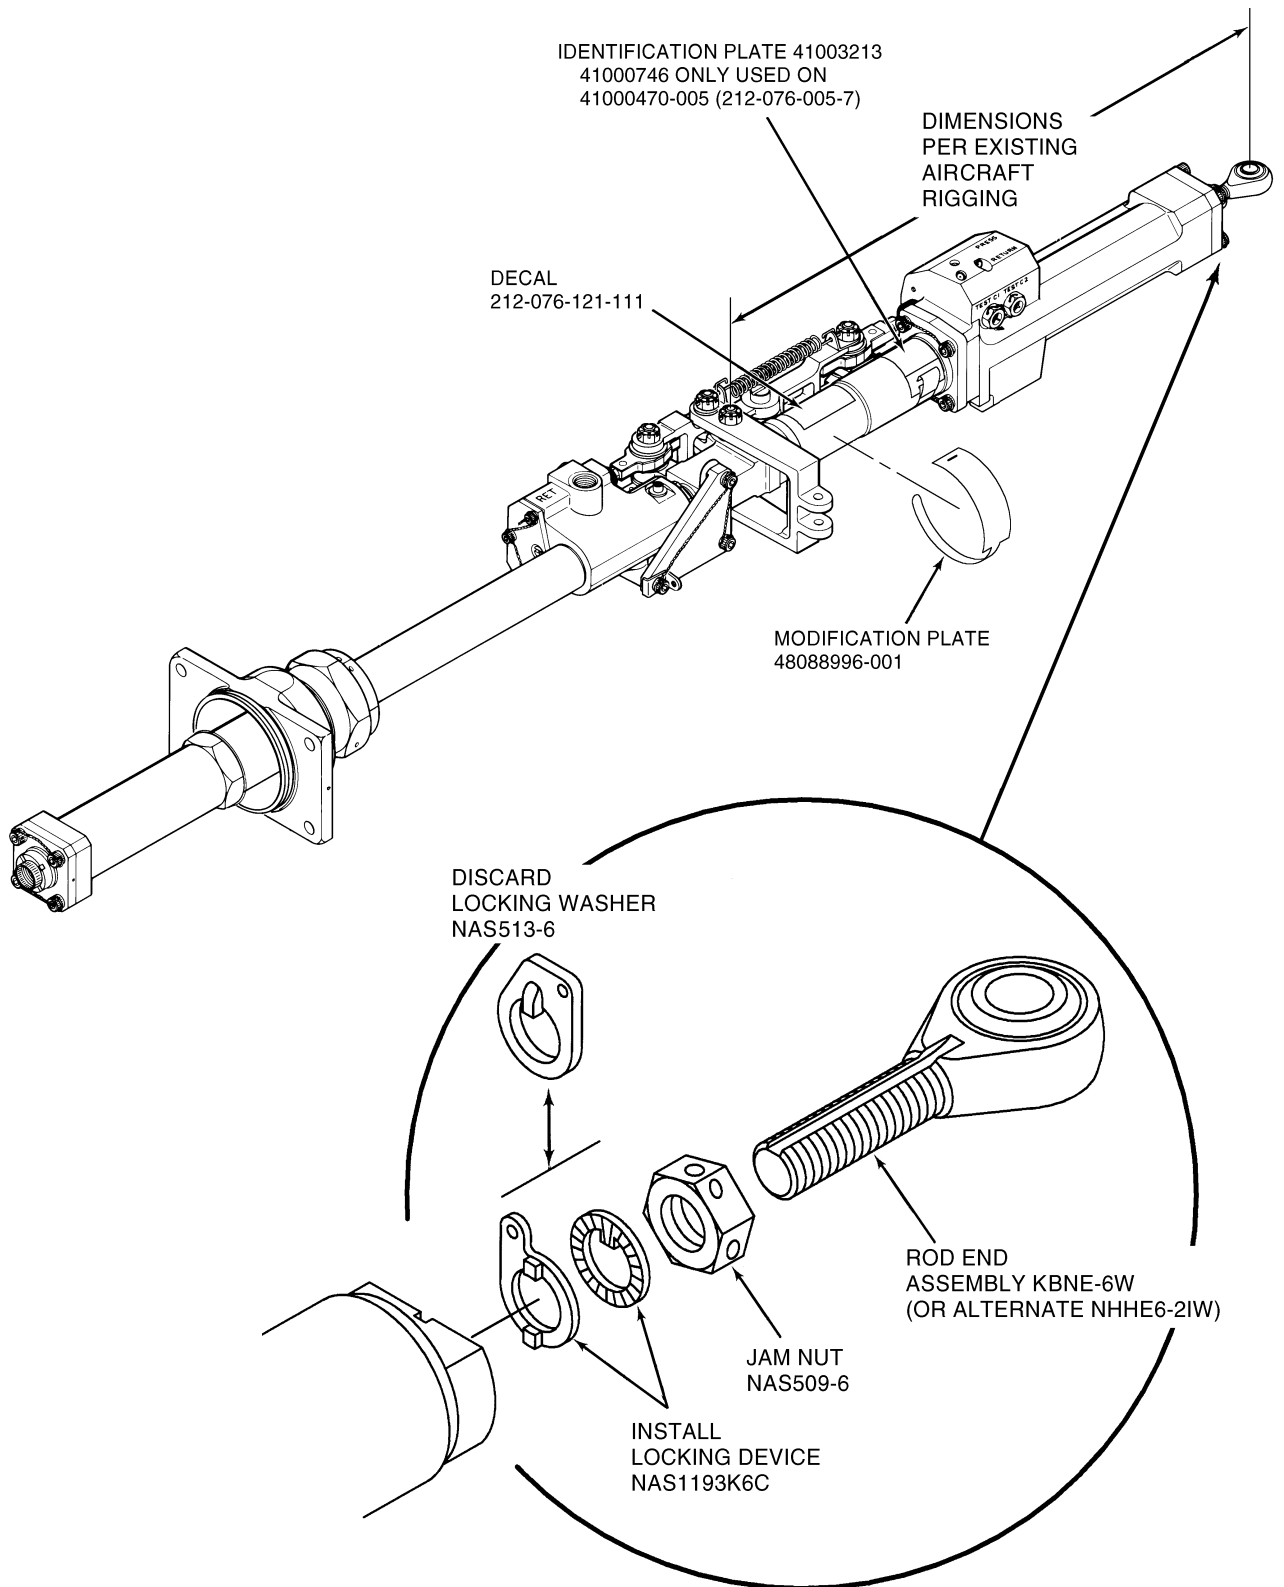
A customer recently discovered a damaged locking washer that had allowed the piston to back itself out of the locking jam nut (Figure 1). This condition prevented the aircraft from taking off and presented a Safety of Flight condition. Bell Helicopter's subsequent investigation determined that all existing locking washers NAS513-6 used on applicable actuators shall be replaced with new locking devices NAS1193K6C.

Locking Washer Inspection Area

- (1) Without removing actuator from aircraft, gain access to locking washer (Figure 1).
- (2) Visually inspect locking washer to ensure it is not broken. Tab shall be in groove of rod end assembly. Immediately replace any locking washer whose tab is twisted or hanging askew.

- (d) Visually inspect locking washer to ensure it was not damaged during torque operation. Tab shall be in groove of rod end assembly. Immediately replace any locking washer whose tab is twisted or hanging askew.

- (7) Carefully install new 2-piece locking device NAS1193K6C onto rod end assembly. Refer to Figure 1 and the following substeps:
 - (a) Install round ring onto threaded rod so that tab fits into groove on rod end and serrated side faces away from jam nut.
