**ALERT SERVICE BULLETIN**  
**Bell Helicopter** **TEXTRON**

NO. 206L-07-147

**MODEL AFFECTED:** 206L4

**SUBJECT:** FREEWHEEL AFT SEAL P/N 209-340-265-103,  
INSTALLATION PROCEDURES IMPROVEMENT  
OF

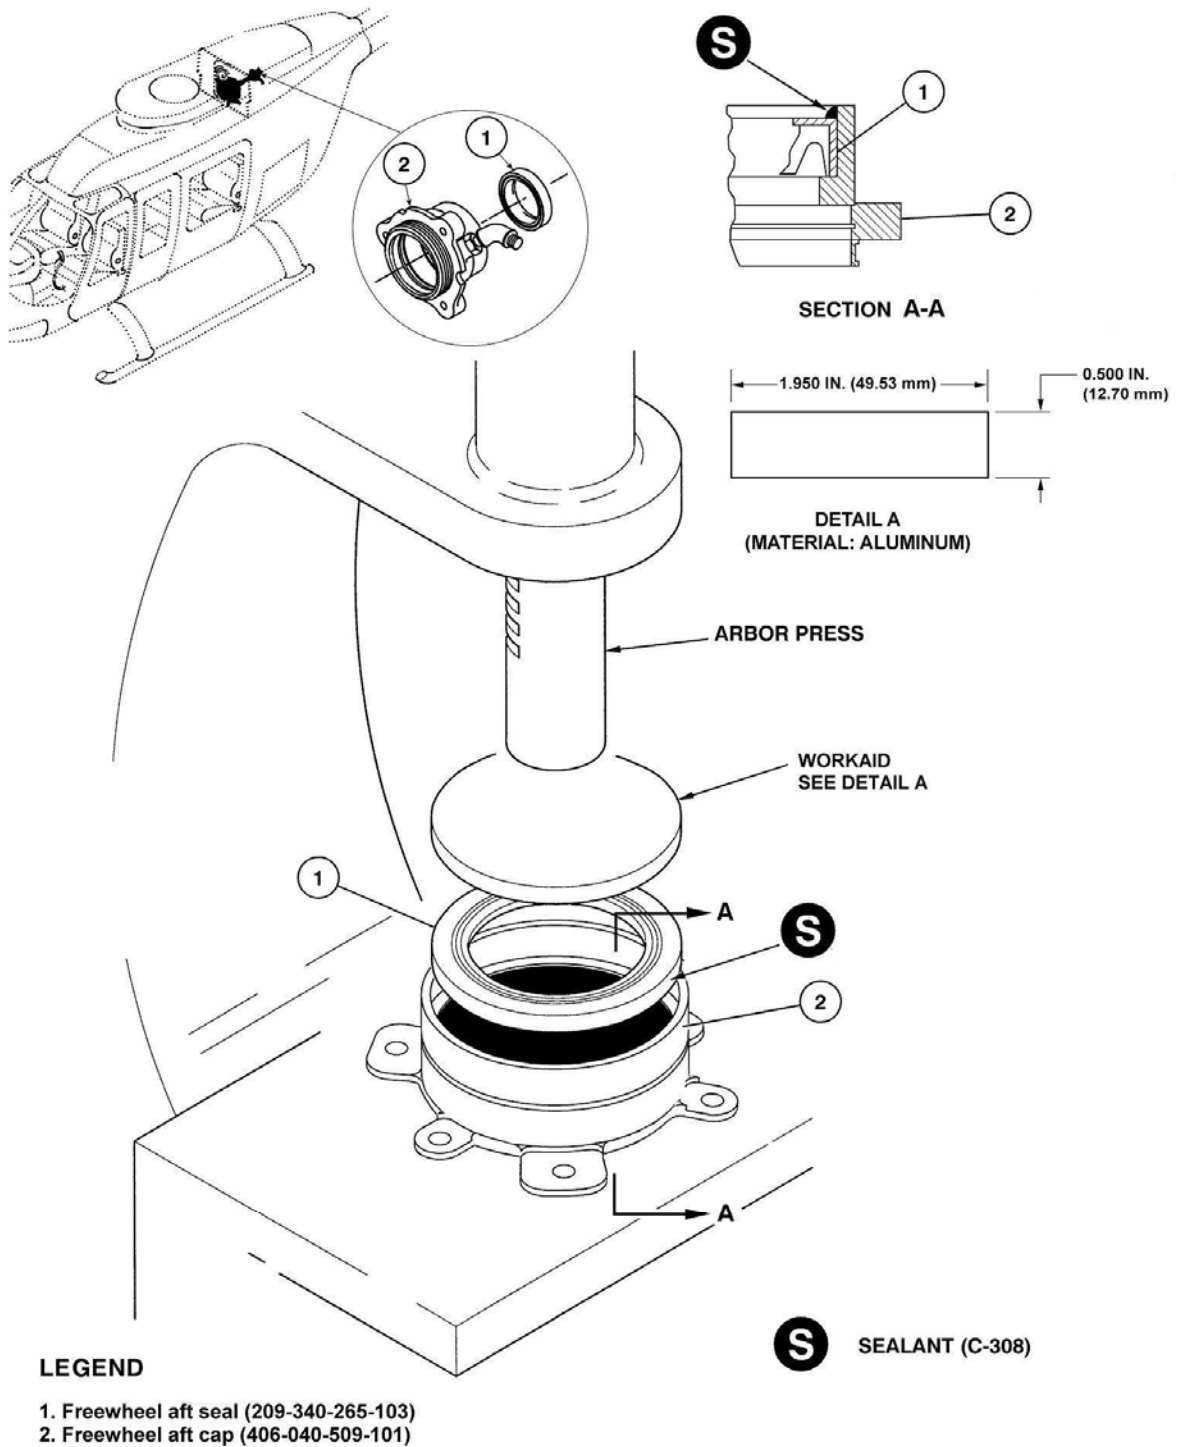
Figure 2. Replacement procedures for seal 209-340-265-103

Bell Helicopter has received reports indicating that seal 209-340-265-103 can move outboard from the freewheel aft bearing cap. This condition may lead to an excessive oil leak, which can result in a lack of lubrication at the transmission and the freewheel assembly.

1. Remove aft bearing cap (2, figure 2) (BHT-206L4-MM, Chapter 63).
2. Remove and discard existing seal (1) (BHT-206L4-MM, Chapter 63).
3. Install new seal as follows:
  - a. Clean aft bearing cap (2) and the outer diameter of the seal (1) with solvent (C-316).
  - b. Apply sealant (C-308) to the outer diameter of the seal (1).

- c. While sealant is wet and using work aid (figure 2) push the seal (1) into the aft bearing cap (2) evenly and smoothly until seated.
- d. Fair the squeeze out of sealant (C-308) as shown in figure 2.
4. Complete the installation of the freewheel assembly (BHT-206L4-MM, Chapter 63) and allow time to cure the sealant (C-308) prior to ground run.
5. Perform a ground run for 5 minutes at 100% NR and inspect for leaks.
6. Make a log book entry to show that the PART II of this Alert Service Bulletin has been accomplished.
