**ALERT SERVICE BULLETIN**  
**Bell Helicopter** **TEXTRON**

NO. 407-07-79

**MODEL AFFECTED:** 407

**SUBJECT:** FREEWHEEL AFT SEAL P/N 209-340-265-103,  
INSTALLATION PROCEDURES IMPROVEMENT  
OF

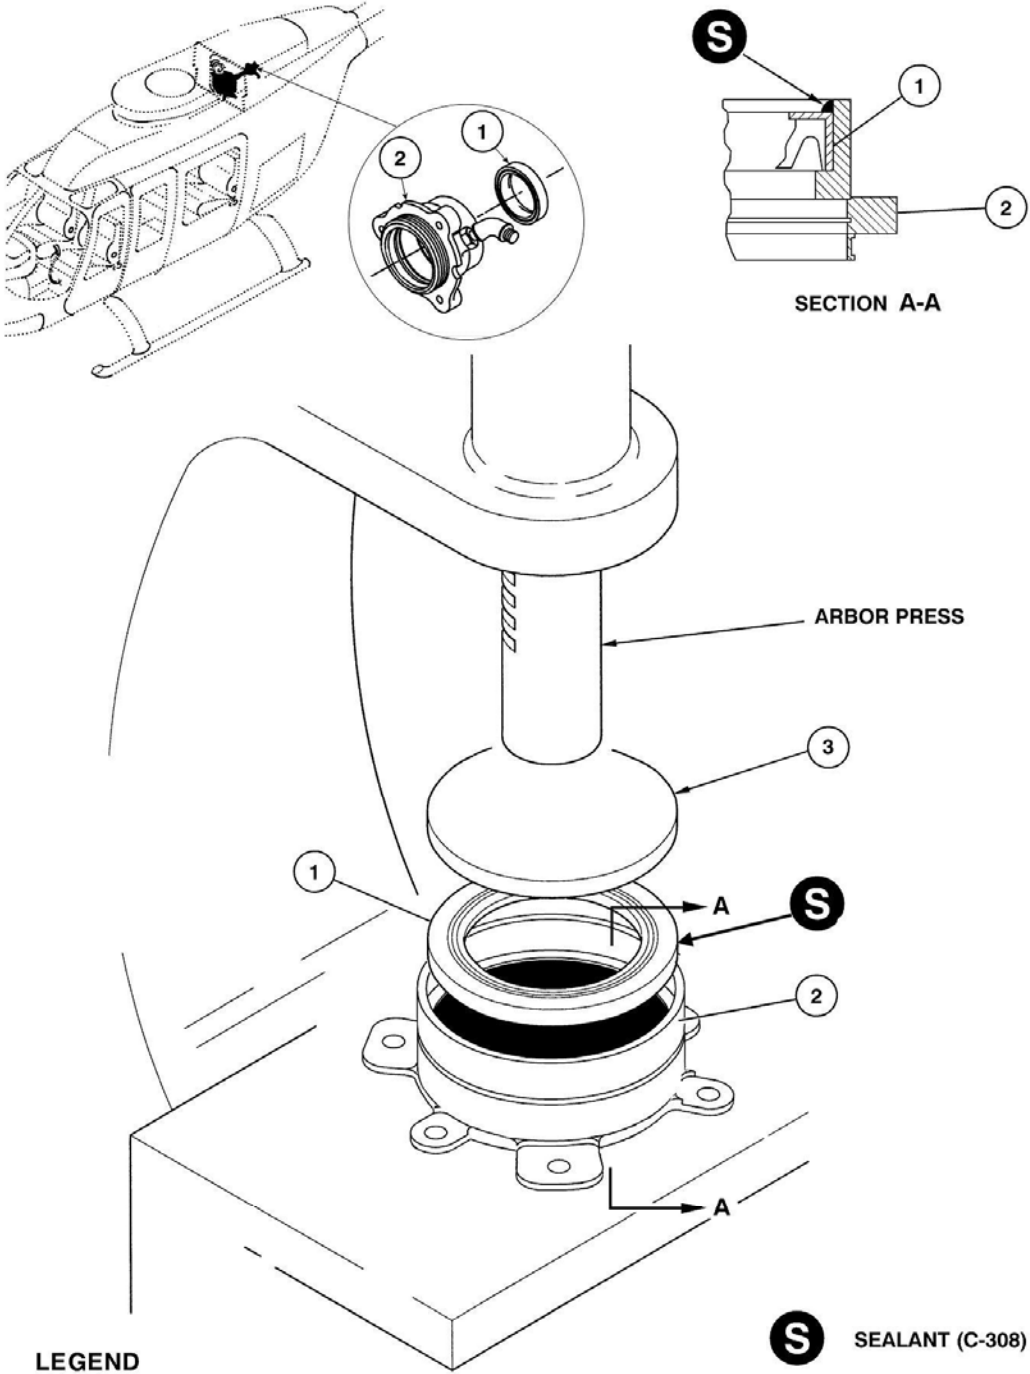
**Figure 2. Installation procedures for seal 209-340-265-103**

Bell Helicopter has received reports indicating that seal 209-340-265-103 can move outboard from the freewheel aft bearing cap. This condition may lead to an excessive oil leak, which can result in a lack of lubrication at the transmission and the freewheel assembly.

1. Remove the aft bearing cap (2, figure 2) (BHT-407-MM, Chapter 63).
2. Remove and discard the existing seal (1) (BHT-407-MM, Chapter 63).
3. Install the new seal as follows:
  - a. Clean the aft bearing cap (2) and the outside diameter of the seal (1) with solvent (C-316).
  - b. Apply sealant (C-308) to the outer diameter of the seal (1).

- c. While sealant is wet and using work aid (figure 2) push the seal (1) into the aft bearing cap (2) evenly and smoothly until seated.
- d. Fair the squeeze out of sealant (C-308) as shown in figure 2.
4. Complete the installation of the freewheel assembly (BHT-407-MM, Chapter 63) and allow time to cure the sealant (C-308) prior to ground run.
5. Perform a ground run for 5 minutes at 100% NR and inspect for leaks.
6. Make a log book entry to show that the PART II of this Alert Service Bulletin has been accomplished.
