ALERT SERVICE BULLETIN
Bell Helicopter **TEXTRON**

NO. 205-05-91

MODEL AFFECTED: 205A1

SUBJECT: TAIL ROTOR BLADE P/N 212-010-750-009 THROUGH -129, INSPECTION AND REWORK OF.

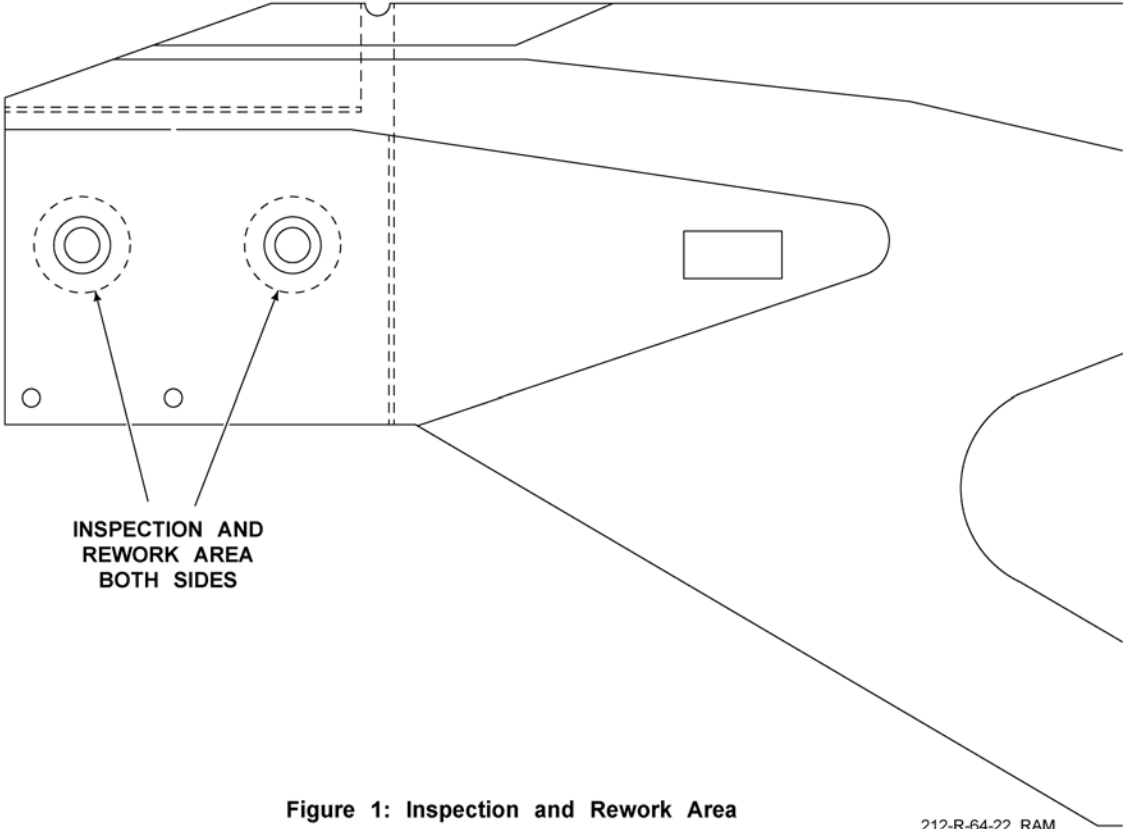
Figure 1: Inspection and Rework Area

Bell Helicopter has discovered that certain serial number tail rotor blades have been manufactured with adhesive filler applied in the blade bolt washer contact area.

1. Visually inspect around the blade bolt washer contact areas at all four locations for cracked or chipped adhesive.
 - a. If adhesive cracks or chips are found around blade bolt washer circumference, remove blade from helicopter and perform PART II.
 - b. If no adhesive cracks or chips are found around blade bolt washer circumference, perform step 2.

Alternate paint and adhesive removal may be accomplished by using a 180 grit cloth or paper and sanding by hand in a spanwise direction only. Surface finish of 32 RMS or better must be accomplished in the rework area after removal of adhesive using 400 grit cloth or paper. Do not remove more than .001" of aluminum material.

2. Remove paint and adhesive filler in blade bolt washer contact area per Figure 1 using plastic media blasting per the BHT-ALL-SPM.
3. Inspect reworked surface for damage and corrosion. If corrosion is found or damage beyond manual limits, send blade to Bell approved repair facility for repair.
4. Measure depth of spotface on reworked surfaces at all four locations. If depth exceeds 0.035 inches remove blade from service.
5. Apply by brush cleaner (C-344) to the bare metal surface of the reworked area.
6. Thoroughly rinse with water and dry surfaces with a clean dry rag or filtered compressed air.
7. Apply chemical film (C-100) to reworked area.
8. If buffers are damaged, replace per applicable section of CR&O.
9. Refinish blade per CR&O.
10. Install tail rotor blade on aircraft and dynamic balance.
11. Annotate records to indicate compliance with Part II of this bulletin.
