ALERT SERVICE BULLETIN
REVISION NOTICE

**SUBJECT: REVISION "A" TO ALERT SERVICE BULLETIN 205-07-94:
(STARTER/GENERATOR POWER CABLE UPGRADE)**

NO. 205-07-94

SUBJECT: STARTER/GENERATOR POWER CABLE, UPGRADE.

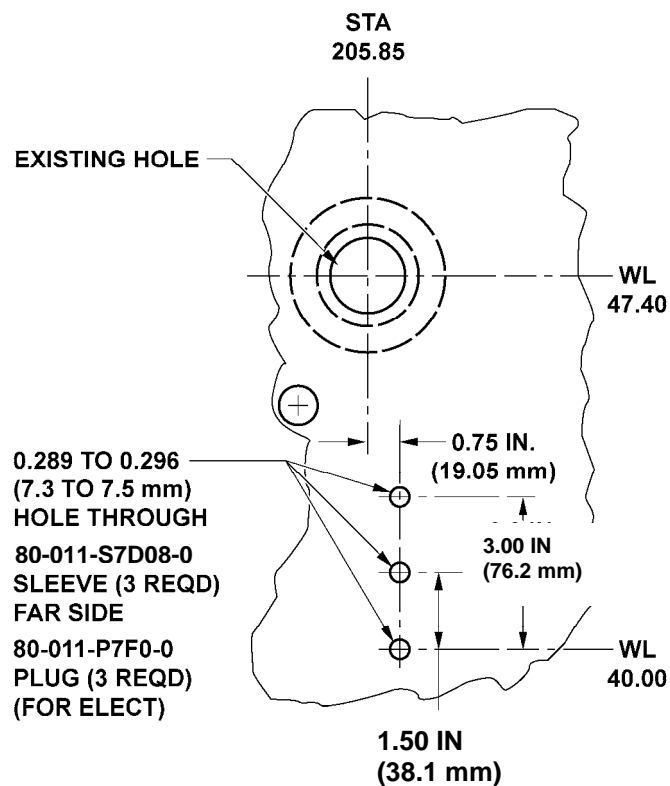
Figure 1
Structural Modification

Bell Helicopter has been made aware of a possibility of fire hazard caused by the starter/generator power cable shorting out at connector P81 (J81) pins. This ASB addresses this issue by replacing the affected cable assemblies.

- 4) Remove wires as per Table 1. Retain hardware for re-installation.
 - 5) Install plugs and sleeves as follow:
 - a) Locate qty 3 holes in accordance with Figure 1.

- b) Drill qty 3 holes 0.296 to 0.289 inch through panel assembly as shown on figure 1.
 - c) Install qty 3 sleeves P/N 80-011-S7D08-0 far side and plug P/N 80-011-P7F0-0 using adhesive C-317 as detailed in Structural Repair Manual (SRM).

- d) Allow adhesive to cure.
 - 6) Install terminal board P/N MS27212-5-2, TB 150, on inboard side of main beam at STA 205.10 using qty 3 screws MS35206-233, qty 3 washers AN960PD6L, and qty 3 nuts NAS679A06.
