ALERT SERVICE BULLETIN

NO. 205-09-101

MODEL AFFECTED: 205A & 205A-1

SUBJECT: 205-030-856-157/-159 ELEVATORS, ONE TIME INSPECTION OF.

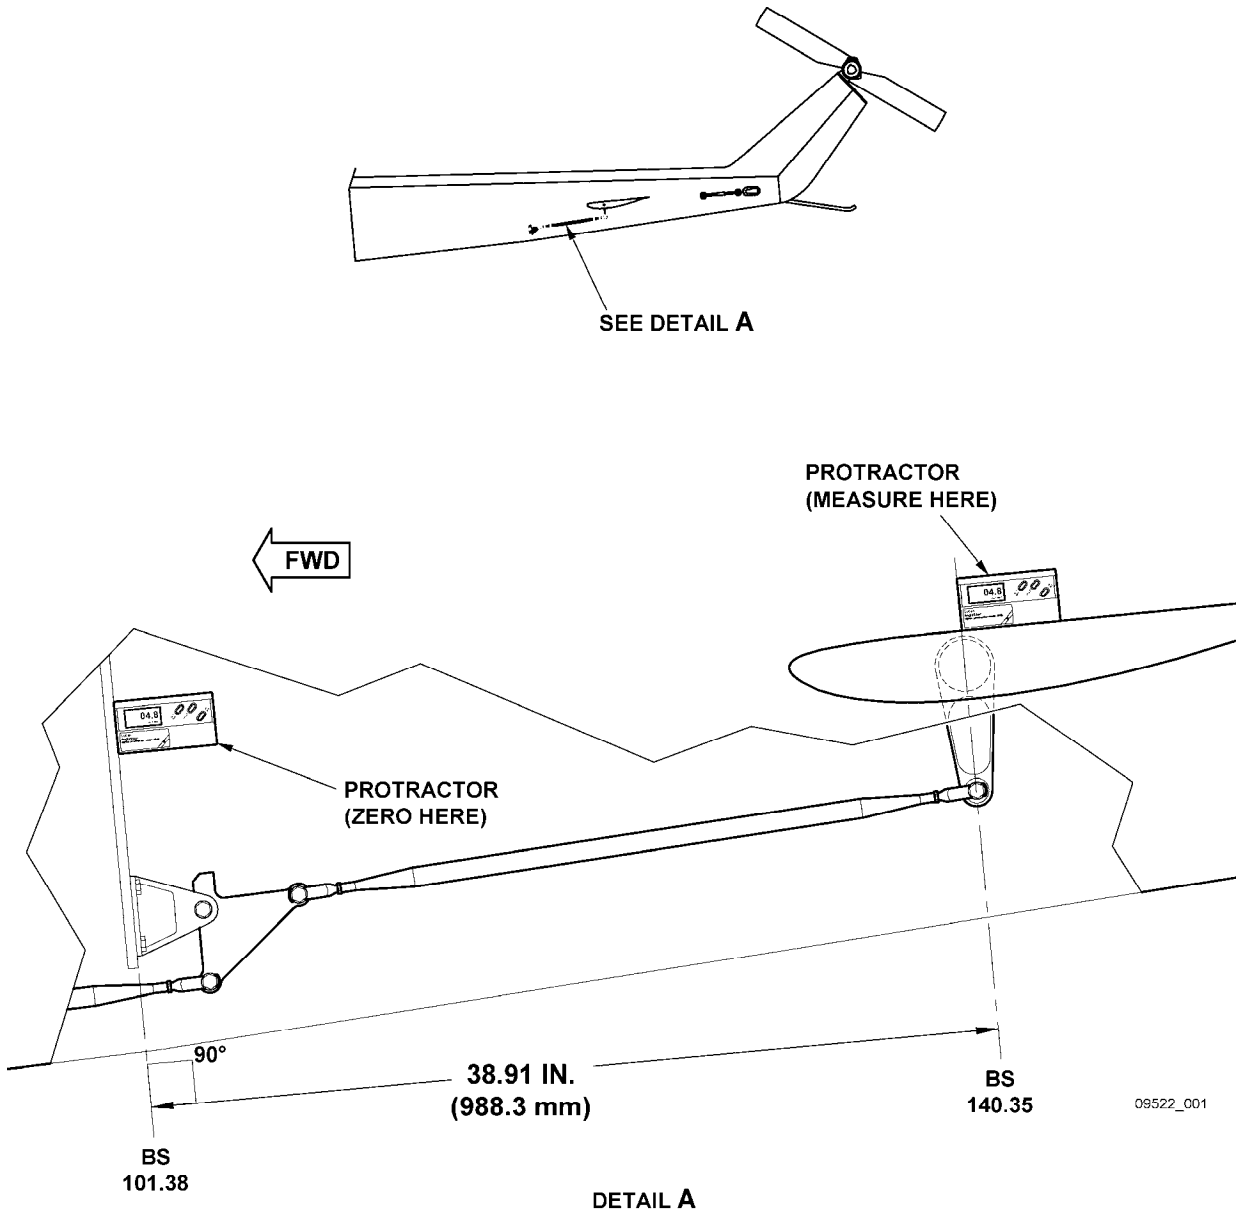
Figure 1
Angle Measurements

There is a built-in angle difference of 1.00 +/- 0.50 degrees between the LH and RH Elevators on the aircraft. Bell Helicopter has learned that some p/n 205-030-856-157/-159 elevators were incorrectly assembled at manufacture. Due to tooling discrepancies, some elevators could have an offset exceeding the angle tolerance. This bulletin explains how to measure the angles to detect discrepant elevators. This angle must be measured while the elevator(s) is (are) installed on the aircraft. Because of the drawing tolerances, the RH Elevator Assy must be good in order to confirm the condition of the LH Elevator. For this reason, this bulletin has been divided in two parts, between which the aircraft may be released for flight, while the parts are procured.

7. Move protractor to top skin of L/H Elevator and record the angle as Angle "B".
8. The correct value for Angle A is 0.00 +/- 0.50 degree. The correct value for Angle B is 1.00 +/- 0.50 degree.

- a. If Angle "A" and Angle "B" are not within their applicable tolerance, replace the RH elevator as per Maintenance Manual within the next 100 flight-hours and proceed to Part II thereafter.

- b. If Angle "A" is not within its applicable tolerance but Angle "B" is within its applicable tolerance, replace the RH elevator as per Maintenance Manual within the next 600 flight-hours and proceed to Part II thereafter.

- c. If Angle "A" is within its applicable tolerance but Angle "B" is not within its applicable tolerance, replace LH elevator as per Maintenance Manual within the next 100 flight-hours. No further action is required. Go to Part II, step 6.

- d. If Angle "A" and Angle "B" are both within their applicable tolerance, both elevators are compliant and no further action is required. Go to Part II, step 6.
