**ALERT SERVICE BULLETIN**

NO. 205-10-103  
DATE Jan 11, 2010  
PAGE 1 of 7

**MODEL AFFECTED:** 205A & 205A1

**SUBJECT:** Inspection of Transmission Oil Line P/N 70-061L000V360A for Correct Length.

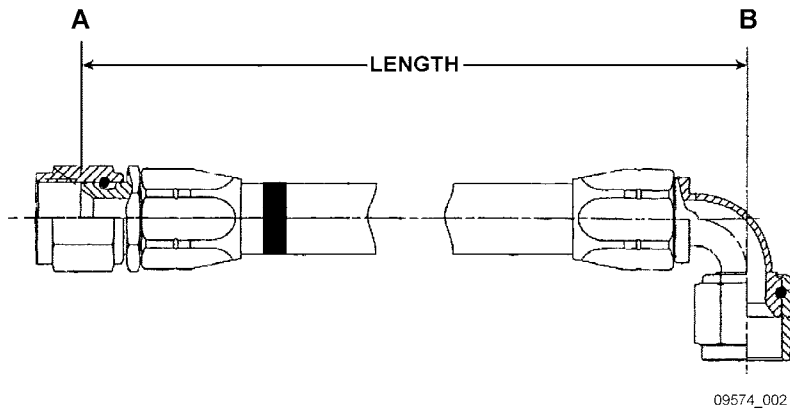
FIGURE 1

6. Lay the Hose Assembly on a flat surface and measure the length of the Hose as detailed in Figure 1.
7. If the part number 70-061L000V360A Hose Assembly is 36.5 inches (92.71 cm) to 37.5 inches (95.25 cm) then the Hose Assembly must be re-identified, as detailed in step 8.

8. Using a vibrating stylus, vibro-etch a single line through the last four characters of the part number 70-061L000V360A on the tag. Then re-identify the part number of the Hose Assembly as 70-061L000V370AFM.

9. If the Hose Assembly part number 70-061L000V360A measures less than 36.5 inches (92.71 cm) it must be replaced by new part number 70-061L000V370A Hose Assembly prior to further flight.
10. Hoses measuring more than 37.5 inches (95.25 cm) must be replaced by new part number 70-061L000V370A Hose Assembly prior to further flight.
11. Re-install the Hose Assembly and ensure there is no fowling between the Hose Assembly and any airframe components, drive system components, and wiring on the aircraft. See Figure 2 and view "A" for the correct routing of the Hose Assembly.

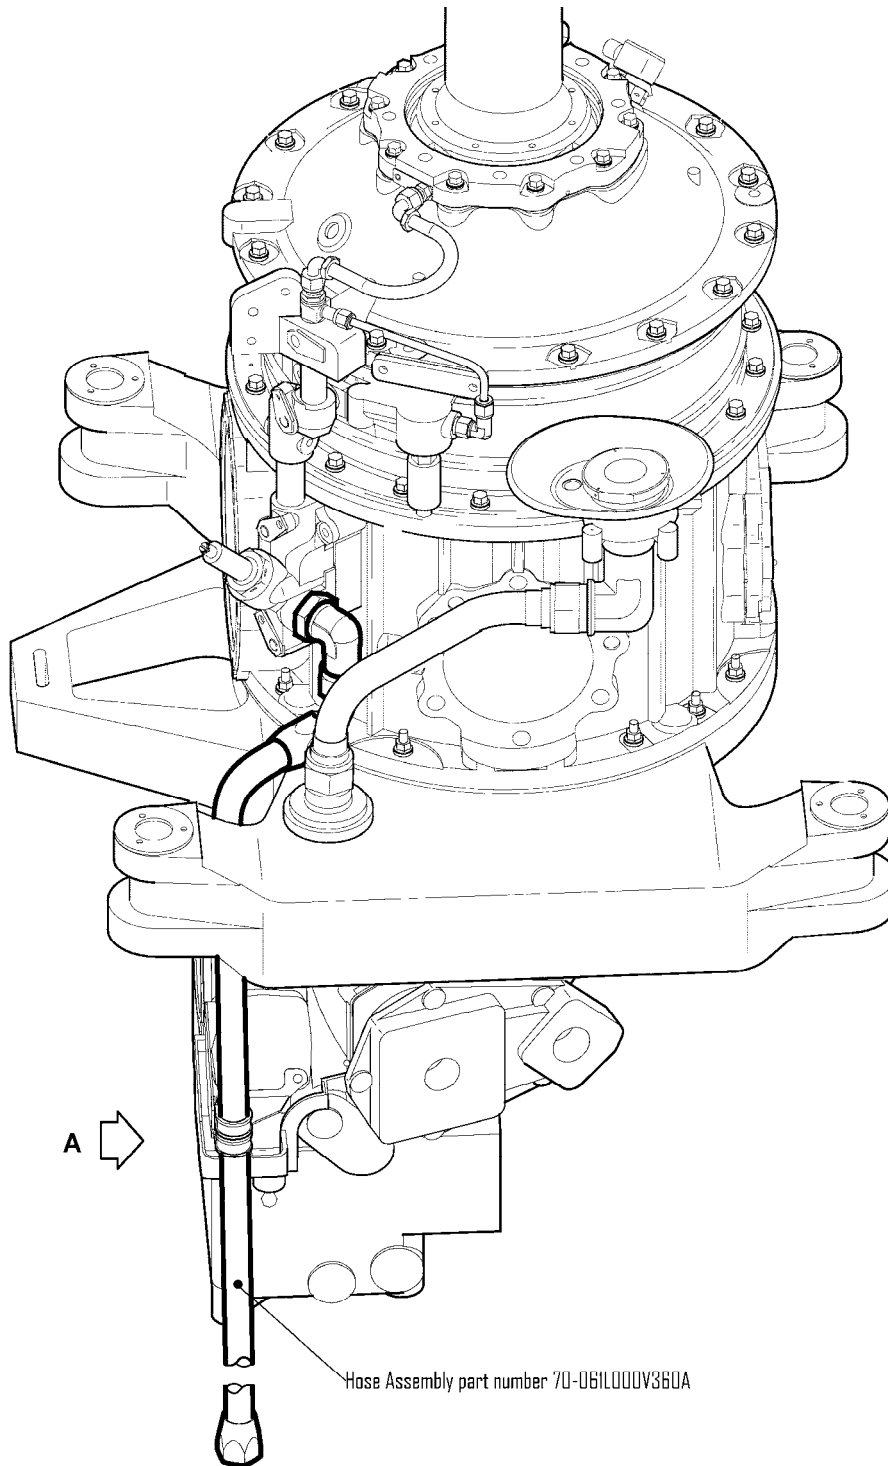
FIGURE 2

Failure to properly install, align and torque the transmission Hose Assembly could lead to the loss of transmission lubricating oil.
