ALERT SERVICE BULLETIN

NO. 205B-08-51

MODEL AFFECTED: 205B

SUBJECT: MAIN ROTOR BLADE P/N 212-015-501-005, -111, -113, -115, -117, -119 and, -121; INSPECTION OF.

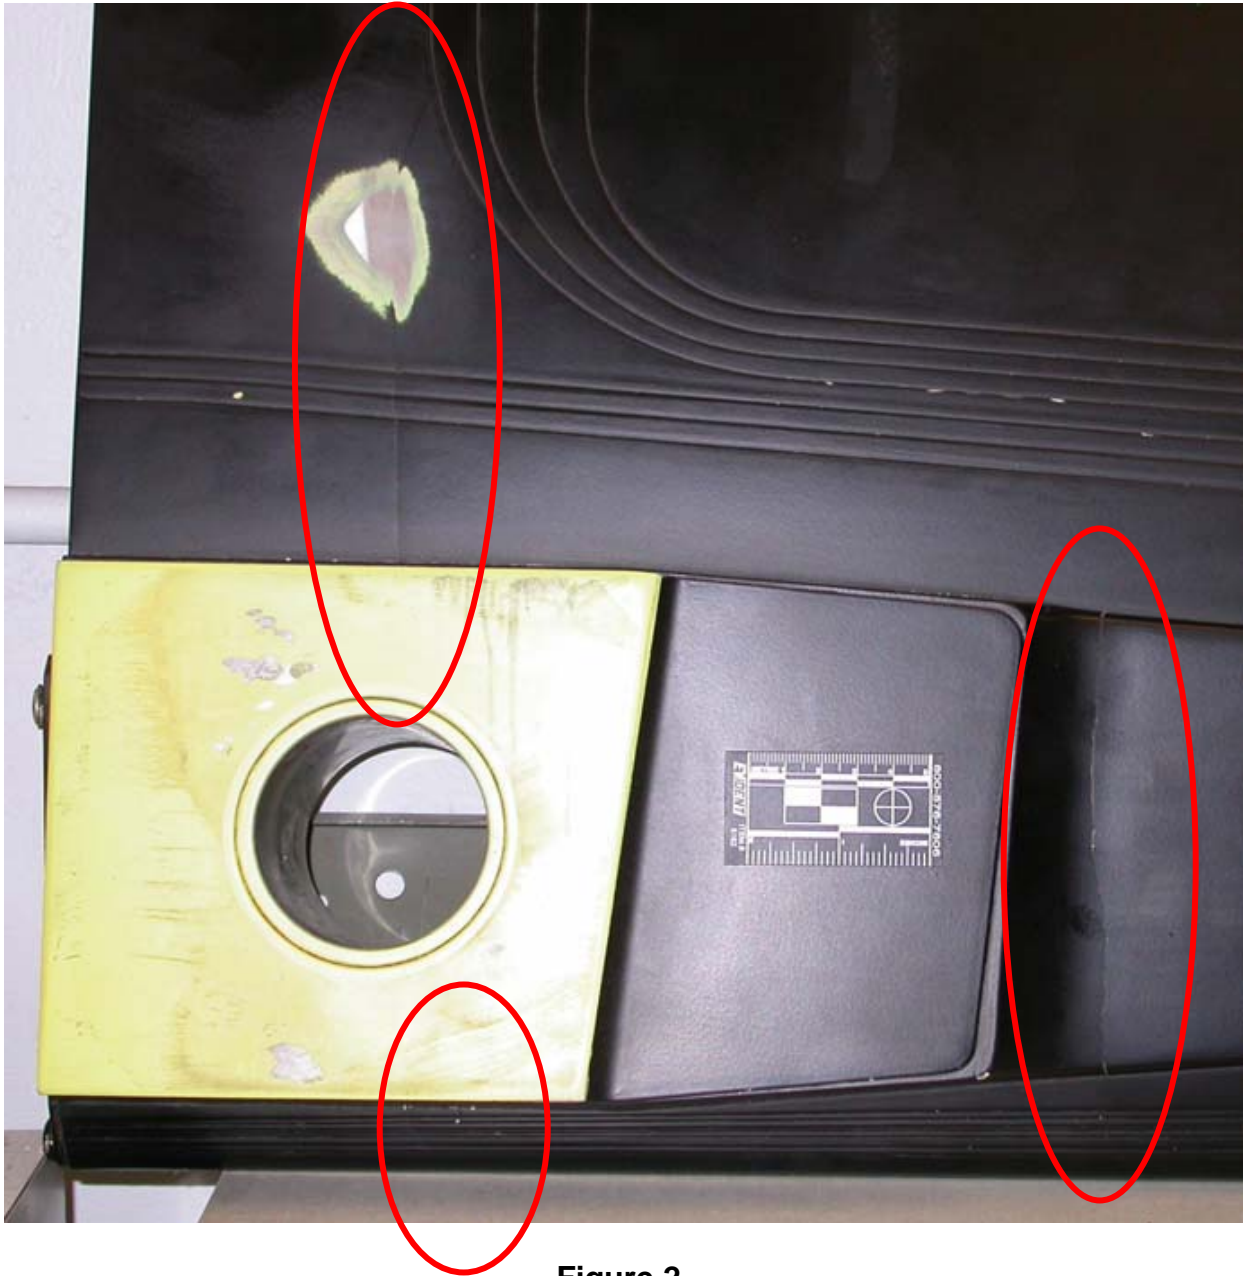
Figure 2
Crack Indications

A model 212 Main Rotor Blade P/N 212-015-501-115 with approximately 1000 hours total time was recently returned to BHTI for evaluation. The blade was found cracked through the blade retention bolt hole at Blade Station 28.0 and another crack through the lower grip plate at Blade Station 36.0. The main rotor blade contained a fatigue fractured grip plate, fatigue fractured doublers and a fatigue cracked spar on the bottom of the blade as a result of inadequate bond between the doublers and grip plate. This bulletin introduces a recurring inspection of the Main Rotor Blade every 100 hours of operation to ensure continued safety of operation. Refer to Figures 1 for the inspection area and Figure 2 showing the cracks.
