ALERT SERVICE BULLETIN
REVISION NOTICE

SUBJECT: REVISION "A" TO ALERT SERVICE BULLETIN 205B-08-051:
MAIN ROTOR BLADE P/N 212-015-501-005, -111, -113, -115, -117, -119
and, -121; INSPECTION OF.

NO. 205B-08-51

SUBJECT: MAIN ROTOR BLADE P/N 212-015-501-005, -111, -113, -115, -117, -119 and, -121; INSPECTION OF.

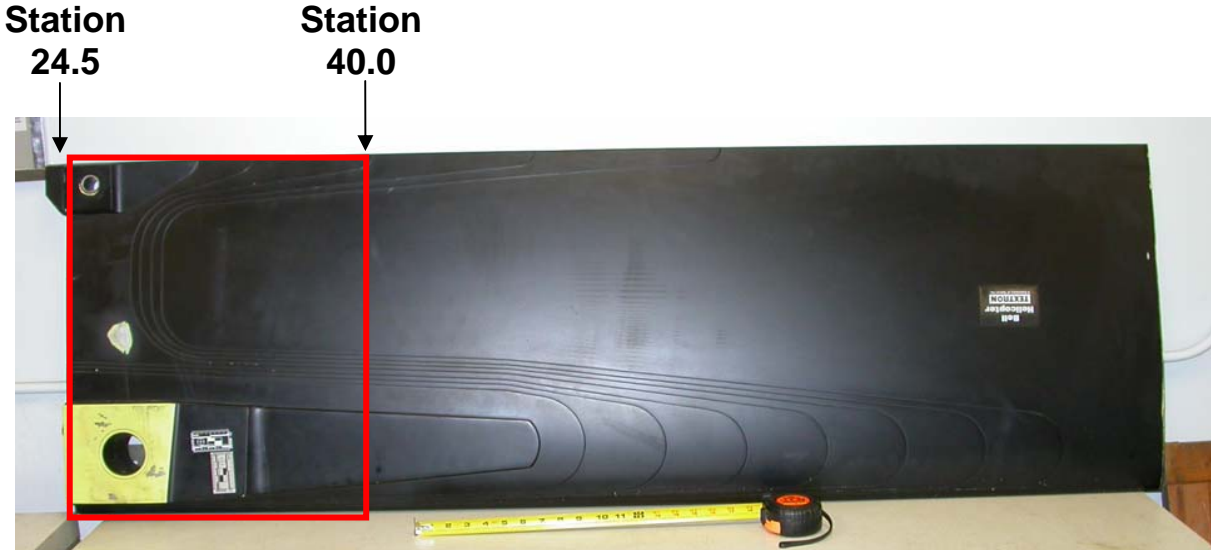
Figure 1
Inspection Area

2. Inspect the Main Rotor Blade upper and lower grip plates and doublers between blade station 24.5 and 40.0 and the whole width of the chord. Inspect for signs of edge voids, corrosion and cracks. Hair line cracks in the paint finish should be suspect for possible cracks / voids.
3. Carry out a detailed visual inspection of the top and bottom inspection areas of the blade using a 3X-power magnifying glass. Any cracks in the finish must be investigated further by removing paint in affected areas (sand with 180-220 grit paper in a spanwise direction) to determine if the grip plate / doublers are cracked. If any cracks or delamination are detected, immediately remove blade from service and contact Bell Helicopter Product Support.

4. Refinish the sanded area as per BHT-212-CR&O.
5. Following the inspection, apply a light coat of preservative oil (C-125) to all surfaces of blade.
6. Annotate records to indicate compliance with this bulletin.

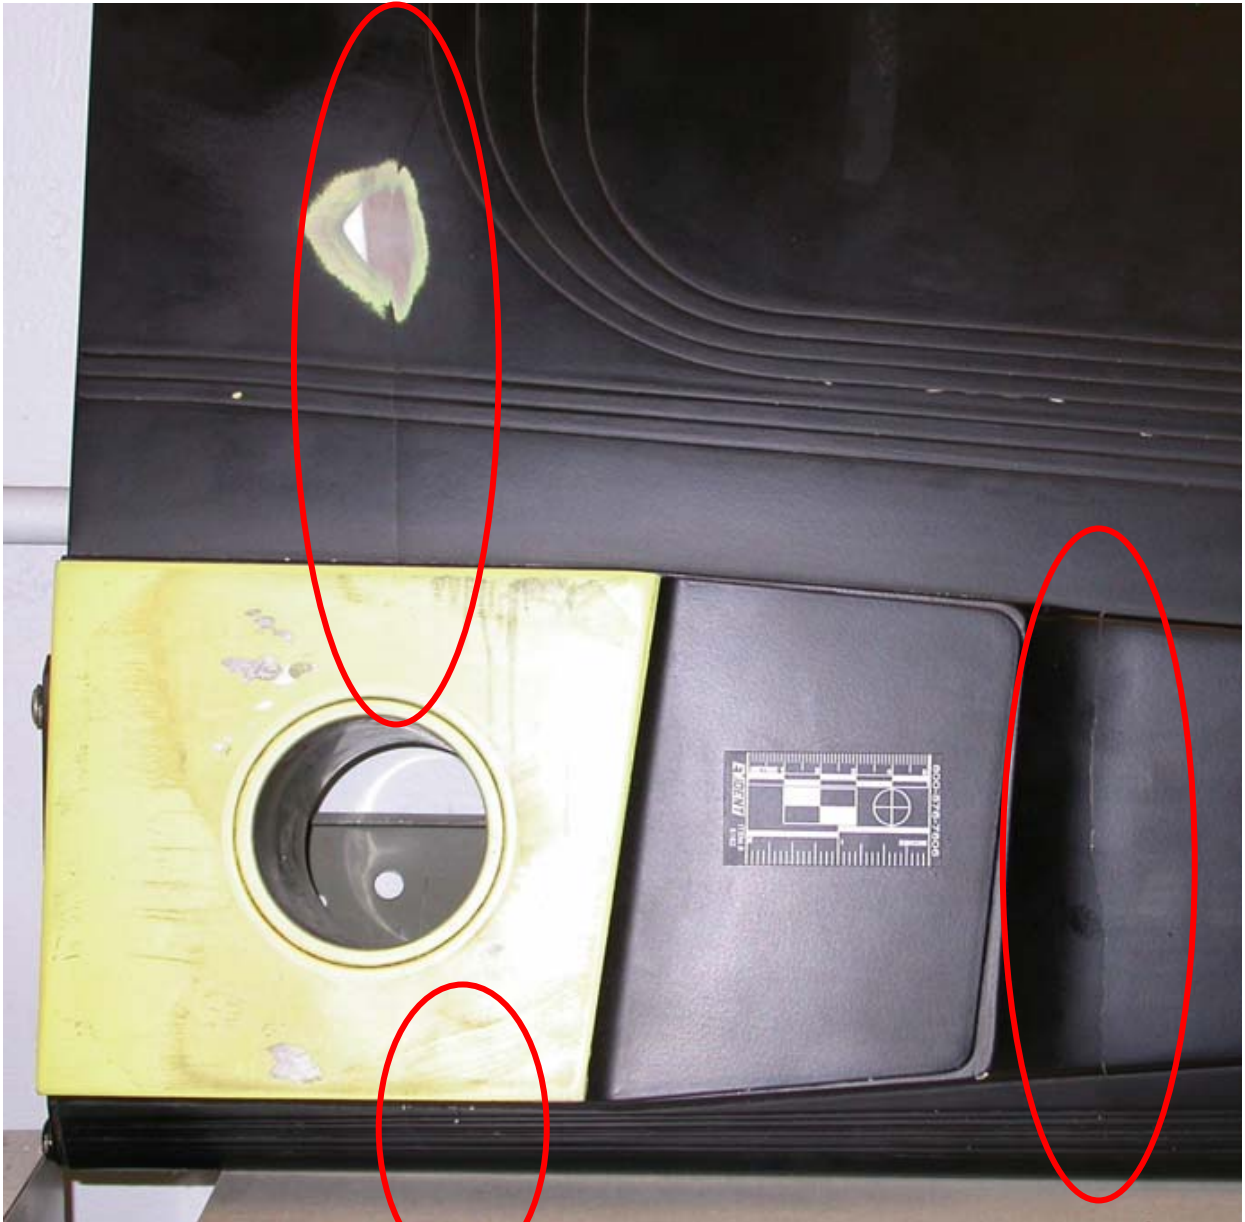
Figure 2
Crack Indications

A model 212 Main Rotor Blade P/N 212-015-501-115 with approximately 1000 hours total time was recently returned to BHTI for evaluation. The blade was found cracked through the blade retention bolt hole at Blade Station 28.0 and another crack through the lower grip plate at Blade Station 36.0. The main rotor blade contained a fatigue fractured grip plate, fatigue fractured doublers and a fatigue cracked spar on the bottom of the blade as a result of inadequate bond between the doublers and grip plate. This bulletin introduces a recurring inspection of the Main Rotor Blade every 100 hours of operation for continued safety of operation. Refer to Figures 1 for the inspection area and Figure 2 showing the cracks. **A**
