# ALERT SERVICE BULLETIN

NO. 205B-09-53

**MODEL AFFECTED:** 205B

**SUBJECT:** 205-030-856-157/-159 ELEVATORS, ONE TIME INSPECTION OF.

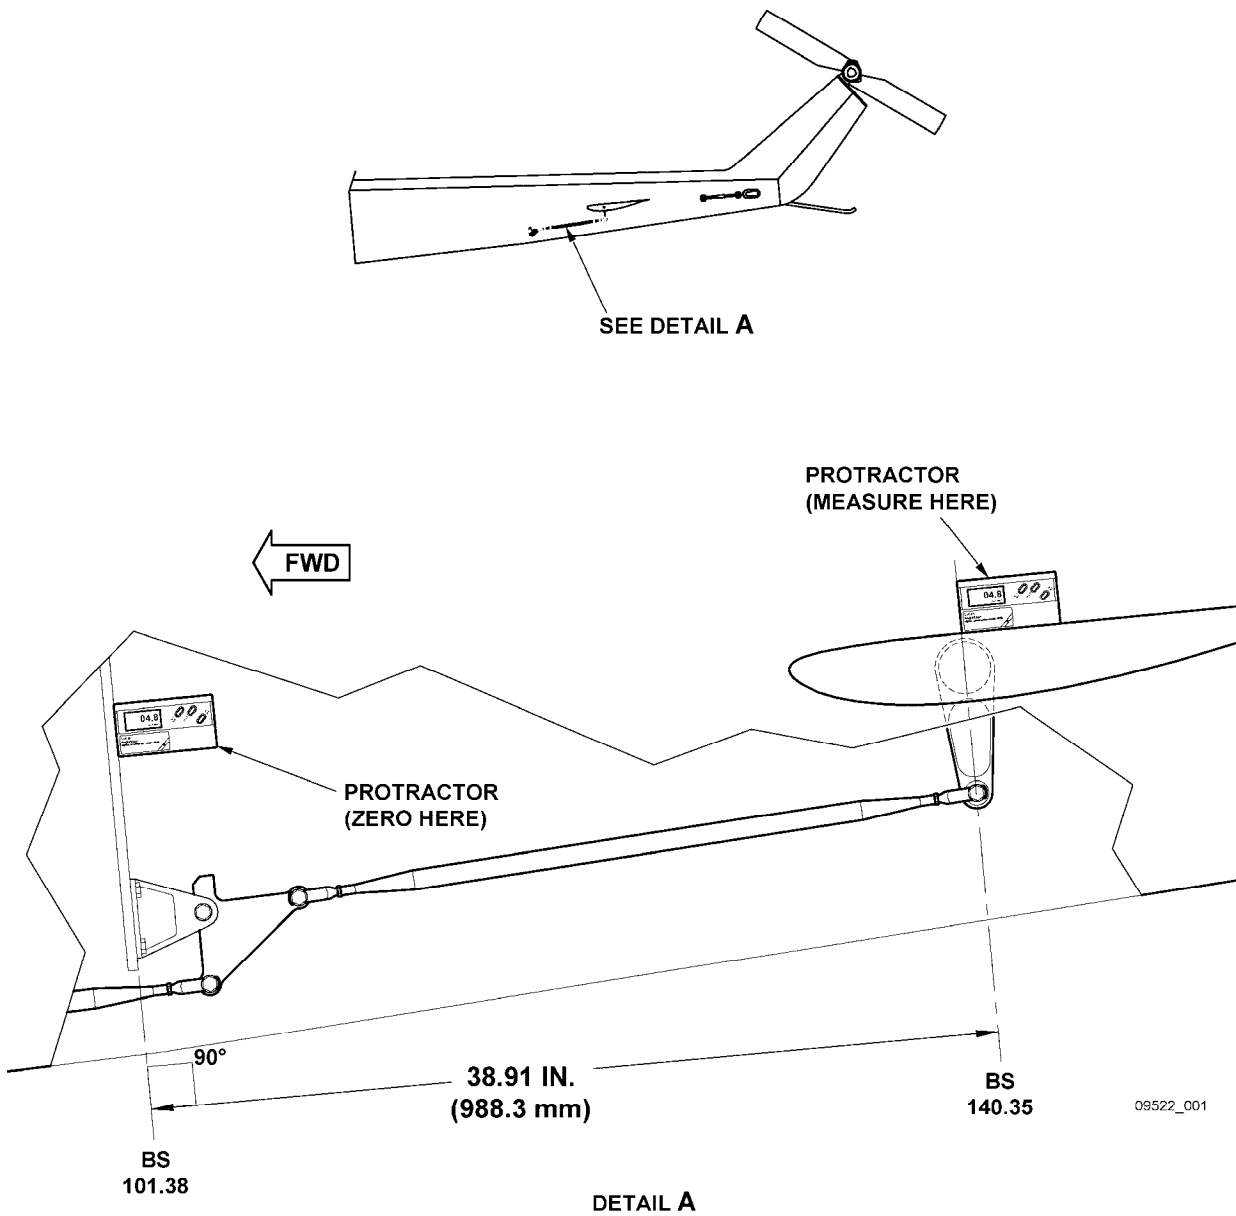
**Figure 1**  
Angle Measurements

There is a built-in angle difference of 3.00 +/- 0.75 degrees between the LH and RH Elevators on the aircraft. Bell Helicopter has learned that some p/n 205-030-856-157/-159 elevators were incorrectly assembled at manufacture. Due to tooling discrepancies, some elevators could have an offset exceeding the angle tolerance. This bulletin explains how to measure the angles to detect discrepant elevators. This angle must be measured while the elevator(s) is (are) installed on the aircraft. Because of the drawing tolerances, the RH Elevator Assy must be good in order to confirm the condition of the LH Elevator. For this reason, this bulletin has been divided in two parts, between which the aircraft may be released for flight, while the parts are procured.

8. The correct value for Angle A is 0.00 +/- 0.50 degree. The correct value for Angle B is 3.00 +/- 0.75 degree.
  - a. If Angle "A" and Angle "B" are not within their applicable tolerance, replace the RH elevator as per Maintenance Manual within the next 100 flight-hours and proceed to Part II thereafter.

- b. If Angle "A" is not within its applicable tolerance but Angle "B" is within its applicable tolerance, replace the RH elevator as per Maintenance Manual within the next 600 flight-hours and proceed to Part II thereafter.

- c. If Angle "A" is within its applicable tolerance but Angle "B" is not within its applicable tolerance, replace LH elevator as per Maintenance Manual within the next 100 flight-hours. No further action is required. Go to Part II, step 6.

- d. If Angle "A" and Angle "B" are both within their applicable tolerance, both elevators are compliant and no further action is required. Go to Part II, step 6.
