**SUBJECT: REVISION "A" TO ALERT SERVICE BULLETIN 205B-09-54:  
TAIL ROTOR BLADE P/N 212-010-750-ALL, INSPECTION OF.**

NO. 205B-09-54  
DATE Nov 09, 2009  
PAGE 1 of 5

**MODEL AFFECTED:** 205B

**SUBJECT:** TAIL ROTOR BLADE P/N 212-010-750-ALL, INSPECTION OF.

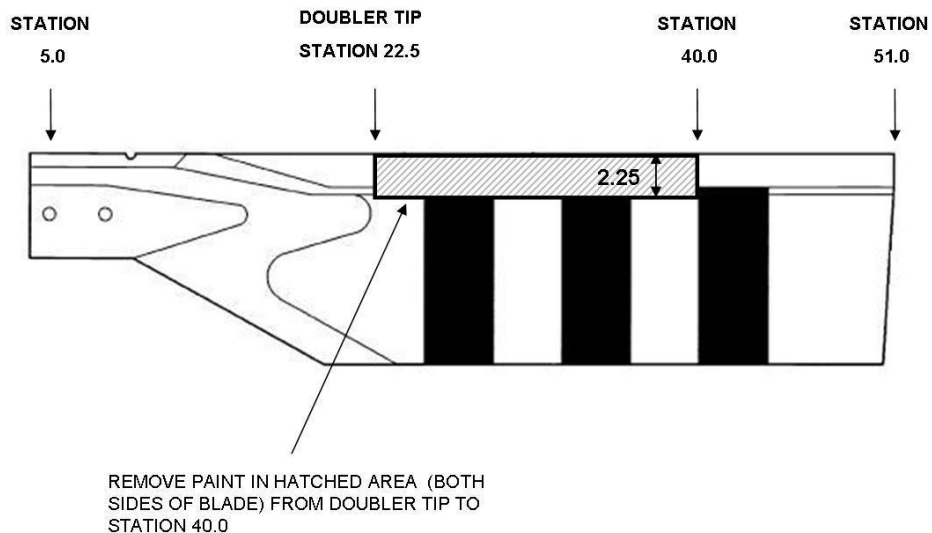
Figure 1

4. Ensure that all paint (on the spar only) is removed from the first 2.25 inches of the leading edge (chordwise) and from the B.S 22.5 (doubler tip) to B.S. 40.0. Refer to Figure 1. This will expose the spar up to the fillet between the blade spar and skin. A fillet filled with adhesive runs spanwise between the blade spar and the skin 2.25 inches aft of the blade leading edge, both inboard and outboard sides. The area to be inspected runs along the edge of the spar fillet and a half inch forward of this point. (Between 1.75 and 2.25 inch from the leading edge of the blade and from Blade Stations 22.5 to 40.0, both inboard and outboard sides).

5. Wipe area with a clean cloth dampened with alcohol (C-385) or aliphatic naphtha (C-305) and dry thoroughly.
6. Carry out a detailed visual inspection of the spar for corrosion and/or pitting using a 3-power or higher magnifying glass. Anomalies on the steel spar 0.003 inch deep or less must be polished out in accordance with BHT-205A1-MM.

Any defect greater than 0.003 inch deep is cause for rejection and the blade must be removed from service.
