ALERT SERVICE BULLETIN
Bell Helicopter **TEXTRON**

NO. 206-05-105

MODEL AFFECTED: 206A/B-SERIES and TH-67

SUBJECT: TAIL ROTOR TRUNNION HOUSING SEAL 535642
INSTALLATION, ONE-TIME INSPECTION OF

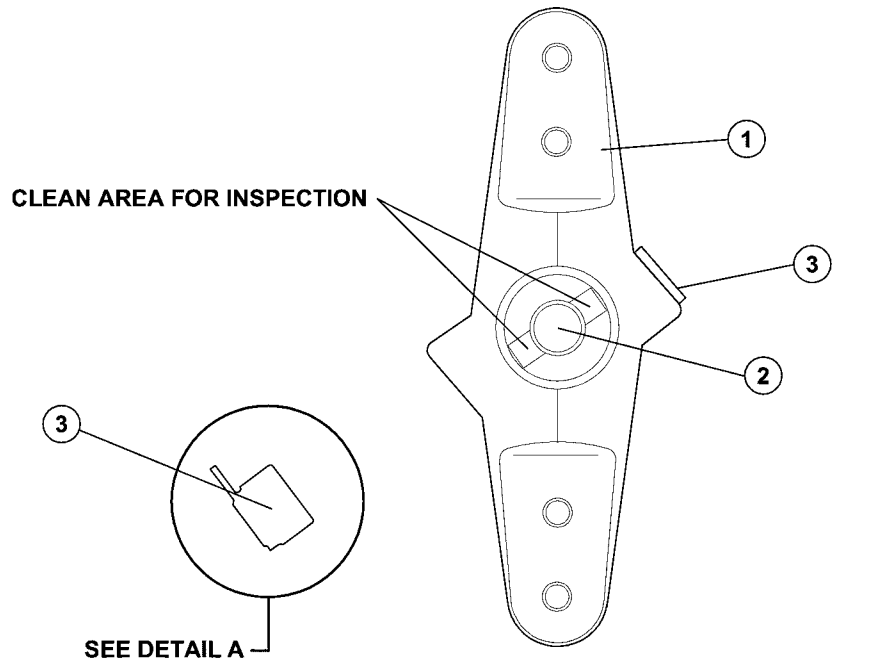
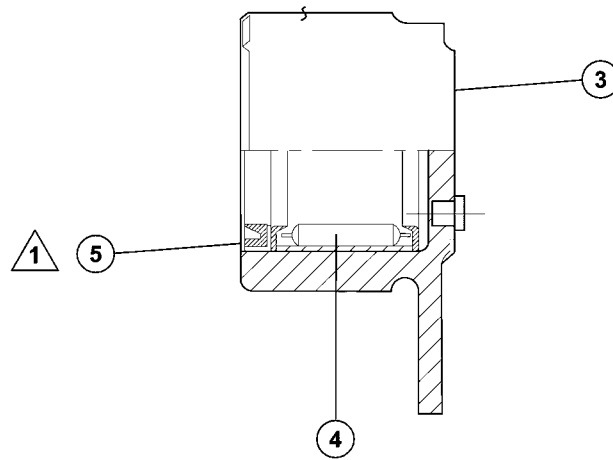
Figure 1. Correct orientation of seal in housing assembly

Bell Helicopter found that some 206-011-814-113 tail rotor trunnion housing assemblies sold as spares may have been assembled with the 26001-7027 seal installed backward. Incorrect installation of the seal will prevent the bearing from getting adequate lubrication and may result in the seal being pushed out of the housing assembly during lubrication.

1. Inspect new housing assembly (3, Figure 1) not installed in a hub assembly (1) for correct seal (5) installation. If the housing assembly (3) is found with the seal (5) incorrectly installed, return the defective housing assembly (3) to Bell Helicopter and order a new housing assembly (3).
2. Inspect new housing assembly (3) installed in tail rotor hub assembly (1) for correct seal (5) installation. If the housing assembly (3) is found with the seal (5) incorrectly installed, perform PART III a. of this Alert Service Bulletin.
3. Inspect housing assembly (3) installed in a hub assembly (1) with time in service for correct seal (5) installation. If the housing assembly (3) is found with the seal (5) incorrectly installed, perform PART III b. of this Alert Service Bulletin.

Lip of seal facing toward the tail rotor gearbox output shaft.
Correct installation shown.

PART III of this Alert Service Bulletin has you replace the 206-011-814-113 housing assembly in spares or installed on the helicopter if found with a 26001-7027 seal incorrectly installed.

1. Remove the tail rotor hub and blade assembly from the helicopter. Refer to the BHT-206A/B-SERIES MM.
2. Replace affected housing assembly (3) and both trunnion (2) inner races. Refer to the BHT-206B3-CR&O or to the BHT-206A/B-CR&O as applicable.
3. Re-install the tail rotor hub and blade assembly on the helicopter. Refer to BHT-206A/B-SERIES-MM.
4. Ground-run the helicopter and perform a tail rotor balance check. Refer to BHT206A/B-SERIES-MM or the TB 206-96-163.
5. Make an entry in the Helicopter and the Component Historical Records to show that Part III c. of this Alert Service Bulletin has been accomplished.
