ALERT SERVICE BULLETIN
REVISION NOTICE
Bell Helicopter**TEXTRON**
A Subsidiary of Textron Inc.

SUBJECT: **REVISION "A" TO ALERT SERVICE BULLETIN 206-06-107:
(VERTICAL FIN SUPPORTS 206-031-417-003/-007 AND 206-031-418-
001/-005, INSPECTION OF)**

NO. 206-06-107

SUBJECT: VERTICAL FIN SUPPORTS 206-031-417-003/-007
AND 206-031-418-001/-005, INSPECTION OF

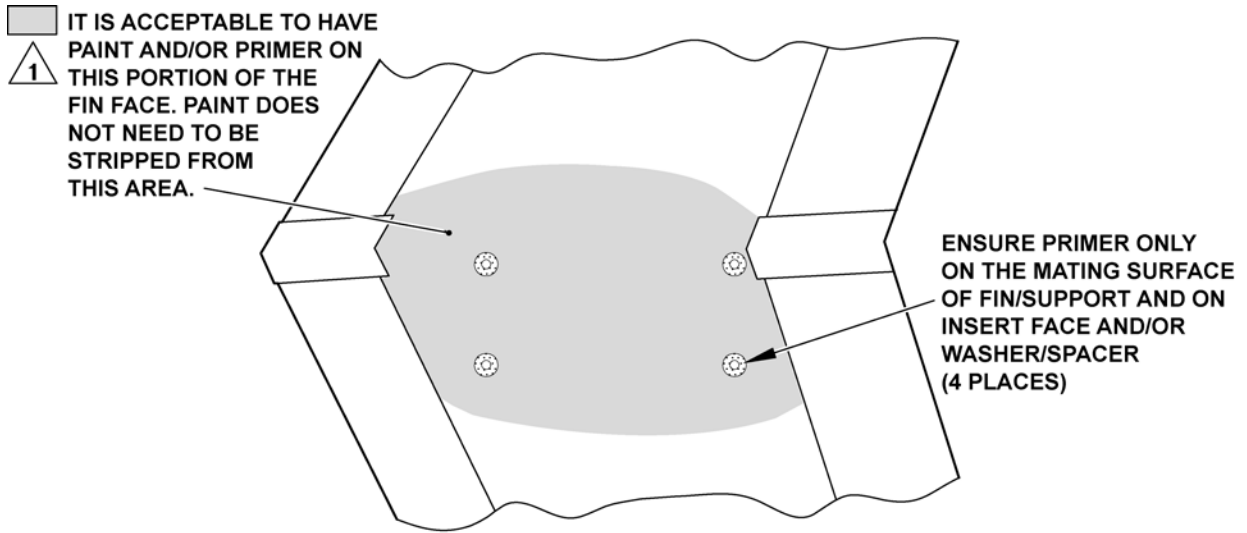
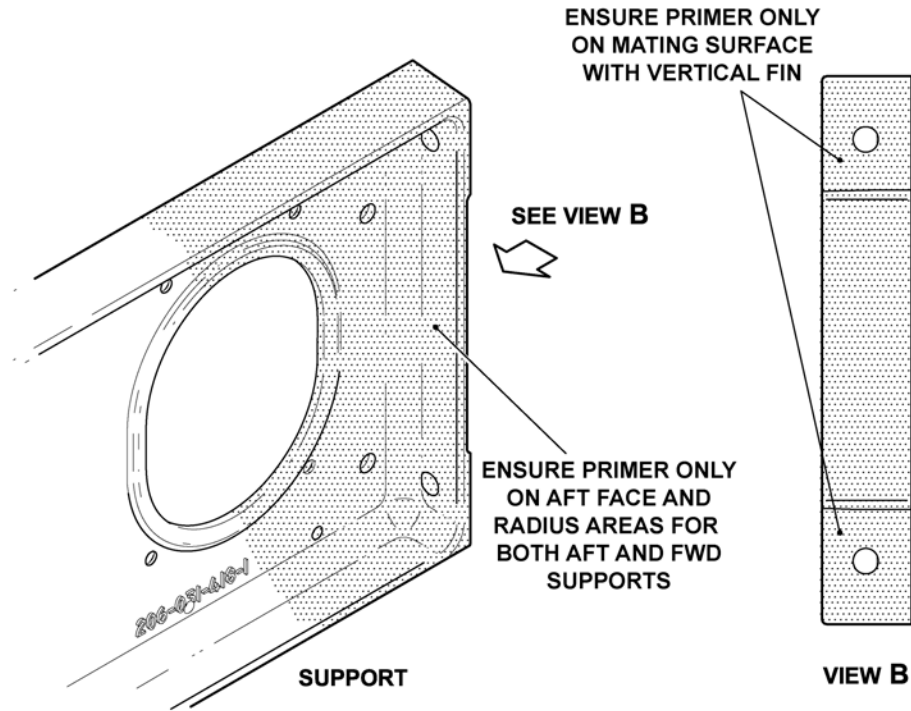
Figure I: Primer Application for Vertical Fin and Support

6. Inspect the supports and fin for the presence of paint coating at the indicated areas on Figure 1. Do not remove paint now, record your findings and proceed with the step 7 (with Type 2 fin only) and 8 or 9 depending on what you have recorded on Table 2 or 3 as applicable.

- c. For Type 2 fin only, if incorrect washers (spacers) or no washers were installed, do the following. Perform a visual inspection with a 10 X power magnifying glass of the potted inserts of the vertical fin as per Figure 1, Detail A.

- e. Perform a visual inspection with a 10 X power magnifying glass of the supports in the areas shown on the Figure 1, View B:
 - 1) If no crack is visible, NDT FPI Method (ASTM E1417) may be performed immediately or within the next 100 hours or 3 months following the visual inspection as per the BHT-ALL-SPM. Portable kits (Method C) may be employed for inspection of localized areas of components and parts installed on aircraft. If you choose to accomplish the NDT inspection within the next 100 hours or 3 months, apply two coat of Polyamide Epoxy Primer (C-204) or (C-245) now until the time of NDT. If no crack is present following the NDT, apply two coats of Polyamide Epoxy Primer (C-204) or (C-245) on bare metal surfaces and proceed to step f.

1 If paint is present in this area, it is suspected that the washer (spacer) and mating surface has paint coating. In this case, the fin shall be removed for verification.

This surface shall have primer coating only. Remove all paint coating, if present. Refer to BHT-ALL-SPM.

- b. Remove all organic finish (primer and paint coating) at the areas indicated on the Figure 1. Reference the BHT-ALL-SPM for paint removal and primer application.

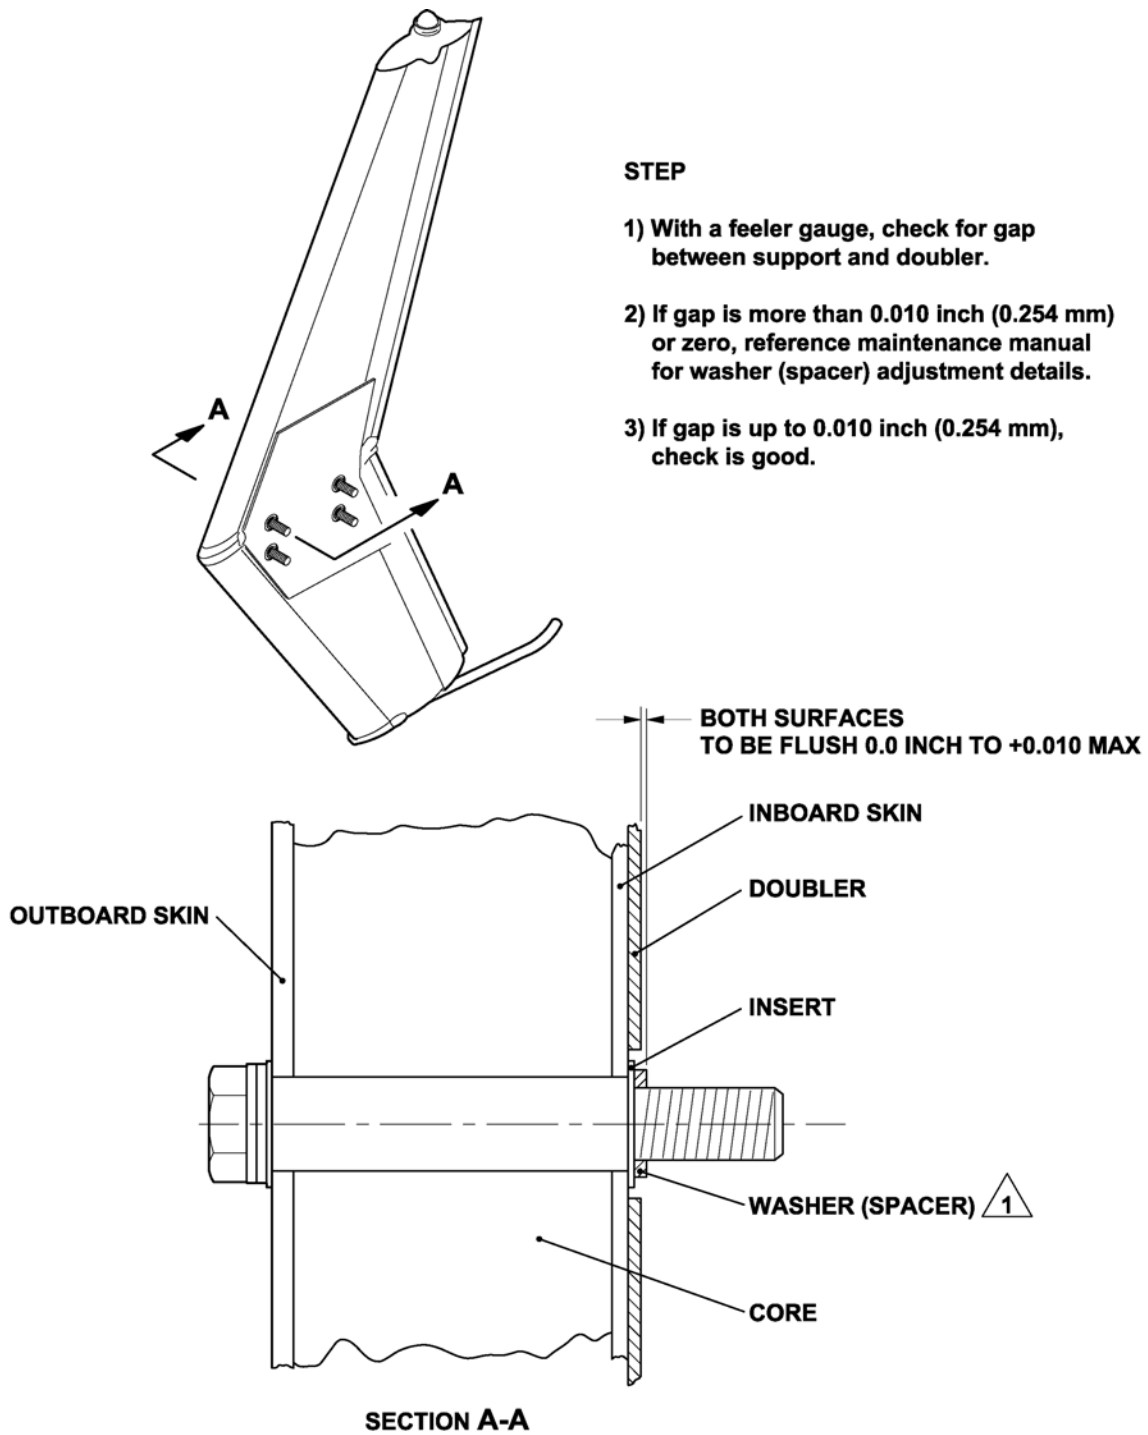
Figure II: Vertical Fin Type 2 Doubler and Washer (Spacer) Stack-Up Gap Check

7. Perform gap check. Reference Figure 2. Record your findings and proceed with step 8 or 9 depending on what you have recorded on Table 3.
8. If the torque was within limits (not below 50 in-lbs (5.65 Nm)), no presence of paint and the gap check (Type 2 fin) was good; perform a 10 X visual inspection of the supports in the area of the fin attaching hardware.

1 FOR WASHER (SPACER) INSTALLATION, REFER TO MAINTENANCE MANUAL.

- 1) If no damage is found, proceed to step d.
 - 2) If any damage of the potted insert is detected, contact Product Support Engineering.
 - d. If the fin installed is of Type 2, ensure the correct washers (spacers) are installed between the supports and the fin inner skin. Refer to the Figure 2 Section A-A. For washers (spacers) inspection and installation procedure, refer to the BHT-206A/B-SERIES-MM, chapter 53.
