ALERT SERVICE BULLETIN
Bell Helicopter **TEXTRON**

NO. 206-06-108

SUBJECT: AERONAUTICAL ACCESSORIES INC. FLAT CREW WINDOW P/N 206-202-001 AND 206-202-002, STC SH5773SW

ALERT SERVICE BULLETIN ASB No. AA-06066

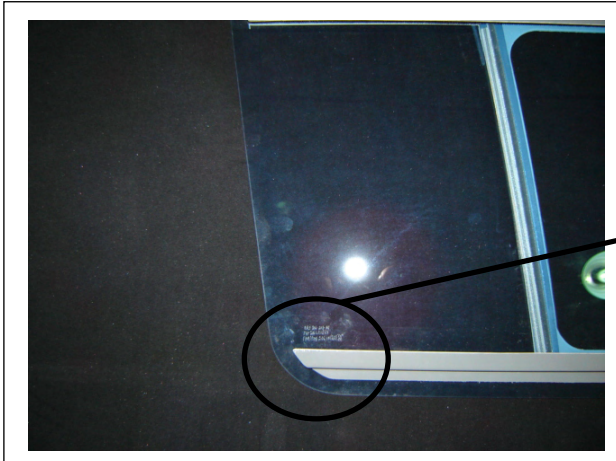
FIGURE 1 – Identification

COMPLIANCE: Immediately upon receipt of this bulletin, determine by part number, serial number, and manufacture date (ref. Figure 1) if affected window(s) is (are) installed. Only those serial numbers listed are affected. A part with a serial number that is close to, or has a serial number prefix different from those listed is not affected by this bulletin. For installed windows, conduct Part I visual inspection within 8 hours; conduct Part II inspections within 24 hours. For uninstalled windows, accomplish Part I and Part II prior to installation on a helicopter.

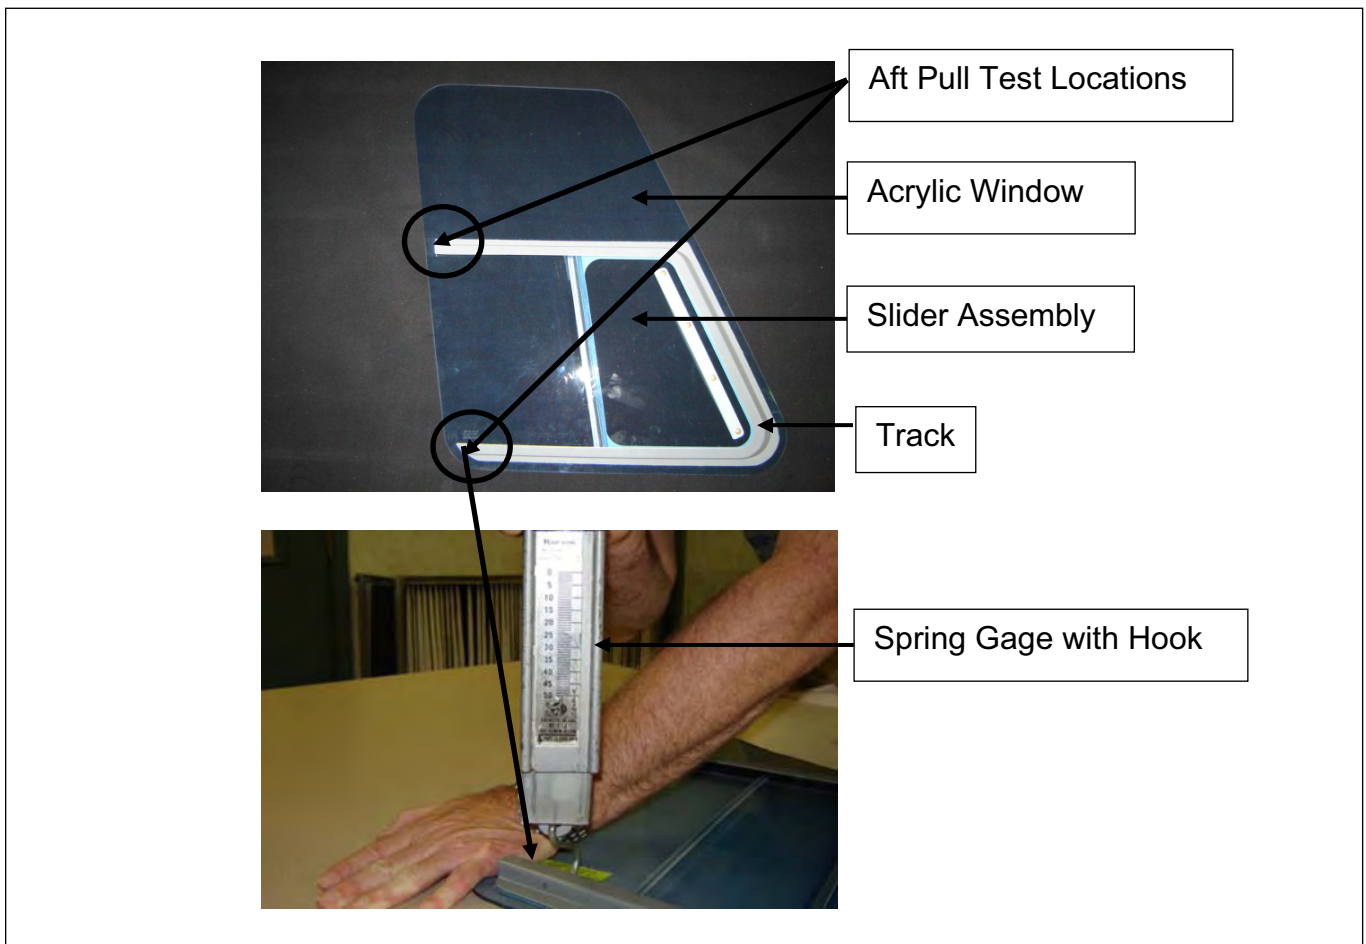
FIGURE 3 – Aft Pull Test Locations

1. With the slider assembly in the full-closed (fwd) position from the exterior of the aircraft using the spring gage, insert the hook directly into the channel of the slider track at the aft end of the slider (ref. Figure 3). Pull outward on the slider track (away from the acrylic) until the gage reads 25 lbs. Visually inspect track frame of slider for any obvious signs that the frame is de-bonding from the acrylic.

2. Repeat step 1 at second track location indicated in Figure 3.
3. With the slider assembly in the full-closed (fwd) position, from the interior of the aircraft, apply manual outward pressure at the two locations indicated in Figure 4. Visually inspect slider track for any obvious signs that the track is de-bonding from the acrylic.

6. Remove and replace any defective window with an airworthy window.
7. Annotate records to indicate compliance with Part II of this inspection.

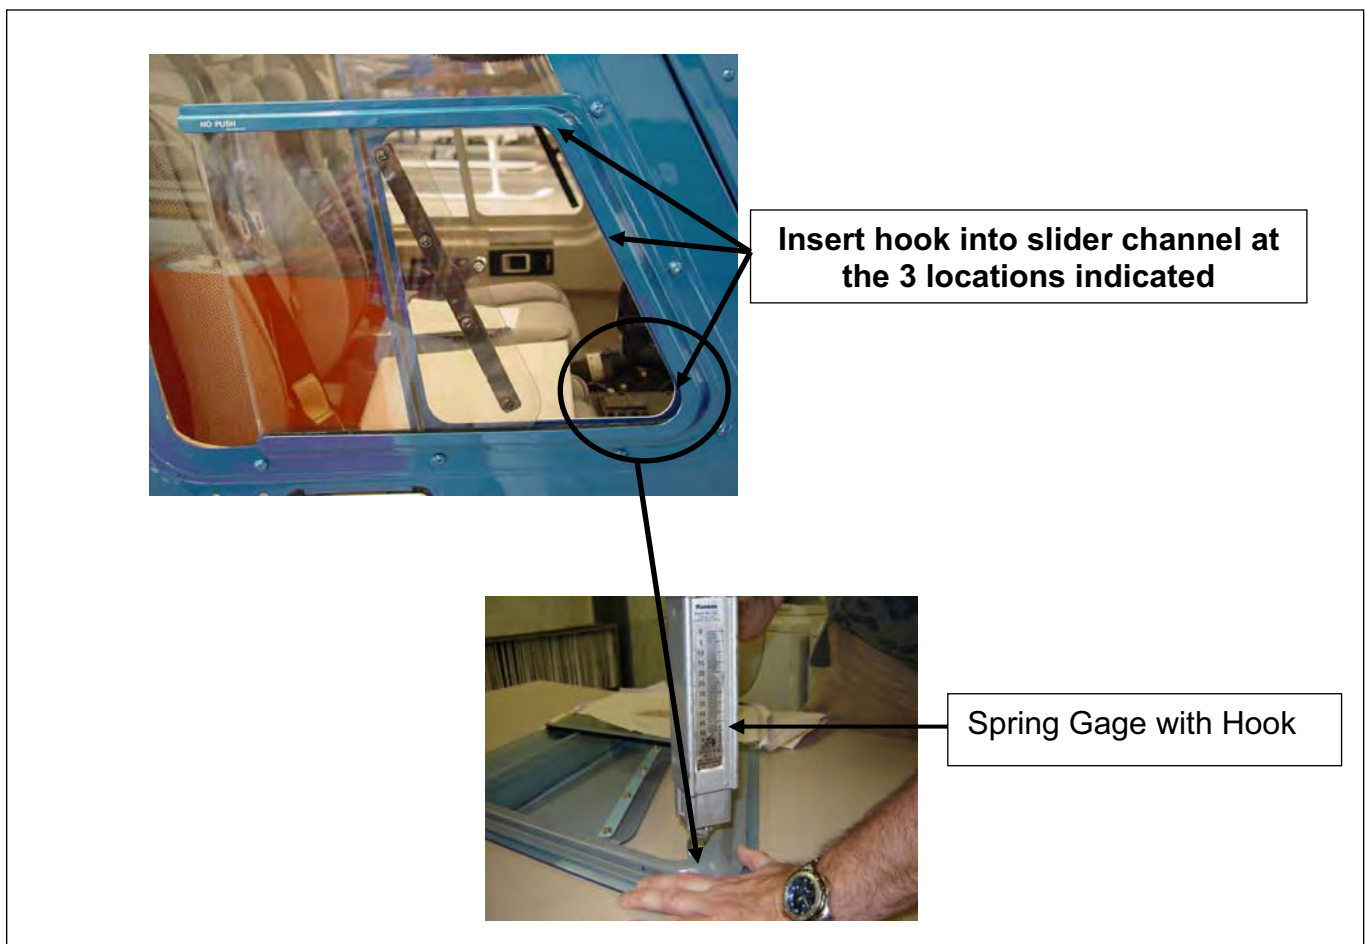
FIGURE 5 – Forward Pull Test Locations

4. With the slider assembly in the full-open (aft) position, from the exterior of the aircraft, insert the spring hook directly into the channel of the slider track at the 3 locations indicated in Figure 5.

5. Using the spring gage, pull outward on the slider track (away from the acrylic) until the gage reads 25 lbs. Visually inspect the slider track for any obvious signs that the track is de-bonding from the acrylic.
