**ALERT SERVICE BULLETIN**  
**Bell Helicopter** **TEXTRON**

NO. 206-06-110

**MODEL AFFECTED:** 206A/B and TH-67 Series

**SUBJECT:** UPPER LEFT-HAND TAILBOOM ATTACHMENT  
HARDWARE, INSPECTION OF

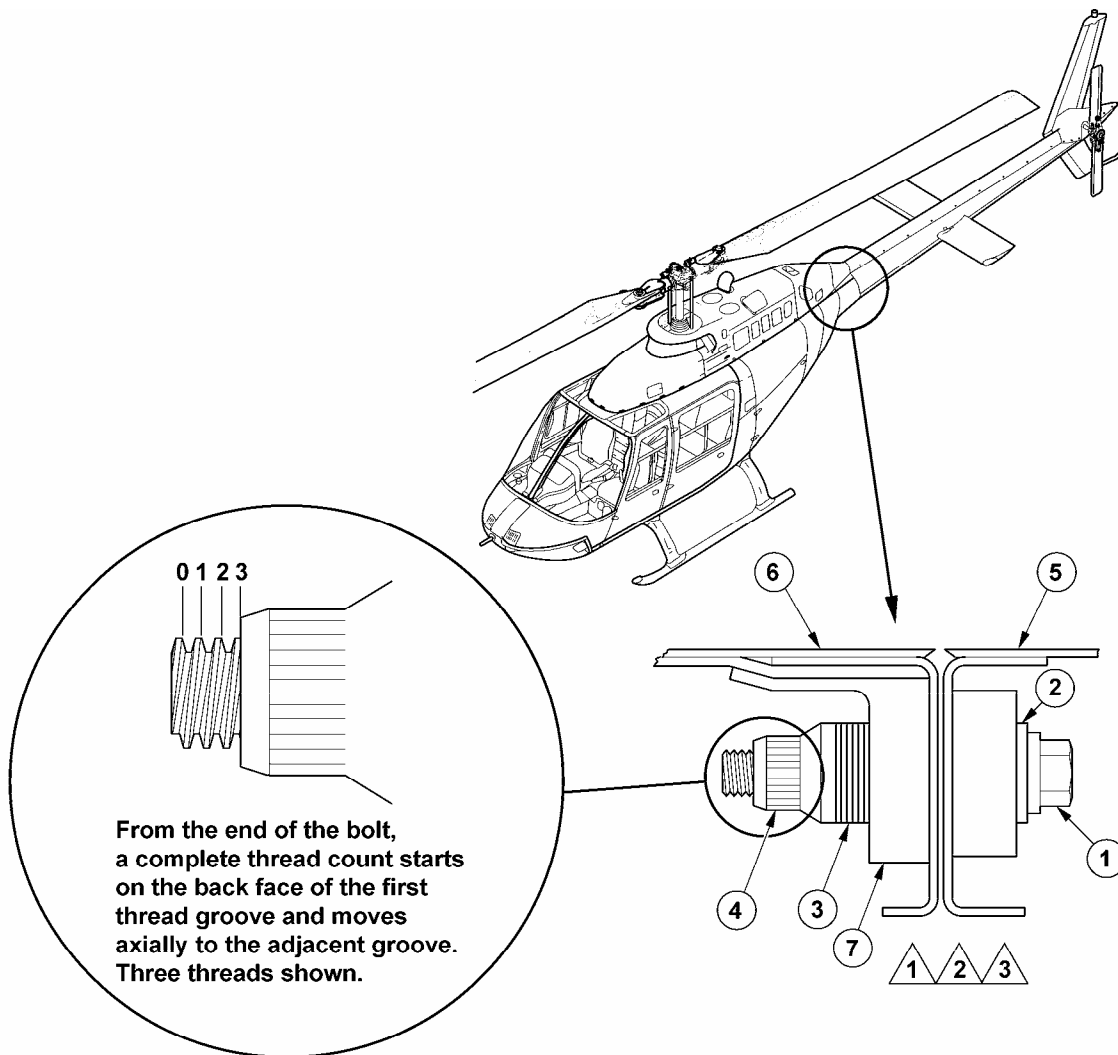
**Figure 1: Tailboom Attachment**

Bell Helicopter found that on some helicopters having the 407-030-750-103 CRES steel fitting installed at the upper left-hand location, the attachment bolt might not meet the installation requirement.

From the end of the bolt, a complete thread count starts on the back face of the first thread groove and moves axially to the adjacent groove. Three threads shown.

- 1 Bolt (1) and chamfered washer (2) are to be installed through tailboom (5) and Aft fuselage (6). Bolt head and chamfered washer are to be installed on the tailboom side. Steel washers (3) are to be installed next to fitting (7) to provide not less than one thread and not more than three threads exposed on threaded end of bolt (1).
- 2 If thread count is less than one, remove washers as required.
- 3 If thread count is more than three, remove and replace bolt, then readjust number of washers to meet requirement of note 1.

7. If less than 1 thread is exposed, adjust the washer (3) quantity as required per Figure 1. Refer to the Maintenance Manual and torque as required. Make an entry in the helicopter records to indicate that this bulletin has been accomplished.

8. If more than 3 threads are exposed and a replacement bolt (1) is not available at this time, adjust the washer (3) quantity as required per Figure 1. Refer to the Maintenance Manual and torque as required. Make an entry in the helicopter records to indicate that the PART I of this bulletin have been accomplished and that the PART II of this bulletin will require accomplishment.

9. If more than 3 threads are exposed and a replacement bolt (1) is available, accomplish PART II of this bulletin.

1. Remove and discard the upper left hand tailboom attachment bolt (1, Figure 1). Install new bolt (1) and adjust the quantity of washer (3) as required to ensure correct installation as shown on Figure 1. If serviceable, the nut (4) does not require replacement. Refer to Maintenance Manual.
2. 100 hours after installation, do a torque check of the upper left hand tailboom attaching hardware (BHT-206A/B-SERIES-MM).
3. Make an entry in the helicopter records to indicate that this bulletin has been accomplished.
